RING SMRA 16-17285-01 - CU ALLOY - ROMAN TIMES - SWITZERLAND

Artefact name Ring SMRA 16-17285-01

Authors Christian. Degrigny (HE-Arc CR, Neuchâtel, Neuchâtel, Switzerland) & Naima. Gutknecht (HE-Arc CR, Neuchâtel, Neuchâtel, Switzerland) & Valentina. Valbi (Laboratoire Métallurgie et Culture LMC-IRAMAT-CNRS-UTBM, Belfort, Franche-Comté, France)

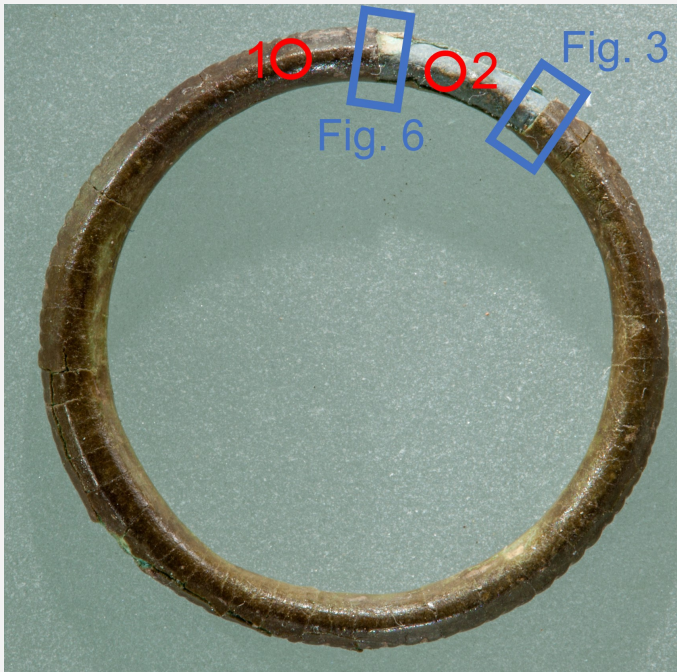
Fig. 2: Location of XRF analyses (red circles), Fig. 3 (blue square) and Fig. 6 (Raman spectroscopy (blue square)) on face A.

XRF analysis was carried out without sampling. For point 1, all strata (soil, corrosion products, and metal) are analyzed at the same time. As for point 2, the analysis was performed where corrosion layers flaked. Therefore, it reflects better the metal composition. The metal is presumably a copper-tin alloy with some lead, while the Si, Fe, Al and P are probably coming from the burial environment. The higher amount of tin on point 1 (with corrosion layers) than on point 2 (corrosion structure flaked, metal visible) is a strong indicator of tin enrichment on the corrosion layers. The presence of chlorine could not be revealed.

Table 2: Chemical composition analysed with handheld XRF at the surface of the ring for two representative points shown in Fig.2. The results are rounded up to the nearest whole number (n.d.: below the detection limit), UR-Arc CR.

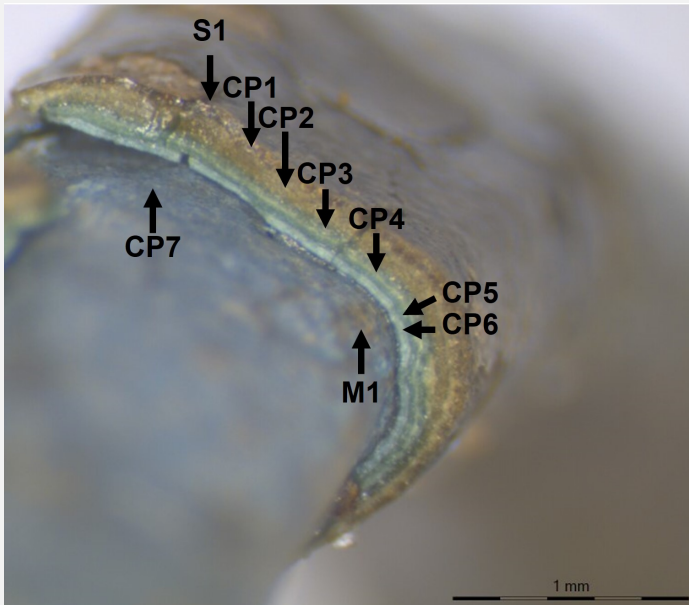
Fig. 3: Description of the corrosion structure.

The schematic representation below gives an overview of the corrosion structure encountered on the ring from a first visual macroscopic observation. There are cracks through CP1 to CP6 that generate the flaking of the layers.

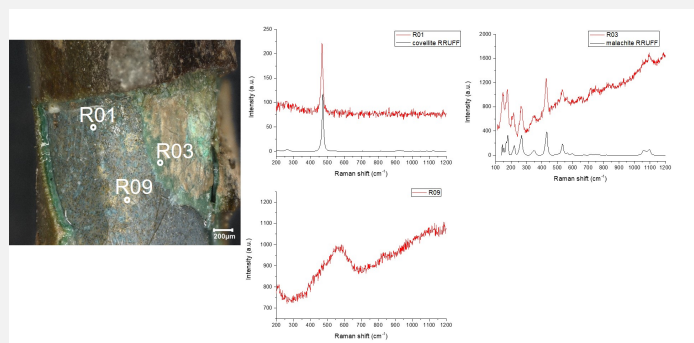
It was not possible to sample this artefact. Therefore, μ -Raman point analyses were performed on the surface of the object in an area where different strata of corrosion products were exposed, as shown in Fig. 6 in a micrograph taken by optical microscopy. The surface of the object appears brown (CP1). It covers a green stratum (CP5) and a blue/golden one (CP7 and M1) with black spots in it. The R01 analysis point was performed on one of the black spots observed in the blue stratum and can be identified as covellite (CuS) by comparison with a reference spectrum. Point analyses performed on the blue (CP7) and golden stratum showed a spectrum with a large peak at around 560 cm^{-1} (R09) that can be identified as nanocassiterite (SnO_2) by comparison with the work of Ospitali et al. 2012. The R03 point analysis was performed on the green stratum (CP5) and is identified as malachite ($\text{Cu}_2(\text{CO}_3)(\text{OH})_2$) by comparison with a reference spectrum.

Fig. 6: Raman points of analysis on the surface of the object and Raman spectra obtained for R01 (together with the covellite reference spectrum RRUFFID=R060306), R03 (together with the malachite reference spectrum RRUFFID=R050508) and R09,

The ring is a tin bronze probably with some lead. The identification of nanocassiterite as the most internal CP shows a phenomenon of decuprification typical of bronze corrosion, accompanied by the formation of copper hydroxycarbonate as a more external CP. The dark inclusions observed in the CP7 and identified as covellite are likely to be residuals of copper sulfide inclusions from the metal microstructure.
