## RING SMRA 16-17285-01 - CU ALLOY - ROMAN TIMES - SWITZERLAND

<b>Artefact name</b>	Ring SMRA 16-17285-01
<b>Authors</b>	Christian. Degrigny (HE-Arc CR, Neuchâtel, Neuchâtel, Switzerland) & Naima. Gutknecht (HE-Arc CR, Neuchâtel, Neuchâtel, Switzerland) & Valentina. Valbi (Laboratoire Métallurgie et Culture LMC-IRAMAT-CNRS-UTBM, Belfort, Franche-Comté, France)
<b>Url</b>	/artefacts/1324/

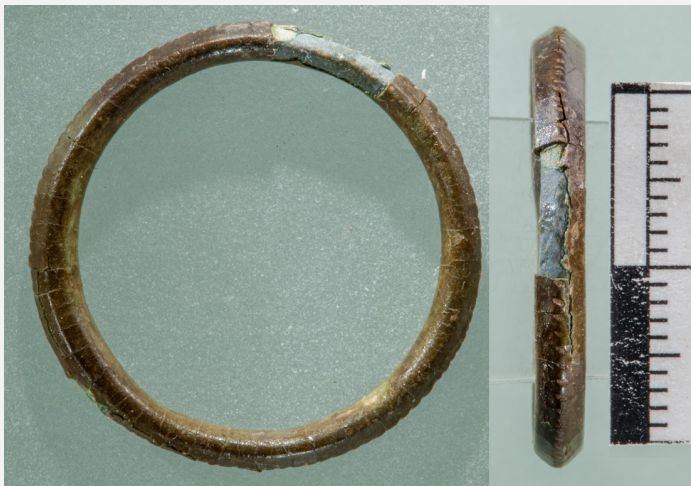
Fig. 1: Ring (face A and side views),

<b>Description of the artefact</b>	Ring with a faceted cross-section and decorated with ridges on the outside. Its original shape seems to be preserved although the brown corrosion structure is heavily cracked and even has a large lacuna on face A (Fig. 1). Diameter (external) = 2.6cm and weight = 2.5g.
<b>Type of artefact</b>	Jewellery
<b>Origin</b>	Avenches, Switzerland, Avenches, Vaud, Switzerland
<b>Recovering date</b>	2016
<b>Chronology category</b>	Roman Times
<b>chronology tpq</b>	<input type="text"/> ---- ▾
<b>chronology taq</b>	<input type="text"/> ---- ▾
<b>Chronology comment</b>	
<b>Burial conditions / environment</b>	Soil
<b>Artefact location</b>	Site et musée romains Avenches, Avenches, Vaud
<b>Owner</b>	Site et musée romains Avenches, Avenches, Vaud
<b>Inv. number</b>	SMRA 16/17285-01
<b>Recorded conservation data</b>	Cleaning of soil with ethanol and consolidation with resin paraloid B72 in ethyl acetate. Drying at 50°C.

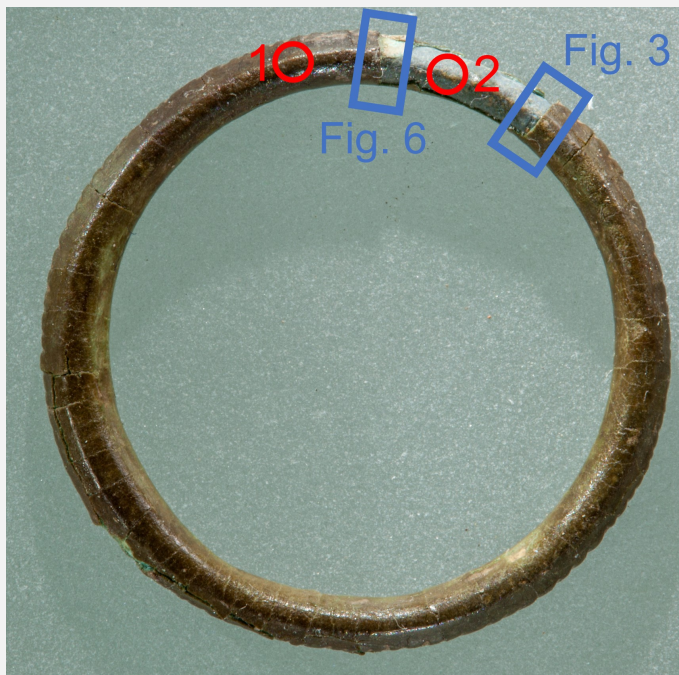
Fig. 2: Location of XRF analyses (red circles), Fig. 3 (blue square) and Fig. 6 (Raman spectroscopy (blue square)) on face A.

XRF analysis was carried out without sampling. For point 1, all strata (soil, corrosion products, and metal) are analyzed at the same time. As for point 2, the analysis was performed where corrosion layers flaked. Therefore, it reflects better the metal composition. The metal is presumably a copper-tin alloy with some lead, while the Si, Fe, Al and P are probably coming from the burial environment. The higher amount of tin on point 1 (with corrosion layers) than on point 2 (corrosion structure flaked, metal visible) is a strong indicator of tin enrichment on the corrosion layers. The presence of chlorine could not be revealed.

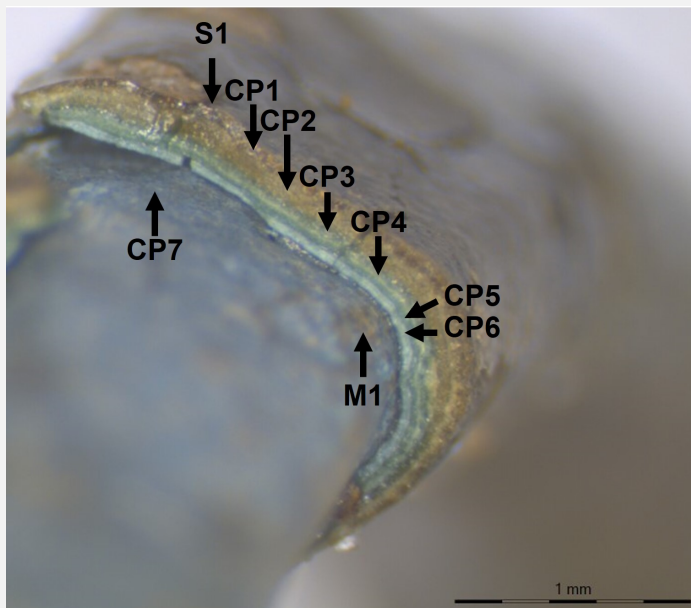
Fig. 3: Description of the corrosion structure.

The schematic representation below gives an overview of the corrosion structure encountered on the ring from a first visual macroscopic observation. There are cracks through CP1 to CP6 that generate the flaking of the layers.

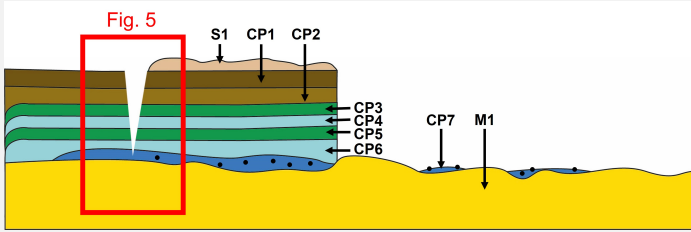
Fig. 4: Stratigraphic representation of the corrosion structure of the ring by macroscopic and binocular observation with indication of the corrosion structure used to build the MiCorr stratigraphy of Fig. 5 (red rectangular),

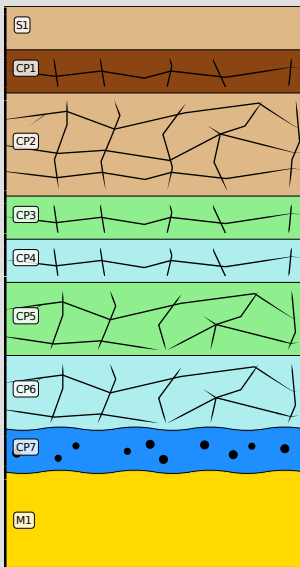
Fig. 5: Stratigraphic representation of the corrosion structure of the ring observed macroscopically under binocular using the MiCorr application with reference to Fig. 4. The characteristics of the strata, such a discontinuity, are accessible by clicking on the drawing that redirects you to the search tool by stratigraphy representation, Credit HE-Arc CR, N.Gutknecht.

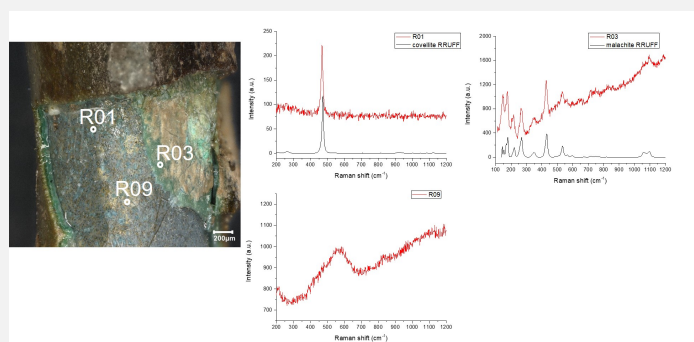
It was not possible to sample this artefact. Therefore,  $\mu$ -Raman point analyses were performed on the surface of the object in an area where different strata of corrosion products were exposed, as shown in Fig. 6 in a micrograph taken by optical microscopy. The surface of the object appears brown (CP1). It covers a green stratum (CP5) and a blue/golden one (CP7 and M1) with black spots in it. The R01 analysis point was performed on one of the black spots observed in the blue stratum and can be identified as covellite (CuS) by comparison with a reference spectrum. Point analyses performed on the blue (CP7) and golden stratum showed a spectrum with a large peak at around 560  $\text{cm}^{-1}$  (R09) that can be identified as nanocassiterite (SnO<sub>2</sub>) by comparison with the work of Ospitali et al. 2012. The R03 point analysis was performed on the green stratum (CP5) and is identified as malachite (Cu<sub>2</sub>(CO<sub>3</sub>)(OH)<sub>2</sub>) by comparison with a reference spectrum.

Fig. 6: Raman points of analysis on the surface of the object and Raman spectra obtained for R01 (together with the covellite reference spectrum RRUFFID=R060306), R03 (together with the malachite reference spectrum RRUFFID=R050508) and R09,

The ring is a tin bronze probably with some lead. The identification of nanocassiterite as the most internal CP shows a phenomenon of decuprification typical of bronze corrosion, accompanied by the formation of copper hydroxycarbonate as a more external CP. The dark inclusions observed in the CP7 and identified as covellite are likely to be residuals of copper sulfide inclusions from the metal microstructure.
