# PORTUGUESE COIN - 1 ESCUDO - 1962 - CU ZN NI - MODERN TIMES

**Artefact name** Portuguese Coin - 1 Escudo - 1962  
**Authors** Catarina. Cordeiro (Universidade Católica Portuguesa, Porto, Porto, Portugal)  
**Url** /artefacts/1337/

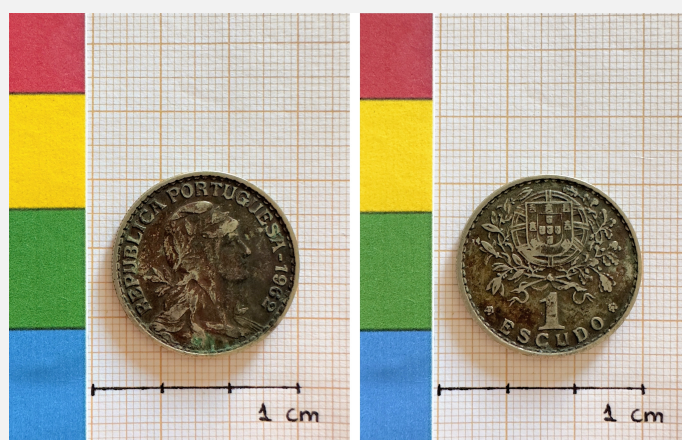
Fig. 1: Views of both sides of a Portuguese coin (front and back, respectively),

<b>Description of the artefact</b>	Portuguese coin (Escudo from 1962) with brown and green corrosion products. Dimensions: about 2.7 cm in diameter.
<b>Type of artefact</b>	coin
<b>Origin</b>	Lisboa, Portugal
<b>Recovering date</b>	Unknown
<b>Chronology category</b>	Modern Times
<b>chronology tpq</b>	<input type="text" value="1962"/> <input type="text" value="A.D."/>
<b>chronology taq</b>	<input type="text"/> <input type="text" value="----"/>
<b>Chronology comment</b>	20th century

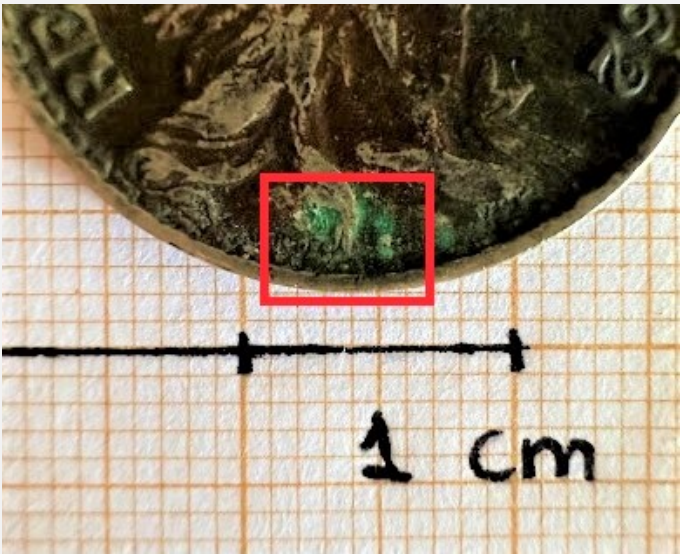
Fig. 2: Study area - detail of the location of Fig. 3 (front of the coin),

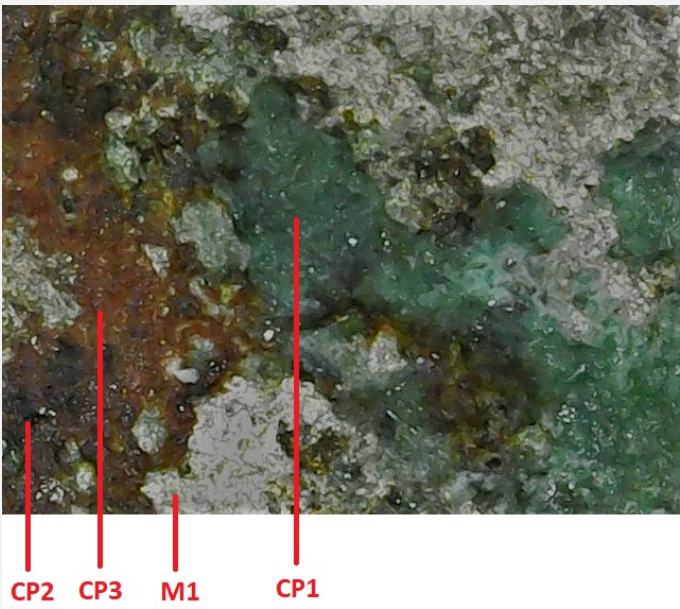
Fig.3: Detail of the corrosion structure. Used as reference for Fig. 4,

The coin presents 3 types of compounds, two with brown tones that occupy most of the surface and one with a green tone (copper-based compound) that is locally distributed and which could be due to chlorides (handling).

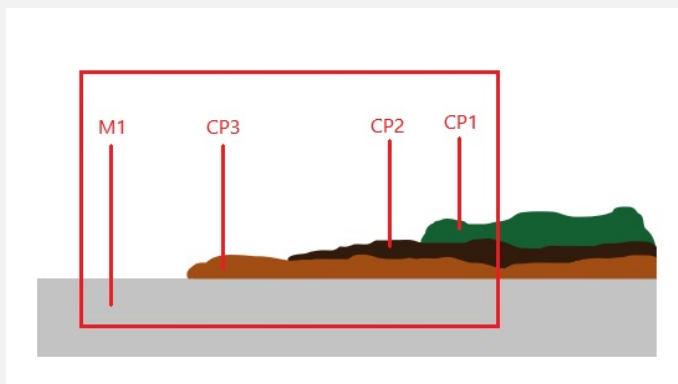
Stratum	Type of stratum	Principal characteristics
CP1	Corrosion product	Cluster, dark green, medium, isolated, compact, very soft
CP2	Corrosion product	Layer, dark brown, thin, discontinuous, compact, soft
CP3	Corrosion product	Layer, brown, thin, discontinuous, compact, soft
M1	Metal	Light grey, metallic, continuous, compact, hard

Fig. 4: Stratigraphic representation of the corrosion structure of the coin based on visual observation under a microscope with indication of the corrosion structure used to build the MiCorr stratigraphy of Fig. 5 (red square),

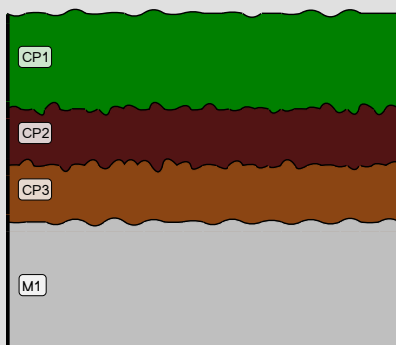
Fig. 5: Stratigraphic representation of the corrosion structure of the coin observed under microscope using the MiCorr application. The features of the strata are only accessible by clicking on the drawing which redirects you to the search tool by stratigraphic representation, credit C.L.Cordeiro.
