PORTUGUESE COIN - 1 ESCUDO - 1962 - CU ZN NI - MODERN TIMES

Artefact name	Portuguese Coin - 1 Escudo - 1962
Authors	Catarina. Cordeiro (Universidade Católica Portuguesa, Porto, Porto, Portugal)
Url	/artefacts/1337/

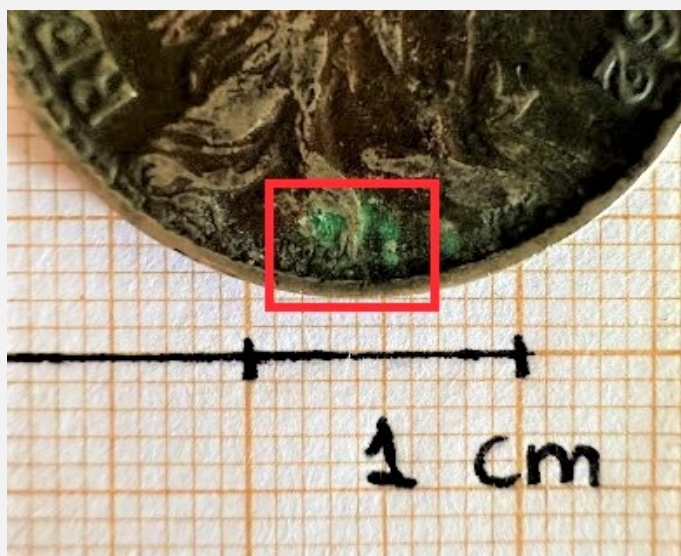
Fig. 2: Study area - detail of the location of Fig. 3 (front of the coin),

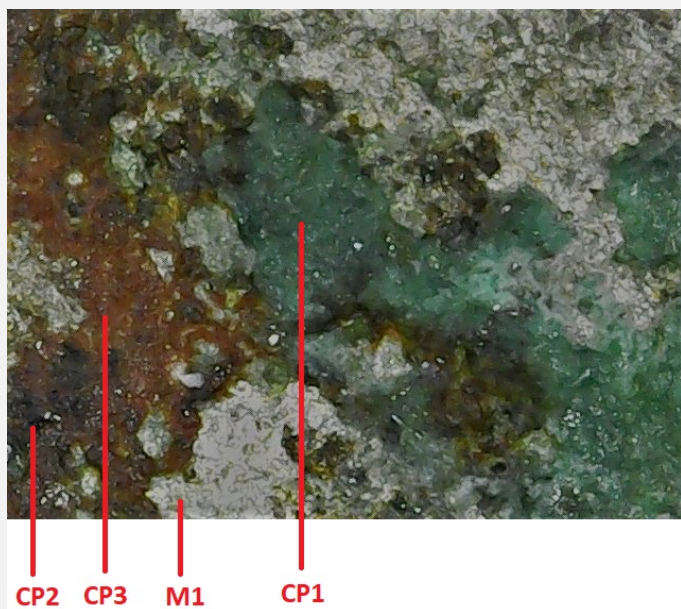
Fig.3: Detail of the corrosion structure. Used as reference for Fig. 4,

The coin presents 3 types of compounds, two with brown tones that occupy most of the surface and one with a green tone (copper-based compound) that is locally distributed and which could be due to chlorides (handling).

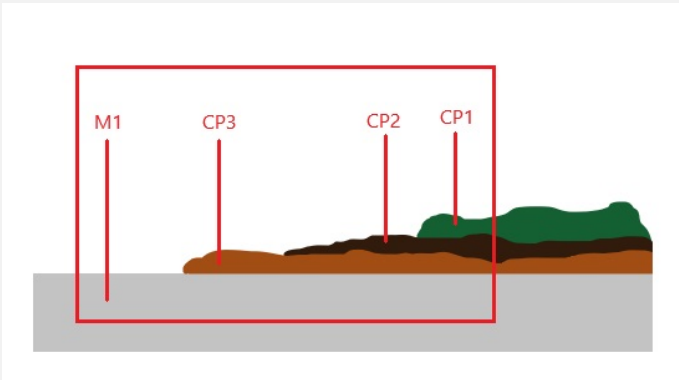
Stratum	Type of stratum	Principal characteristics
CP1	Corrosion product	Cluster, dark green, medium, isolated, compact, very soft
CP2	Corrosion product	Layer, dark brown, thin, discontinuous, compact, soft
CP3	Corrosion product	Layer, brown, thin, discontinuous, compact, soft
M1	Metal	Light grey, metallic, continuous, compact, hard

Fig. 4: Stratigraphic representation of the corrosion structure of the coin based on visual observation under a microscope with indication of the corrosion structure used to build the MiCorr stratigraphy of Fig. 5 (red square),

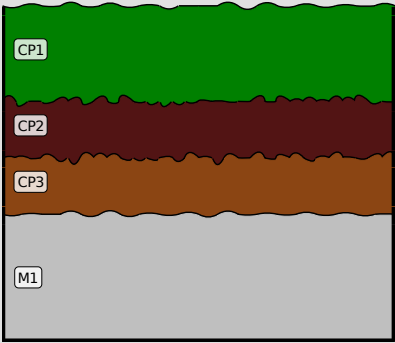
Fig. 5: Stratigraphic representation of the corrosion structure of the coin observed under microscope using the MiCorr application. The features of the strata are only accessible by clicking on the drawing which redirects you to the search tool by stratigraphic representation, credit C.L.Cordeiro.
