FRAGMENT OF AN AEGIS OF NEÏTH 1886.305.0096 – LEADED BRONZE

Artefact name Fragment of an Aegis of Neïth 1886.305.0096

Authors Line. Pedersen (HE-Arc, Neuchâtel, Neuchâtel, Switzerland) & Christian. Degrigny (HE-Arc CR, Neuchâtel, Neuchâtel, Switzerland) & Valentin. Boissonnas (HE-Arc CR, Neuchâtel, Neuchâtel, Switzerland)

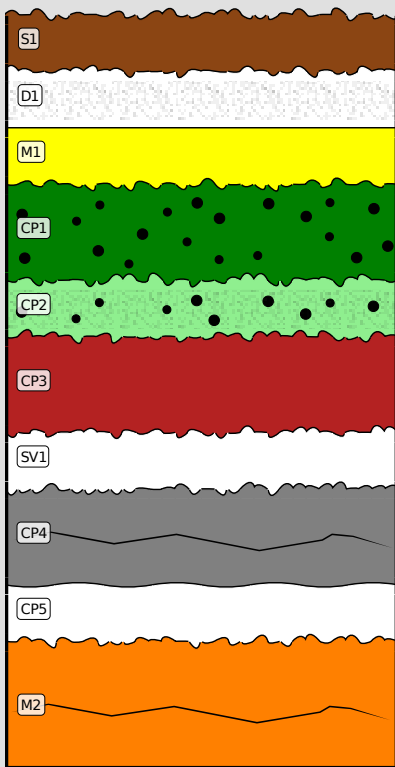
Fig.9: Schematic representation combining stratigraphies 1 and 2 under binocular microscope and using the MiCorr application. The characteristics of the strata are only accessible by clicking on the drawing that redirects you to the search tool by stratigraphy representation, Credit He-Arc CR, L.Pedersen.

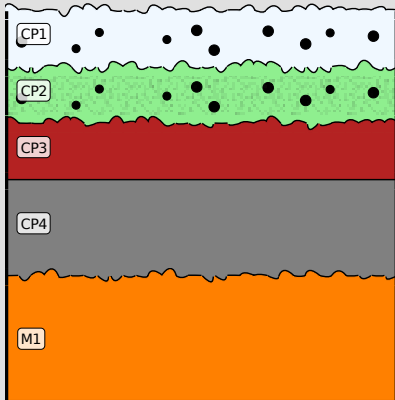
Fig.10: Schematic representation of stratigraphy 3 under binocular microscope and using the MiCorr application. CP1 is CP6 in Fig. 8. The characteristics of the strata are only accessible by clicking on the drawing that redirects you to the search tool by stratigraphy representation, Credit He-Arc CR, L. Pedersen.

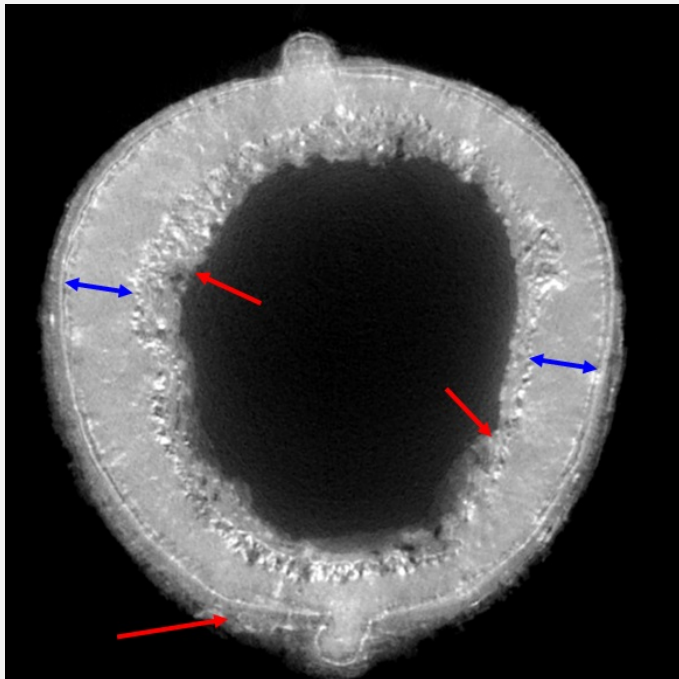
The metal seems to be a leaded bronze with remains of gold leaf on the surface (Table 1). As indicated by the X-ray tomography, the metal of the aegis seems to be well preserved (Figs. 11-12).

Fig. 11: X-ray tomography by cross section of the crown showing a dense and non-porous metal core (blue arrows). The corrosion products however are porous (red arrows). The external limitos is visible as a fine line preserved under corrosion layers,

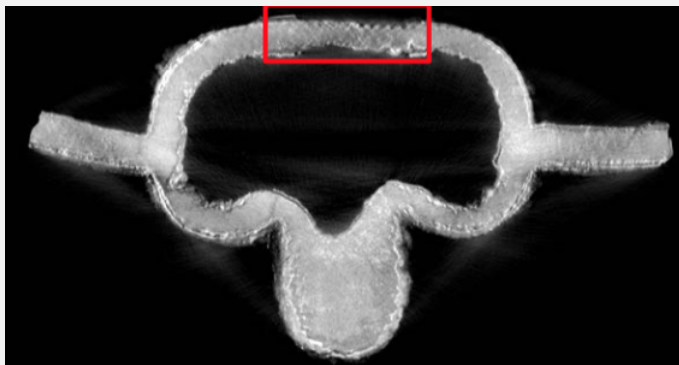
Fig. 12: X-ray tomography by cross section of the lower part showing that there are losses of the original surface (red square),

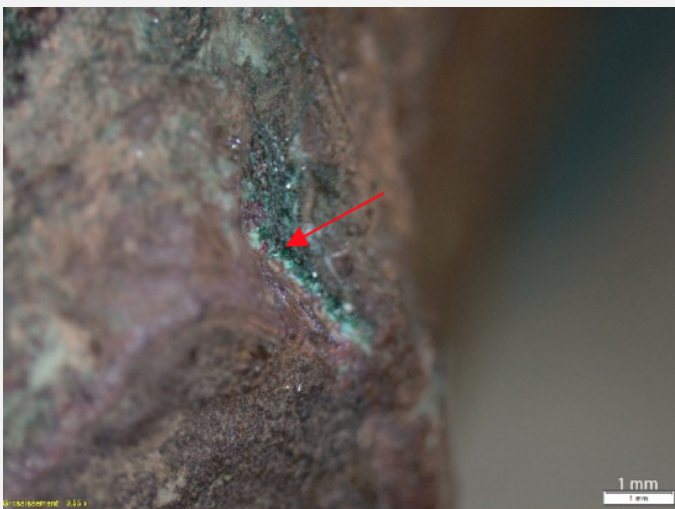
Fig. 13: Observation of the dark green corrosion product,

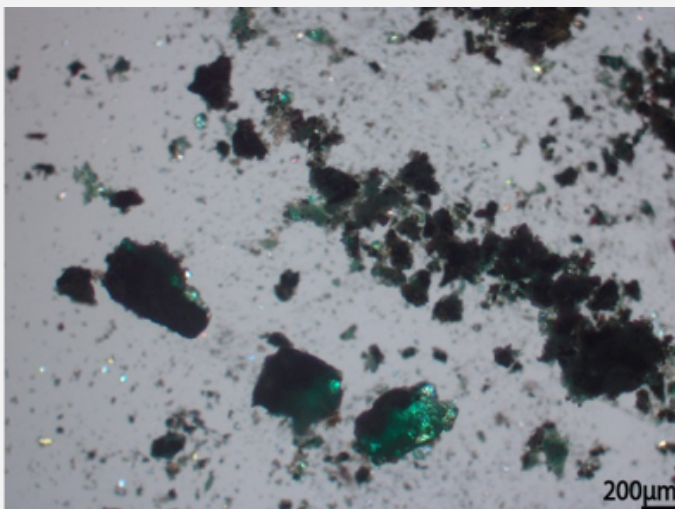
Fig. 14: Dark green corrosion product identified as paratacamite, atacamite $\text{Cu}_2\text{Cl}(\text{OH})_3$ by XRD. Microscopic examination under polarized light,
