DOUBLE-SIDED OIL PAINTING ON IRON PLATE WITH HANGERS – FE ALLOY – SECOND HALF OF 19TH CENTURY

Artefact name	Double-sided oil painting on iron plate with hangers
Authors	Zala. Uršič (, Ljubljana, Ljubljana, Slovenia) & Nataša. Nemeček (National museum of Slovenia, Ljubljana, Ljubljana, Slovenia)
Url	/artefacts/1427/

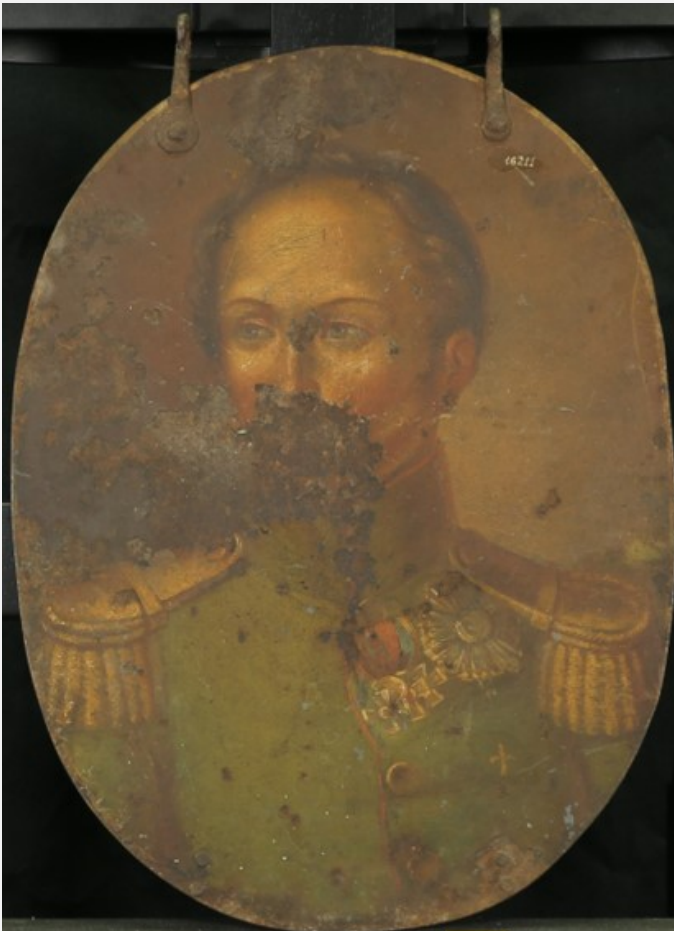
Fig.1: Front side of the oil painting on iron plate before restoration,

On both sides of the painting there is a thick layer of dirt (made up of corrosion products, dust, soot and pollutants) and a yellowed thin layer of coating present (presumably oil-resin based). Paint layer on both sides is damaged (missing paint layer to the support due to flaking and corrosion). Areas where iron is exposed are corroded; brown, red and black corrosion products are visible. Orange corrosion products are also locally present on top of the paint layer.

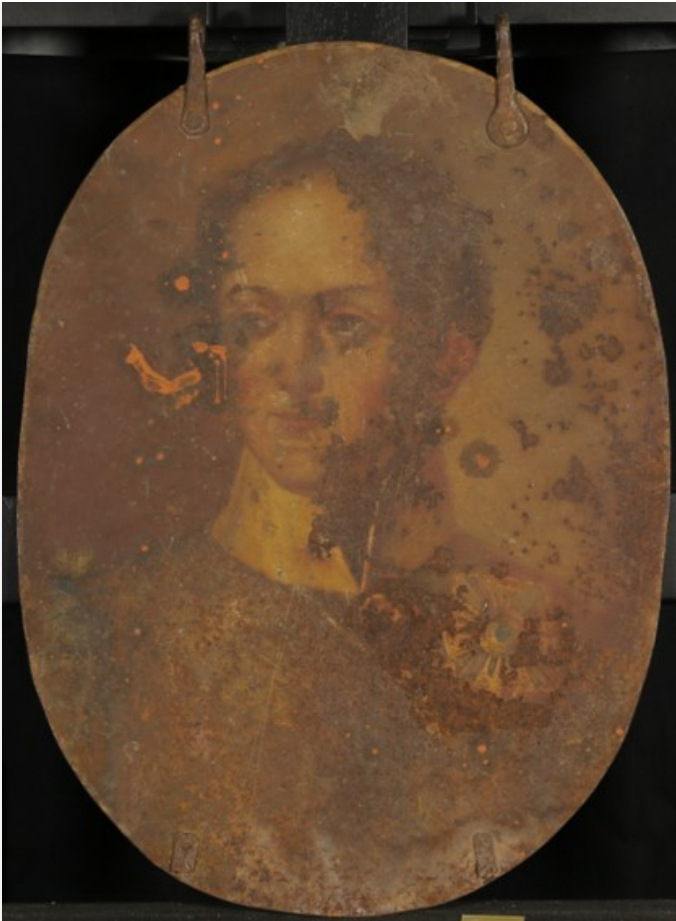
Fig. 2: Back side of the oil painting on iron plate before restoration,

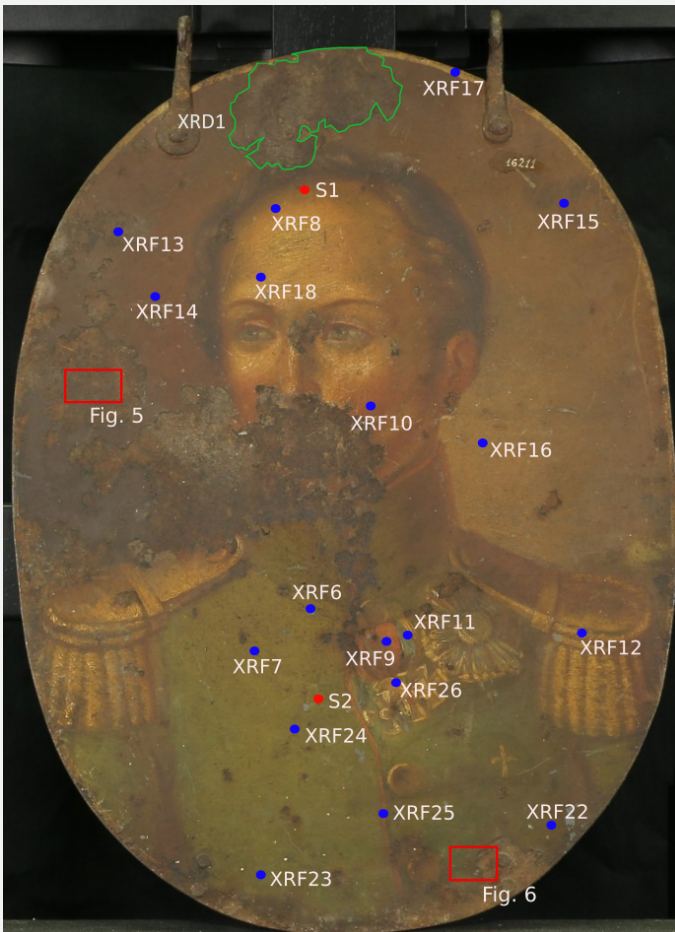
Fig. 3: Front side showing the location of XRF analyses (blue dots), sampling areas for stratigraphy analysis (red dots), sampling area for XRD and SEM-EDS analysis (lined with green), figures 5 and 6 (squares),

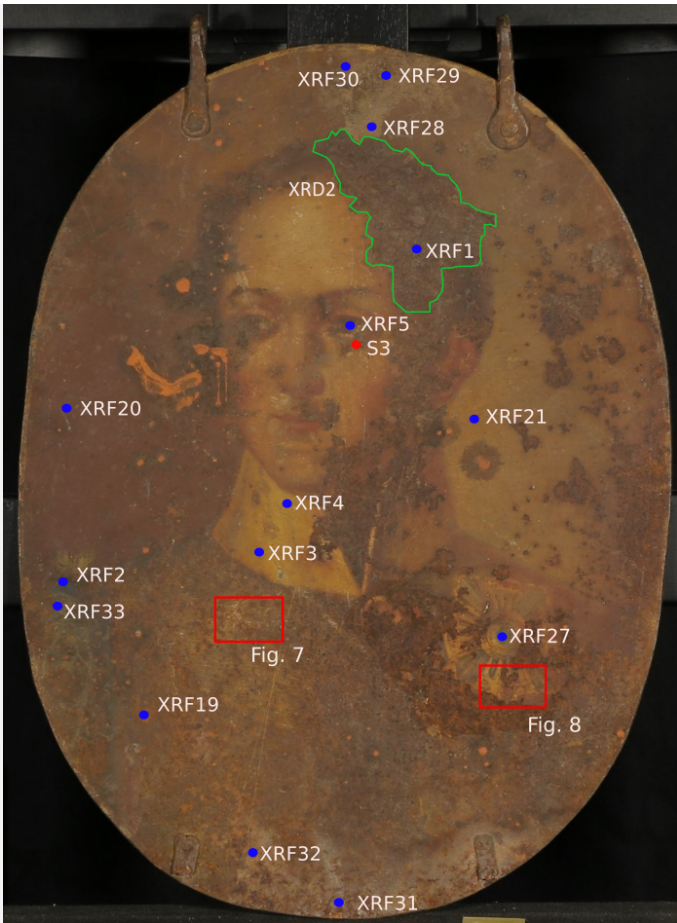
Fig. 4: Back side showing the location of XRF analyses (blue dots), sampling area for stratigraphy analysis (red dot), sampling area for XRD and SEM-EDS analysis (lined with green), figures 7 and 8 (squares),

Metal was analysed with portable XRF machine (XRF1 in fig. 4) on a corroded area on back side of the painting where there was no visible paint flakes or other surface materials present. The analysis confirmed that the metal is an iron (Fe) alloy with high content of silicon (Si) and trace elements of aluminium, magnesium and sulphur (Table 1). We could not determine the specific type of alloy as the carbon content was not analysed. Most likely all present elements except Fe and maybe Si and S are trace elements from pigment residue or atmospheric pollution.

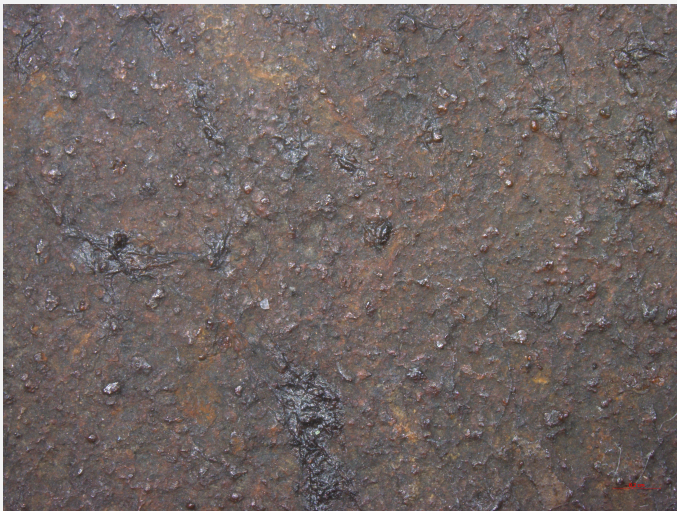
Fig.5: Micrograph of corrosion layer on the front side of the painting,

On the front side of the painting, corrosion products are heterogenous and form multiple layers. Stigraphy of corrosion products is similar on most areas and can be divided by four main layers: outer layer of localized brittle, powdery orange products (CP1), followed by reddish brown powdery layer (CP2), followed by dark red (almost black) shiny brittle wart-like structures of different sizes that appear individually but cover most of the surface (CP3). The lowest layer consists of dark brown, almost black thin hard layer that covers original metal surface (CP4). (Fig. 5) Paint surface on the bottom part of the painting was cleaned with cleaning systems that contained water (rigid agarose gels with chelators) that locally came into contact with exposed corroded metal; on those areas bright orange active corrosion (flash corrosion) formed almost immediately after removal of rigid gels (CP1). (Fig.6).

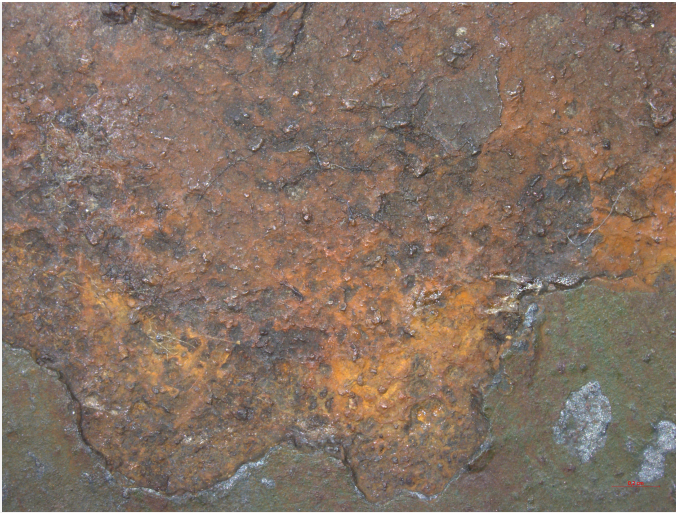
Fig. 6: Micrograph of flash corrosion layer on the front side of the painting,

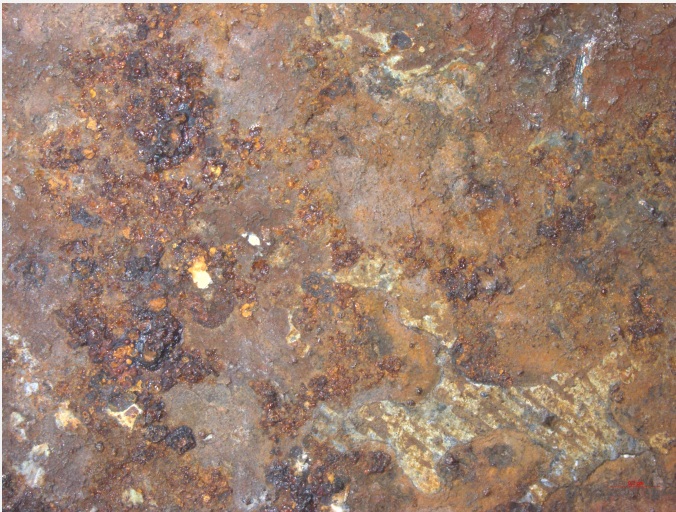
Fig. 7: Micrograph of corrosion layer on the back side of the painting,

On the back side, corrosion on the upper area of the painting are the same type as on the front side. (Fig. 7) On the lower area, corrosion type is slightly different: extensive pitting corrosion appears that forms deep individual pits across the whole surface of that area. Corrosion stigraphy is similar as on the front side of the painting: orange, brittle corrosion products (CP1) are located mainly around the pits and inside them on top of other corrosion layers, but also on top of the remaining paint layer - this is probably because of cleaning of the remaining paint layer with agarose gels which contain water (same problem as on the front side of painting). Inside the pits underneath CP1 is a layer of brownish-red brittle corrosion products (CP2), which is hard to distinguish from other layers. Next layer are dark red (almost black) shiny brittle wart-like structures (CP3) and underneath a thin, hard layer of very dark brown products (CP4). (Fig. 8).

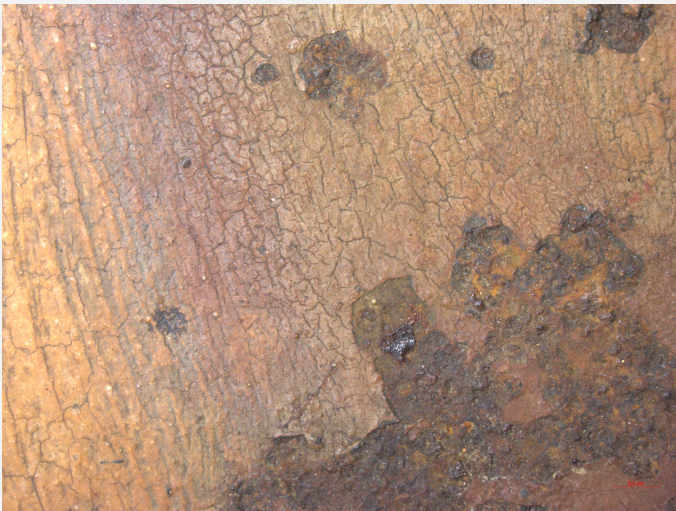
Fig. 8: Micrograph of corrosion layer on the back side of the painting (lower area). Individual pits from pitting corrosion are visible,

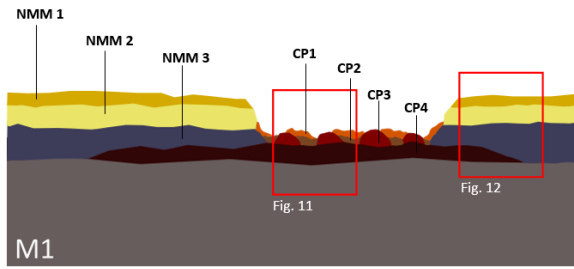
Fig. 9: Stratigraphic representation based on visual observation and visualization of the stratigraphies of the lower back side of the painting (damaged by extensive pitting corrosion). Red squares correspond to stratigraphies in Fig. 11 and 12,

LAYER	DESCRIPTION
NMM1	Varnish or protective coating layer, yellowed/darkened due to aging, transparent, slightly glossy or silky in appearance, mostly very thin but thicker locally, strong adhesion to bottom layer, present on all remaining paint layer, hard to remove with steel scalpel.
NMM2	Paint layer, various thickness depending on the location, stable and hard but can be removed with steel scalpel, very damaged by pitting corrosion.
NMM3	Ground layer, thin, metallic blue gray in appearance, consists of lead oxides and maybe zinc oxides (composition is not determined yet, could be metallic layer), strong adhesion to bottom layer, very hard to remove with steel scalpel, very damaged by pitting corrosion.
CP1	Orange thin layer, active corrosion, powdery in appearance, can be easily removed with steel scalpel, present on top of the paint layer and locally on exposed metal surface.
CP2	Reddish brown thin layer, powdery in appearance, poor adhesion to bottom layer, can be easily removed with steel scalpel, hard to distinguish from other corrosion layers, present discontinuously on much of the paint layer and exposed metal surface.

CP3	Dark red to black wart-like structures, glossy in appearance, localized but present on the whole surface of corroded metal, poor to medium adhesion to bottom layer, can be easily removed with steel scalpel, texture reminds of dry brittle resin.
CP4	Very dark (almost black) stable corrosion layer, hard, thin, strong adhesion to underlying metal, can be partially removed with strong action with steel scalpel, is present on the whole surface of exposed metal and under the edges of paint layer. It is not present under larger areas of paint where metal underneath did not oxidize.
M1	Dense, stable, hard, cannot be scratched with steel scalpel, not visible under layer of corrosion products.

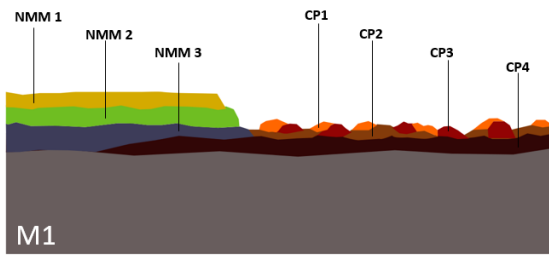
Fig. 10: Stratigraphic representation based on visual observation and visualization of the stratigraphies of the front side and upper back side of the painting,

LAYER	DESCRIPTION
NMM1	Varnish or protective coating layer, yellowed/darkened due to aging, transparent, slightly glossy or silky in appearance, mostly very thin but thicker locally, strong adhesion to bottom layer, present on all remaining paint layer, hard to remove with steel scalpel.
NMM2	Paint layer, various thickness depending on the location, stable and hard but can be removed with steel scalpel.
NMM3	Ground layer, thin, metallic blue gray in appearance, consists of lead oxides and maybe zinc oxides (composition is not determined yet, could be metallic layer), strong adhesion to bottom layer, very hard to remove with steel scalpel.
CP1	Orange thin layer, active corrosion, powdery in appearance, can be easily removed with steel scalpel, present on much of the exposed metal surface.
CP2	Reddish brown thin layer, powdery in appearance, poor adhesion to bottom layer, can be easily removed with steel scalpel, hard to distinguish from other corrosion layers, present on much of the exposed metal surface.

CP3	Dark red to black wart-like structures, glossy in appearance, localized but present on the whole surface of corroded metal, poor to medium adhesion to bottom layer, can be easily removed with steel scalpel, texture reminds of dry brittle resin.
CP4	Very dark (almost black) stable/passivated corrosion layer, hard, thin, strong adhesion to underlying metal, can be partially removed with strong action with steel scalpel, is present on the whole surface of exposed metal and under the paint layer. It is not present under larger areas of paint where metal underneath did not oxidize.
M1	Dense, stable, hard, cannot be scratched with steel scalpel, not visible under layer of corrosion products.

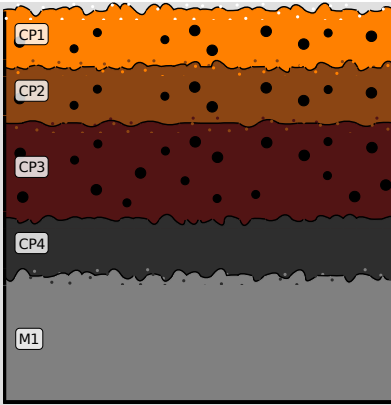
Fig. 11: Stratigraphic representation of lower area of the back side (pitting corrosion) of the object observed macroscopically under binocular microscope using the MiCorr application. This stratigraphy shows a corroded area and is parallel to painted areas. CP4 in this stratigraphy corresponds to CP1 in Fig. 12. The characteristics of the strata are only accessible by clicking on the drawing that redirects you to the search tool by stratigraphy representation, credit NMS, Z.Ursic.

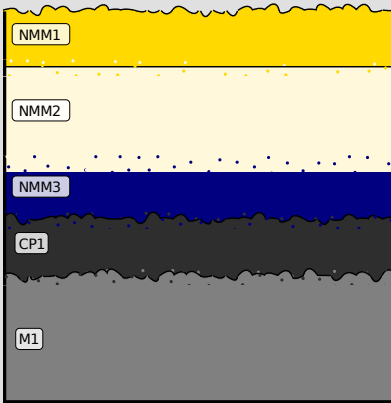
Fig. 12: Stratigraphic representation of lower area of the back side (pitting corrosion) of the object observed macroscopically under binocular microscope using the MiCorr application. This stratigraphy shows a painted area and is parallel to corrosion structures in Fig. 11. CP1 in this stratigraphy corresponds to CP4 in Fig. 11. The characteristics of the strata are only accessible by clicking on the drawing that redirects you to the search tool by stratigraphy representation, credit NMS,Z.Ursic.

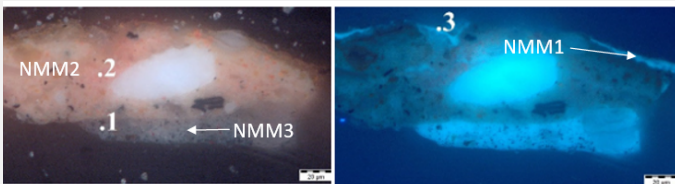
Fig. 13: Sample S1 (see fig. 3 for precise area of sampling) showing stratigraphy of paint layer under visible light (left) and UV light (right): ground layer (.1), paint layer (.2), varnish (.3),

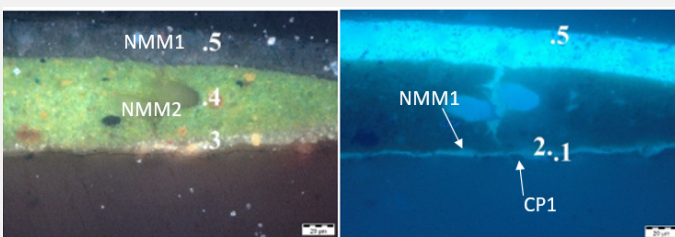
Fig. 14: Sample S2 (see fig. 3 for precise area of sampling) showing stratigraphy of paint layer under visible light (left) and UV light (right): corrosion (.1), ground layer (.2), paint layer (.3 and .4), varnish (.5),

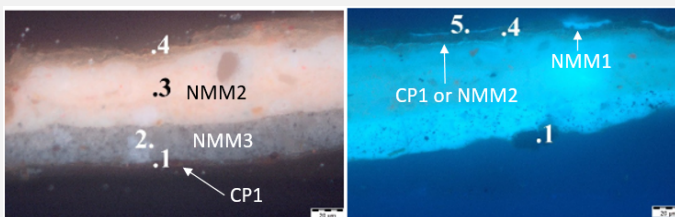
Fig. 15: Sample S3 (see fig. 4 for precise area of sampling) showing stratigraphy of paint layer under visible light (left) and UV light (right): corrosion (.1), ground layer (.2), paint layer (.3), another paint layer or corrosion products (.4), varnish (.5),
