## DOUBLE-SIDED OIL PAINTING ON IRON PLATE WITH HANGERS – FE ALLOY – SECOND HALF OF 19TH CENTURY

<b>Artefact name</b>	Double-sided oil painting on iron plate with hangers
<b>Authors</b>	Zala. Uršič (, Ljubljana, Ljubljana, Slovenia) & Nataša. Nemeček (National museum of Slovenia, Ljubljana, Ljubljana, Slovenia)
<b>Url</b>	/artefacts/1427/

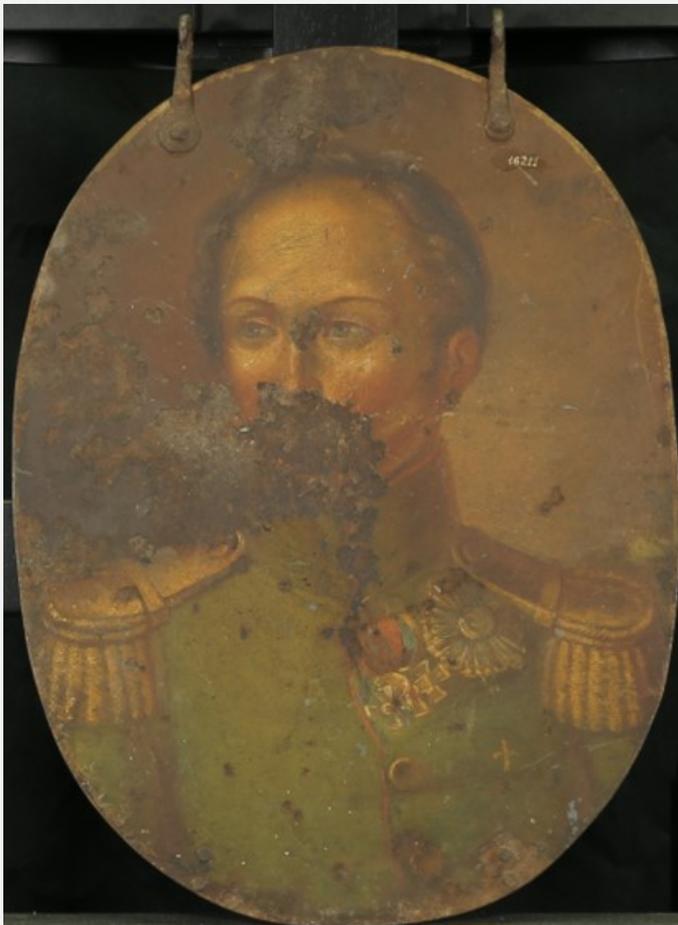
Fig.1: Front side of the oil painting on iron plate before restoration,

On both sides of the painting there is a thick layer of dirt (made up of corrosion products, dust, soot and pollutants) and a yellowed thin layer of coating present (presumably oil-resin based). Paint layer on both sides is damaged (missing paint layer to the support due to flaking and corrosion). Areas where iron is exposed are corroded; brown, red and black corrosion products are visible. Orange corrosion products are also locally present on top of the paint layer.

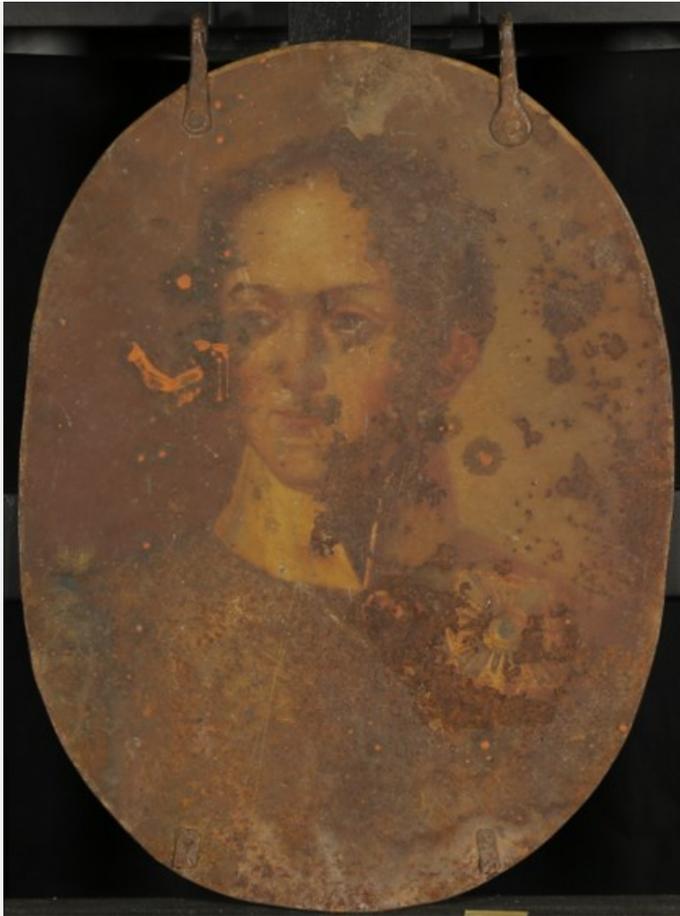
Fig. 2: Back side of the oil painting on iron plate before restoration,

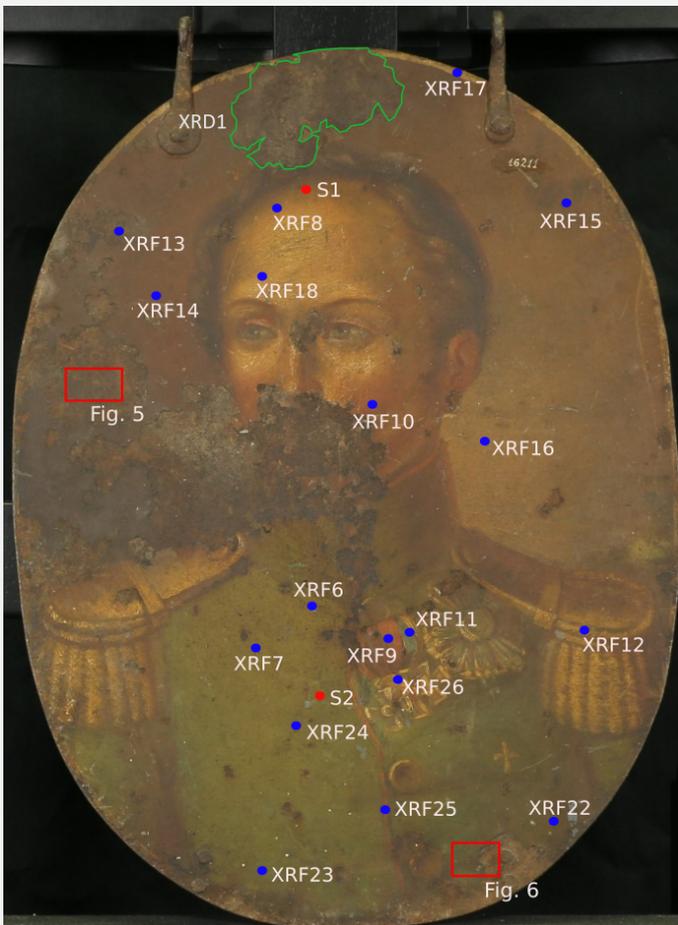
Fig. 3: Front side showing the location of XRF analyses (blue dots), sampling areas for stratigraphy analysis (red dots), sampling area for XRD and SEM-EDS analysis (lined with green), figures 5 and 6 (squares),

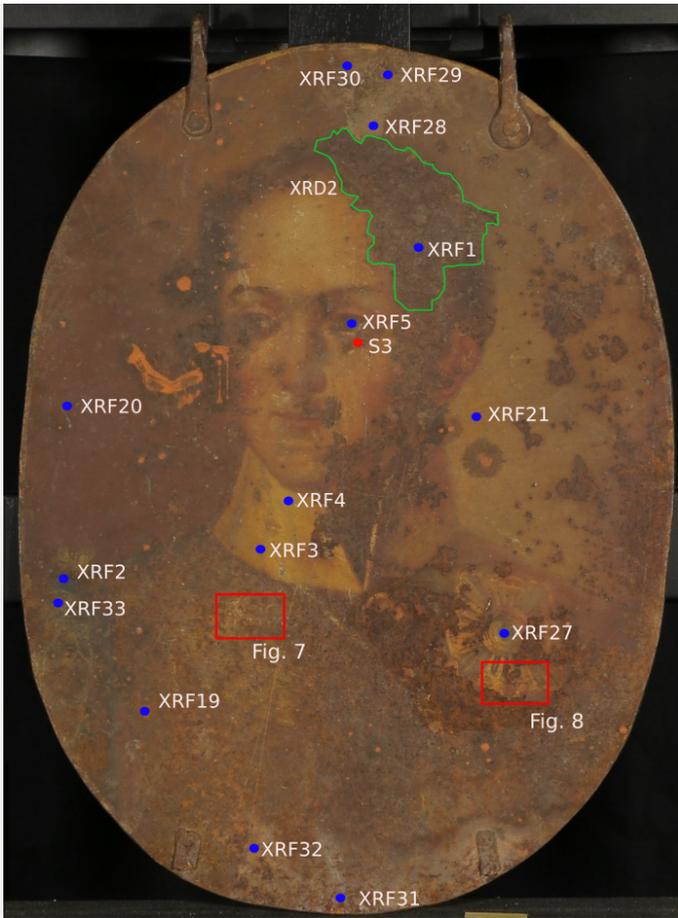
Fig. 4: Back side showing the location of XRF analyses (blue dots), sampling area for stratigraphy analysis (red dot), sampling area for XRD and SEM-EDS analysis (lined with green) , figures 7 and 8 (squares),

Metal was analysed with portable XRF machine (XRF1 in fig. 4) on a corroded area on back side of the painting where there was no visible paint flakes or other surface materials present. The analysis confirmed that the metal is an iron (Fe) alloy with high content of silicon (Si) and trace elements of aluminium, magnesium and sulphur (Table 1). We could not determine the specific type of alloy as the carbon content was not analysed. Most likely all present elements except Fe and maybe Si and S are trace elements from pigment residue or atmospheric pollution.

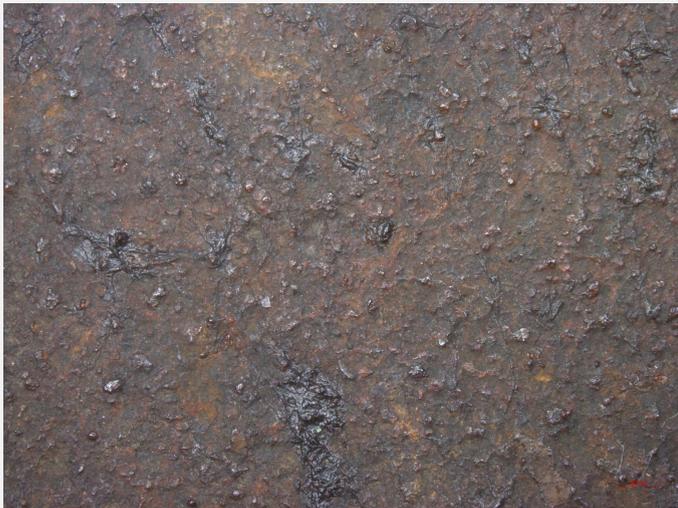
Fig.5: Micrograph of corrosion layer on the front side of the painting,

On the front side of the painting, corrosion products are heterogenous and form multiple layers. Statigraphy of corrosion products is similar on most areas and can be divided by four main layers: outer layer of localized brittle, powdery orange products (CP1), followed by reddish brown powdery layer (CP2), followed by dark red (almost black) shiny brittle wart-like structures of different sizes that appear individually but cover most of the surface (CP3). The lowest layer consists of dark brown, almost black thin hard layer that covers original metal surface (CP4). (Fig. 5) Paint surface on the bottom part of the painting was cleaned with cleaning systems that contained water (rigid agarose gels with chelators) that locally came into contact with exposed corroded metal; on those areas bright orange active corrosion (flash corrosion) formed almost immediately after removal of rigid gels (CP1). (Fig.6).

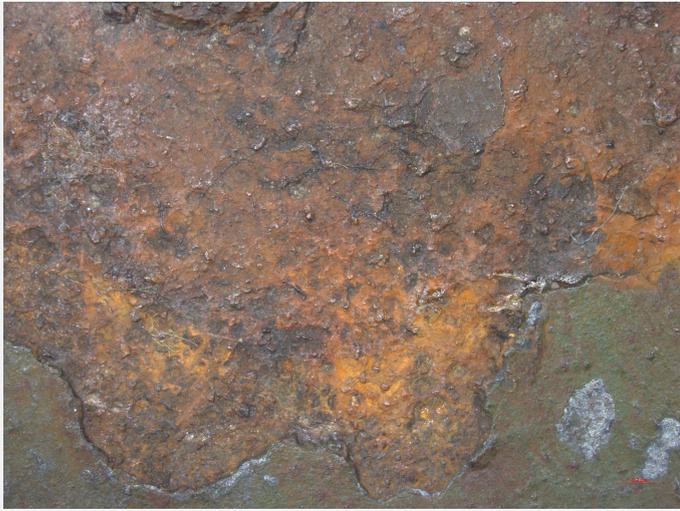
Fig. 6: Micrograph of flash corrosion layer on the front side of the painting,

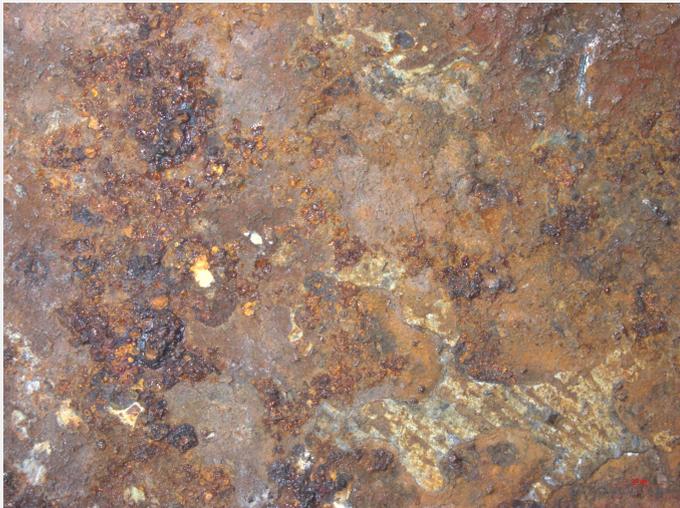
Fig. 7: Micrograph of corrosion layer on the back side of the painting,

On the back side, corrosion on the upper area of the painting are the same type as on the front side. (Fig. 7) On the lower area, corrosion type is slightly different: extensive pitting corrosion appears that forms deep individual pits across the whole surface of that area. Corrosion statigraphy is similar as on the front side of the painting: orange, brittle corrosion products (CP1) are located mainly around the pits and inside them on top of other corrosion layers, but also on top of the remaining paint layer - this is probably because of cleaning of the remaining paint layer with agarose gels which contain water (same problem as on the front side of painting). Inside the pits underneath CP1 is a layer of brownish-red brittle corrosion products (CP2), which is hard to distinguish from other layers. Next layer are dark red (almost black) shiny brittle wart-like structures (CP3) and underneath a thin, hard layer of very dark brown products (CP4). (Fig. 8).

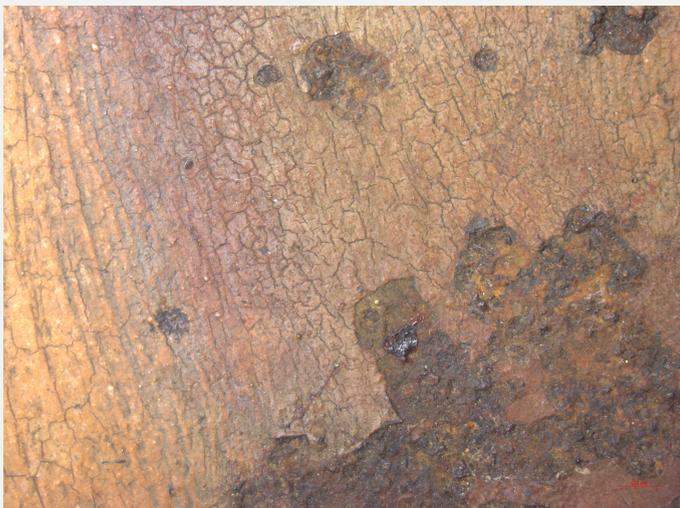
Fig. 8: Micrograph of corrosion layer on the back side of the painting (lower area). Individual pits from pitting corrosion are visible,

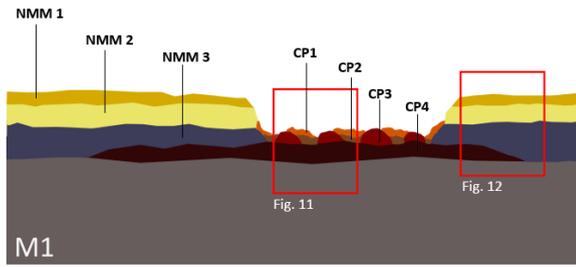
Fig. 9: Stratigraphic representation based on visual observation and visualization of the stratigraphies of the lower back side of the painting (damaged by extensive pitting corrosion). Red squares correspond to stratigraphies in Fig. 11 and 12,

LAYER	DESCRIPTION
NMM1	Varnish or protective coating layer, yellowed/darkened due to aging, transparent, slightly glossy or silky in appearance, mostly very thin but thicker locally, strong adhesion to bottom layer, present on all remaining paint layer, hard to remove with steel scalpel.
NMM2	Paint layer, various thickness depending on the location, stable and hard but can be removed with steel scalpel, very damaged by pitting corrosion.
NMM3	Ground layer, thin, metallic blue gray in appearance, consists of lead oxides and maybe zinc oxides (composition is not determined yet, could be metallic layer), strong adhesion to bottom layer, very hard to remove with steel scalpel, very damaged by pitting corrosion.
CP1	Orange thin layer, active corrosion, powdery in appearance, can be easily removed with steel scalpel, present on top of the paint layer and locally on exposed metal surface.
CP2	Reddish brown thin layer, powdery in appearance, poor adhesion to bottom layer, can be easily removed with steel scalpel, hard to distinguish from other corrosion layers, present discontinuously on much of the paint layer and exposed metal surface.

CP3	Dark red to black wart-like structures, glossy in appearance, localized but present on the whole surface of corroded metal, poor to medium adhesion to bottom layer, can be easily removed with steel scalpel, texture reminds of dry brittle resin.
CP4	Very dark (almost black) stable corrosion layer, hard, thin, strong adhesion to underlying metal, can be partially removed with strong action with steel scalpel, is present on the whole surface of exposed metal and under the edges of paint layer. It is not present under larger areas of paint where metal underneath did not oxidize.
M1	Dense, stable, hard, cannot be scratched with steel scalpel, not visible under layer of corrosion products.

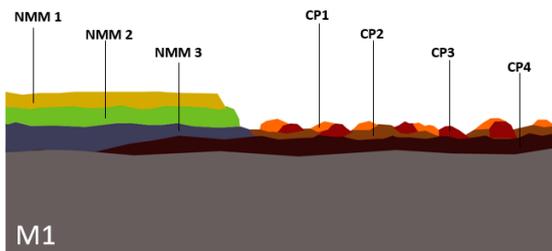
Fig. 10: Stratigraphic representation based on visual observation and visualization of the stratigraphies of the front side and upper back side of the painting,

LAYER	DESCRIPTION
NMM1	Varnish or protective coating layer, yellowed/darkened due to aging, transparent, slightly glossy or silky in appearance, mostly very thin but thicker locally, strong adhesion to bottom layer, present on all remaining paint layer, hard to remove with steel scalpel.
NMM2	Paint layer, various thickness depending on the location, stable and hard but can be removed with steel scalpel.
NMM3	Ground layer, thin, metallic blue gray in appearance, consists of lead oxides and maybe zinc oxides (composition is not determined yet, could be metallic layer), strong adhesion to bottom layer, very hard to remove with steel scalpel.
CP1	Orange thin layer, active corrosion, powdery in appearance, can be easily removed with steel scalpel, present on much of the exposed metal surface.
CP2	Reddish brown thin layer, powdery in appearance, poor adhesion to bottom layer, can be easily removed with steel scalpel, hard to distinguish from other corrosion layers, present on much of the exposed metal surface.

CP3	Dark red to black wart-like structures, glossy in appearance, localized but present on the whole surface of corroded metal, poor to medium adhesion to bottom layer, can be easily removed with steel scalpel, texture reminds of dry brittle resin.
CP4	Very dark (almost black) stable/passivated corrosion layer, hard, thin, strong adhesion to underlying metal, can be partially removed with strong action with steel scalpel, is present on the whole surface of exposed metal and under the paint layer. It is not present under larger areas of paint where metal underneath did not oxidize.
M1	Dense, stable, hard, cannot be scratched with steel scalpel, not visible under layer of corrosion products.

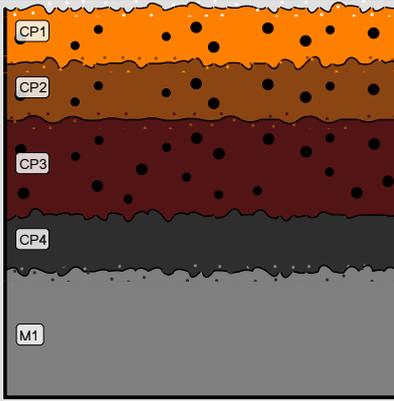
Fig. 11: Stratigraphic representation of lower area of the back side (pitting corrosion) of the object observed macroscopically under binocular microscope using the MiCorr application. This stratigraphy shows a corroded area and is parallel to painted areas. CP4 in this stratigraphy corresponds to CP1 in Fig. 12. The characteristics of the strata are only accessible by clicking on the drawing that redirects you to the search tool by stratigraphy representation, credit NMS, Z.Ursic.

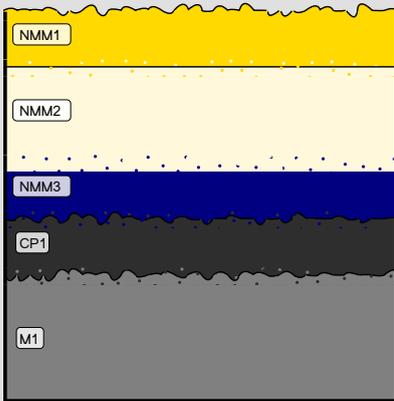
Fig. 12: Stratigraphic representation of lower area of the back side (pitting corrosion) of the object observed macroscopically under binocular microscope using the MiCorr application. This stratigraphy shows a painted area and is parallel to corrosion structures in Fig. 11. CP1 in this stratigraphy corresponds to CP4 in Fig. 11. The characteristics of the strata are only accessible by clicking on the drawing that redirects you to the search tool by stratigraphy representation, credit NMS, Z.Ursic.

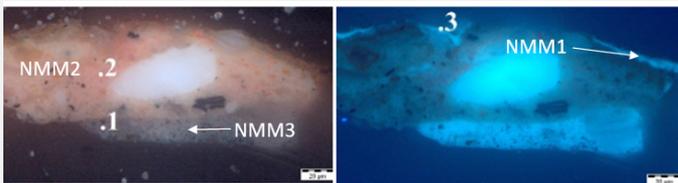
Fig. 13: Sample S1 (see fig. 3 for precise area of sampling) showing stratigraphy of paint layer under visible light (left) and UV light (right): ground layer (.1), paint layer (.2), varnish (.3),

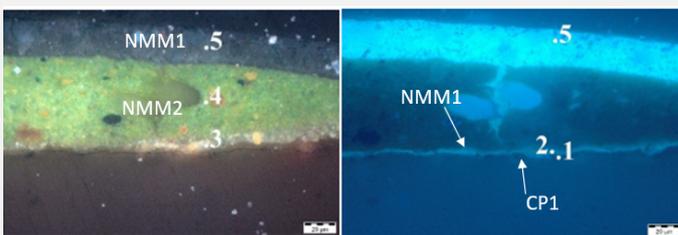
Fig. 14: Sample S2 (see fig. 3 for precise area of sampling) showing stratigraphy of paint layer under visible light (left) and UV light (right): corrosion (.1), ground layer (.2), paint layer (.3 and .4), varnish (.5),

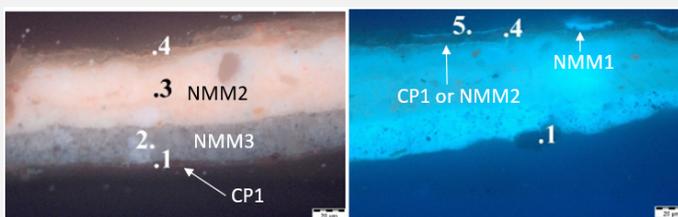
Fig. 15: Sample S3 (see fig. 4 for precise area of sampling) showing stratigraphy of paint layer under visible light (left) and UV light (right): corrosion (.1), ground layer (.2), paint layer (.3), another paint layer or corrosion products (.4), varnish (.5),
