## DOUBLE-SIDED OIL PAINTING ON IRON PLATE WITH HANGERS – FE ALLOY – SECOND HALF OF 19TH CENTURY

**Artefact name** Double-sided oil painting on iron plate with hangers

**Authors** Zala. Uršič (, Ljubljana, Ljubljana, Slovenia) & Nataša. Nemeček (National museum of Slovenia, Ljubljana, Ljubljana, Slovenia)

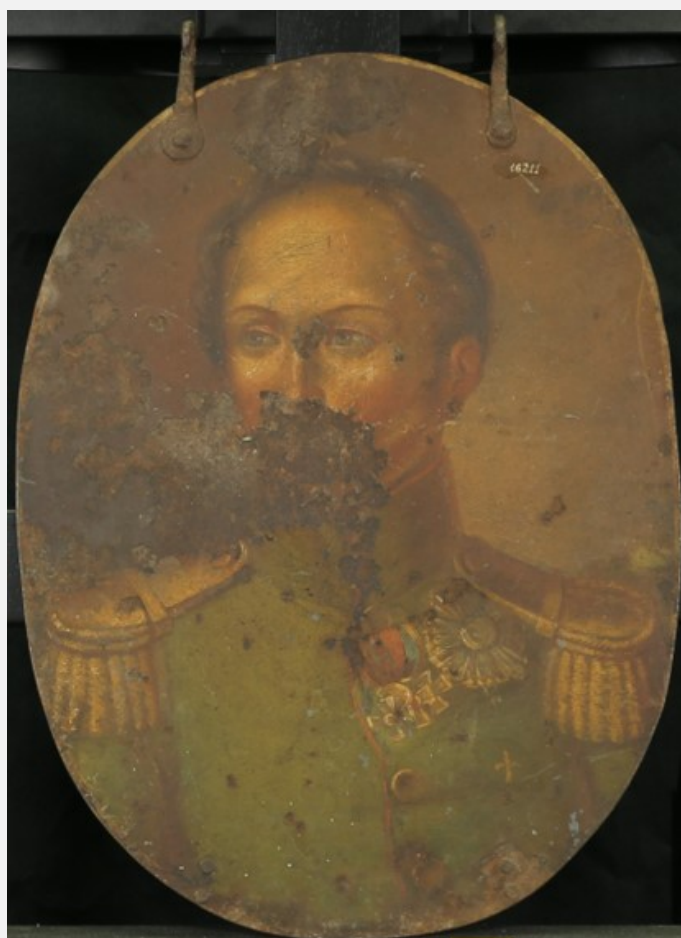
Fig.1: Front side of the oil painting on iron plate before restoration,

On both sides of the painting there is a thick layer of dirt (made up of corrosion products, dust, soot and pollutants) and a yellowed thin layer of coating present (presumably oil-resin based). Paint layer on both sides is damaged (missing paint layer to the support due to flaking and corrosion). Areas where iron is exposed are corroded; brown, red and black corrosion products are visible. Orange corrosion products are also locally present on top of the paint layer.

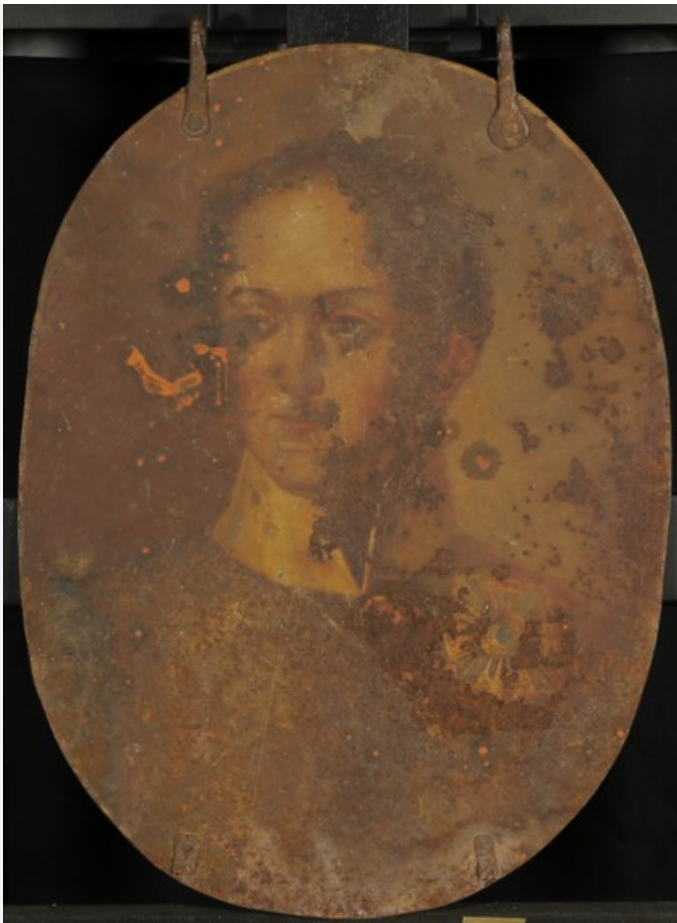
Fig. 2: Back side of the oil painting on iron plate before restoration,

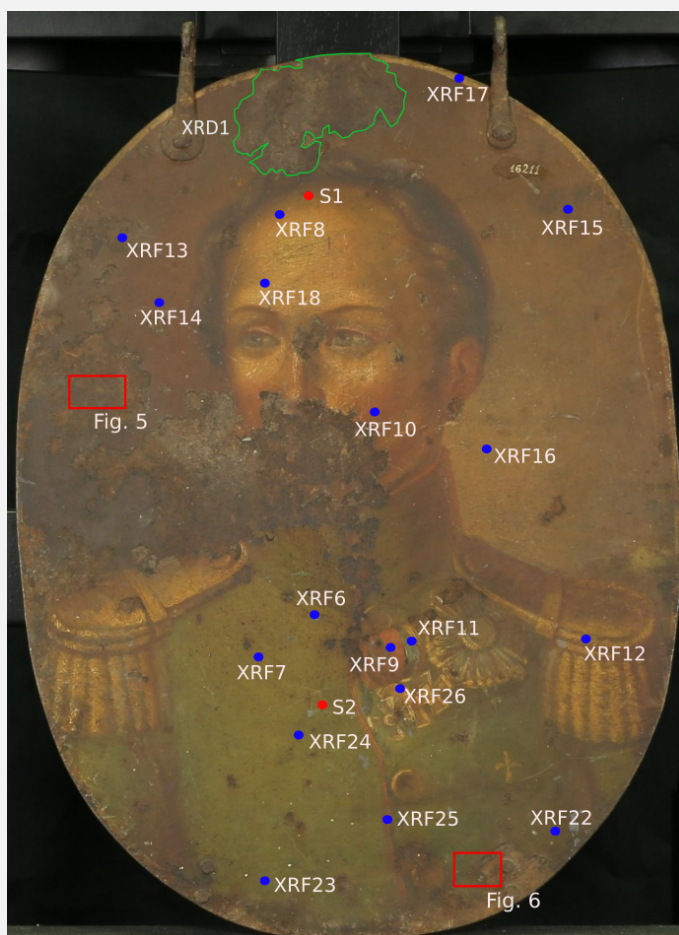
Fig. 3: Front side showing the location of XRF analyses (blue dots), sampling areas for stratigraphy analysis (red dots), sampling area for XRD and SEM-EDS analysis (lined with green), figures 5 and 6 (squares),

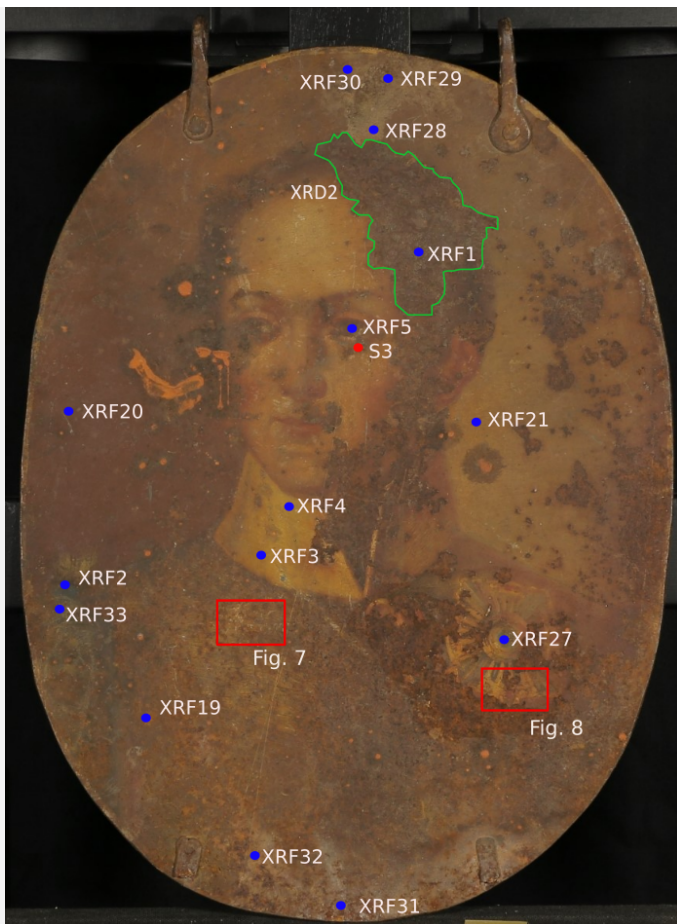
Fig. 4: Back side showing the location of XRF analyses (blue dots), sampling area for stratigraphy analysis (red dot), sampling area for XRD and SEM-EDS analysis (lined with green) , figures 7 and 8 (squares),

Metal was analysed with portable XRF machine (XRF1 in fig. 4) on a corroded area on back side of the painting where there was no visible paint flakes or other surface materials present. The analysis confirmed that the metal is an iron (Fe) alloy with high content of silicon (Si) and trace elements of aluminium, magnesium and sulphur (Table 1). We could not determine the specific type of alloy as the carbon content was not analysed. Most likely all present elements except Fe and maybe Si and S are trace elements from pigment residue or atmospheric pollution.

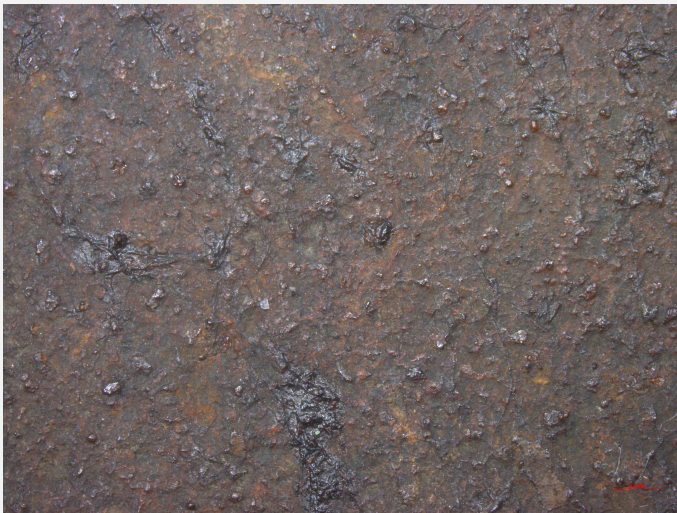
Fig.5: Micrograph of corrosion layer on the front side of the painting,

On the front side of the painting, corrosion products are heterogenous and form multiple layers. Statigraphy of corrosion products is similar on most areas and can be divided by four main layers: outer layer of localized brittle, powdery orange products (CP1), followed by reddish brown powdery layer (CP2), followed by dark red (almost black) shiny brittle wart-like structures of different sizes that appear individually but cover most of the surface (CP3). The lowest layer consists of dark brown, almost black thin hard layer that covers original metal surface (CP4). (Fig. 5) Paint surface on the bottom part of the painting was cleaned with cleaning systems that contained water (rigid agarose gels with chelators) that locally came into contact with exposed corroded metal; on those areas bright orange active corrosion (flash corrosion) formed almost immediately after removal of rigid gels (CP1). (Fig.6).

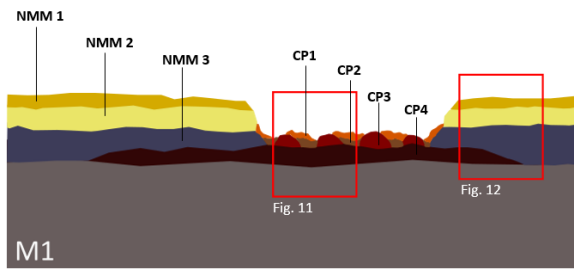
Fig. 9: Stratigraphic representation based on visual observation and visualization of the stratigraphies of the lower back side of the painting (damaged by extensive pitting corrosion). Red squares correspond to stratigraphies in Fig. 11 and 12,

LAYER	DESCRIPTION
NMM1	Varnish or protective coating layer, yellowed/darkened due to aging, transparent, slightly glossy or silky in appearance, mostly very thin but thicker locally, strong adhesion to bottom layer, present on all remaining paint layer, hard to remove with steel scalpel.
NMM2	Paint layer, various thickness depending on the location, stable and hard but can be removed with steel scalpel, very damaged by pitting corrosion.
NMM3	Ground layer, thin, metallic blue gray in appearance, consists of lead oxides and maybe zinc oxides (composition is not determined yet, could be metallic layer), strong adhesion to bottom layer, very hard to remove with steel scalpel, very damaged by pitting corrosion.
CP1	Orange thin layer, active corrosion, powdery in appearance, can be easily removed with steel scalpel, present on top of the paint layer and locally on exposed metal surface.
CP2	Reddish brown thin layer, powdery in appearance, poor adhesion to bottom layer, can be easily removed with steel scalpel, hard to distinguish from other corrosion layers, present discontinuously on much of the paint layer and exposed metal surface.

CP3	Dark red to black wart-like structures, glossy in appearance, localized but present on the whole surface of corroded metal, poor to medium adhesion to bottom layer, can be easily removed with steel scalpel, texture reminds of dry brittle resin.
CP4	Very dark (almost black) stable corrosion layer, hard, thin, strong adhesion to underlying metal, can be partially removed with strong action with steel scalpel, is present on the whole surface of exposed metal and under the edges of paint layer. It is not present under larger areas of paint where metal underneath did not oxidize.
M1	Dense, stable, hard, cannot be scratched with steel scalpel, not visible under layer of corrosion products.

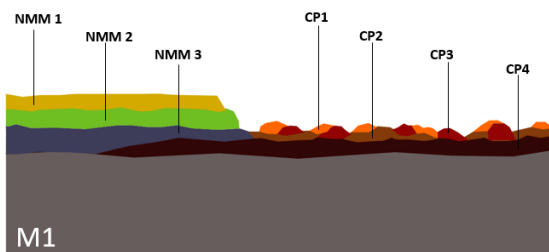
Fig. 10: Stratigraphic representation based on visual observation and visualization of the stratigraphies of the front side and upper back side of the painting,

LAYER	DESCRIPTION
NMM1	Varnish or protective coating layer, yellowed/darkened due to aging, transparent, slightly glossy or silky in appearance, mostly very thin but thicker locally, strong adhesion to bottom layer, present on all remaining paint layer, hard to remove with steel scalpel.
NMM2	Paint layer, various thickness depending on the location, stable and hard but can be removed with steel scalpel.
NMM3	Ground layer, thin, metallic blue gray in appearance, consists of lead oxides and maybe zinc oxides (composition is not determined yet, could be metallic layer), strong adhesion to bottom layer, very hard to remove with steel scalpel.
CP1	Orange thin layer, active corrosion, powdery in appearance, can be easily removed with steel scalpel, present on much of the exposed metal surface.
CP2	Reddish brown thin layer, powdery in appearance, poor adhesion to bottom layer, can be easily removed with steel scalpel, hard to distinguish from other corrosion layers, present on much of the exposed metal surface.

CP3	Dark red to black wart-like structures, glossy in appearance, localized but present on the whole surface of corroded metal, poor to medium adhesion to bottom layer, can be easily removed with steel scalpel, texture reminds of dry brittle resin.
CP4	Very dark (almost black) stable/passivated corrosion layer, hard, thin, strong adhesion to underlying metal, can be partially removed with strong action with steel scalpel, is present on the whole surface of exposed metal and under the paint layer. It is not present under larger areas of paint where metal underneath did not oxidize.
M1	Dense, stable, hard, cannot be scratched with steel scalpel, not visible under layer of corrosion products.

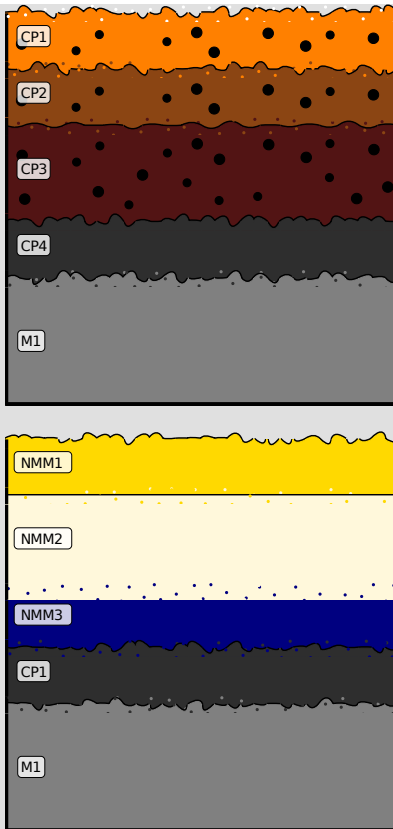
Fig. 11: Stratigraphic representation of lower area of the back side (pitting corrosion) of the object observed macroscopically under binocular microscope using the MiCorr application. This stratigraphy shows a corroded area and is parallel to painted areas. CP4 in this stratigraphy corresponds to CP1 in Fig. 12. The characteristics of the strata are only accessible by clicking on the drawing that redirects you to the search tool by stratigraphy representation, credit NMS, Z.Ursic.

Fig. 12: Stratigraphic representation of lower area of the back side (pitting corrosion) of the object observed macroscopically under binocular microscope using the MiCorr application. This stratigraphy shows a painted area and is parallel to corrosion structures in Fig. 11. CP1 in this stratigraphy corresponds to CP4 in Fig. 11. The characteristics of the strata are only accessible by clicking on the drawing that redirects you to the search tool by stratigraphy representation, credit NMS,Z.Ursic.

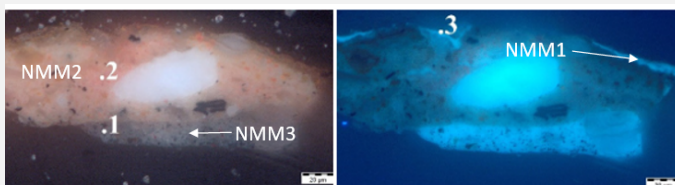
Fig. 13: Sample S1 (see fig. 3 for precise area of sampling) showing stratigraphy of paint layer under visible light (left) and UV light (right): ground layer (.1), paint layer (.2), varnish (.3),

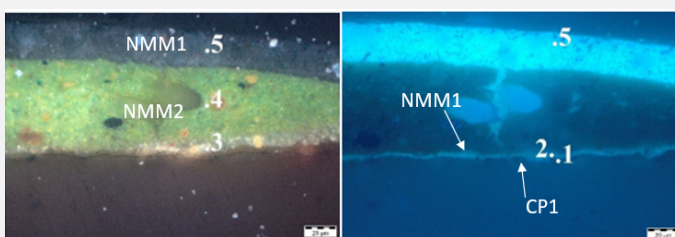
Fig. 14: Sample S2 (see fig. 3 for precise area of sampling) showing stratigraphy of paint layer under visible light (left) and UV light (right): corrosion (.1), ground layer (.2), paint layer (.3 and .4), varnish (.5),

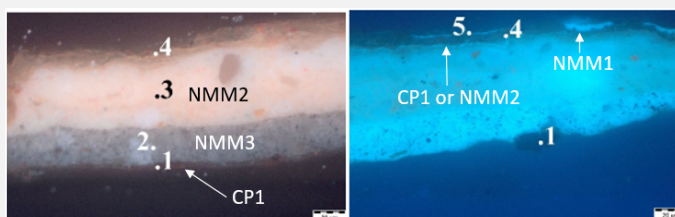
Fig. 15: Sample S3 (see fig. 4 for precise area of sampling) showing stratigraphy of paint layer under visible light (left) and UV light (right): corrosion (.1), ground layer (.2), paint layer (.3), another paint layer or corrosion products (.4), varnish (.5),
