UNDETERMINED – FE ALLOY – EARLY MEDIEVAL TIMES

Artefact name	Undetermined
Authors	Moreau. Caroline (Laboratoire MATERIA VIVA, Toulouse, Midi-Pyrénées, France) & TOUZEAU. Julie (Laboratoire MATERIA VIVA, Toulouse, Midi-Pyrénées, France)
Url	/artefacts/1443/

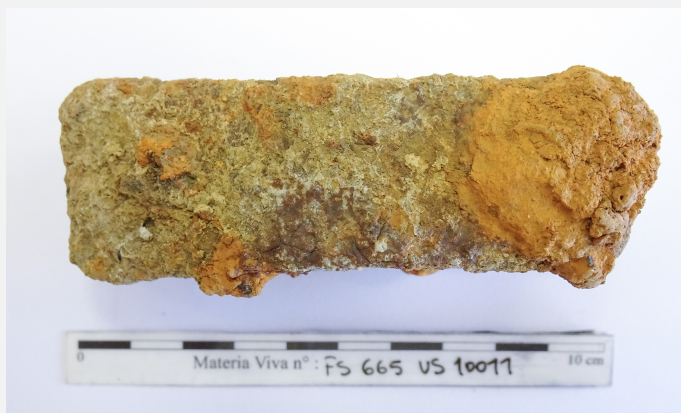
Fig. 1: Iron artefact (component of a furniture?) with soil and corrosion products (side view),

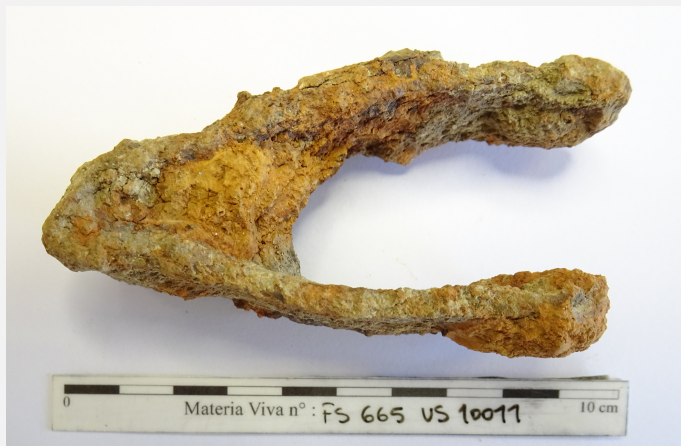
Fig. 2: Lateral view of the object,

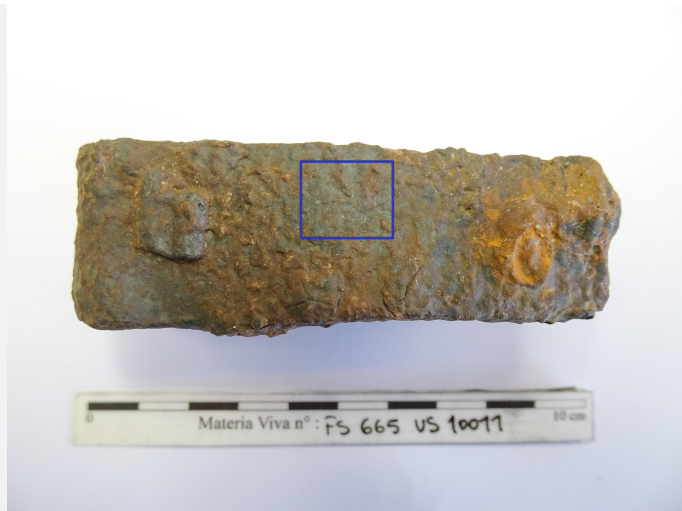
Fig. 3: Artefact after restoration, the blue square indicates the detail of Fig.4,

Burial conditions / environment	Soil
Artefact location	Las Cravieros, Fanjeaux (Favennec Benoît), Languedoc-Roussillon
Owner	None
Inv. number	FS665 US10011
Recorded conservation data	Mechanical removal of the corrosion products and protection with resin paraloid B72 in acetone.

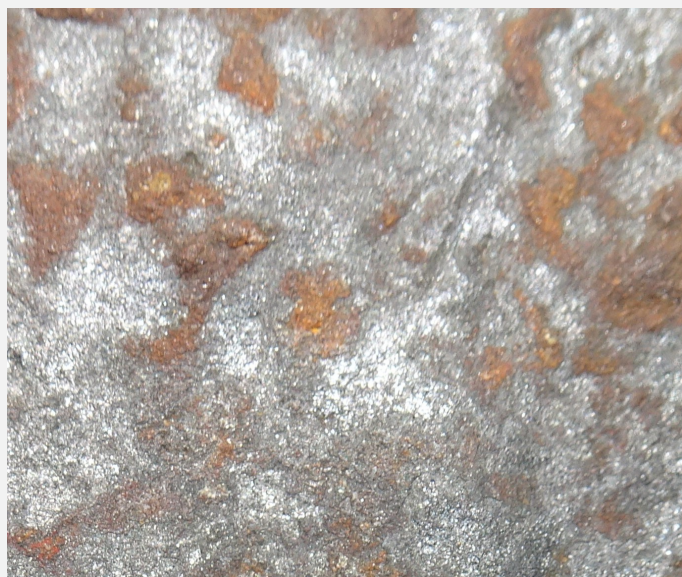
Fig. 4: Detail of the cleaned surface showing shiny grey/blue surface and red/brown spots,

The limit of the original surface is probably between CP2/CP3 and CP3/CP4. Layer CP3 (in red) shows no more silica grain coming from the burial environment. CP3 can be removed, but this will eliminate certain elements relating to the history of the artefact.

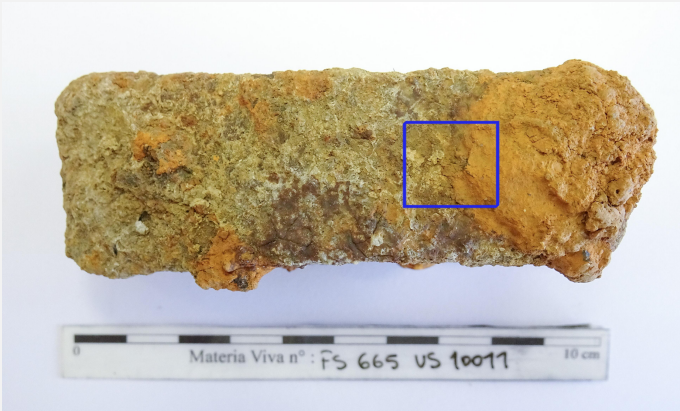
Fig. 5: The blue square indicates the location of the analysed area by binocular observation,

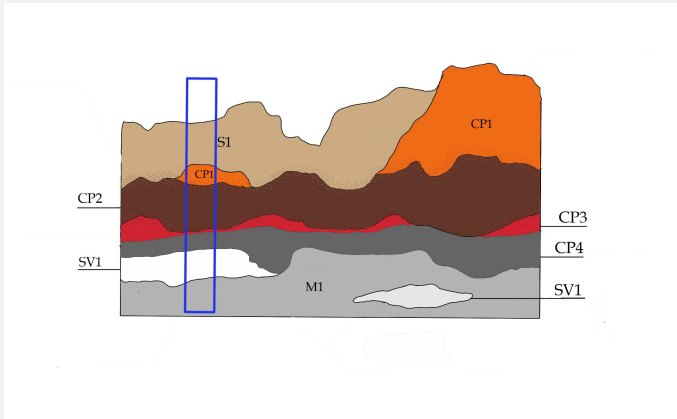
S1	Sediment	powdery and non adherent
CP1	Corrosion product	bright orange corrosion product or soil orange-coloured by corrosion products
CP2	Corrosion product	brown layer of corrosion products with silica grains
CP3	Corrosion product	very thin discontinuous layer of a red corrosion product without silica grains
CP4	Corrosion product	grey/blue continuous layer
SV1	Structural void	
M1	Metal	compact metal. Observation of stretched metal around the structural voids

Fig. 6: Stratigraphic representation of the corrosion structure of the object by macroscopic and binocular observation with indication of the corrosion structure used to build the MiCorr stratigraphy of Fig. 7 (blue rectangle),

This ferrous alloy object that may have belonged to a wooden box was found near a forge area. Among the observed corrosion strata and characteristic of the corrosion process of ferrous metals, two corrosion layers CP3 and CP4 appear atypical compared to other corrosion profiles of similar metals (cf [MiCorr | Knife with a groove on both sides DEV 995/814 PR - Fe Alloy - Early medieval times - Switzerland](#)). They could be related to high temperature exposure due to the proximity of a forging zone.

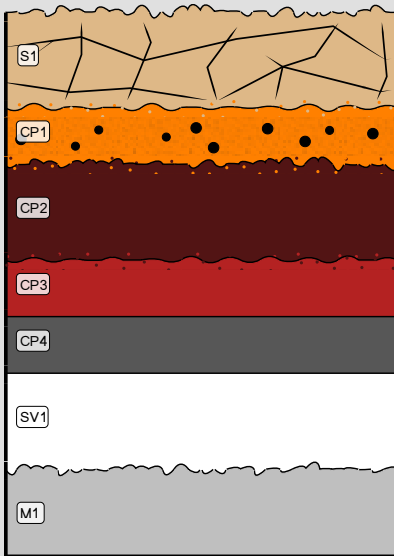
Fig. 7: Stratigraphic representation of the corrosion structure of the object observed macroscopically under binocular microscope using the MiCorr application with reference to Fig. 6. The characteristics of the strata are only accessible by clicking on the drawing that redirects you to the search tool by stratigraphy representation, credit Materia Viva, C.Moreau.
