UNDETERMINED - FE ALLOY - EARLY MEDIEVAL TIMES

Artefact name Undetermined

Authors Moreau. Caroline (Laboratoire MATERIA VIVA, Toulouse, Midi-Pyrénées, France) & TOUZEAU. Julie

Url /artefacts/1443/

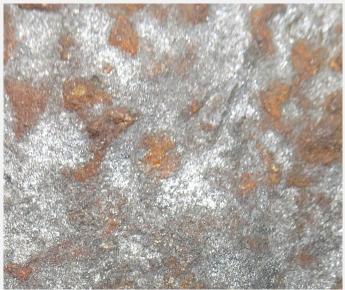
Fig. 4: Detail of the cleaned surface showing shiny grey/blue surface and red/brown spots,
