UNDETERMINED – FE ALLOY – EARLY MEDIEVAL TIMES

Artefact name Undetermined

Authors Moreau. Caroline (Laboratoire MATERIA VIVA, Toulouse, Midi-Pyrénées, France) & TOUZEAU. Julie (Laboratoire MATERIA VIVA, Toulouse, Midi-Pyrénées, France)

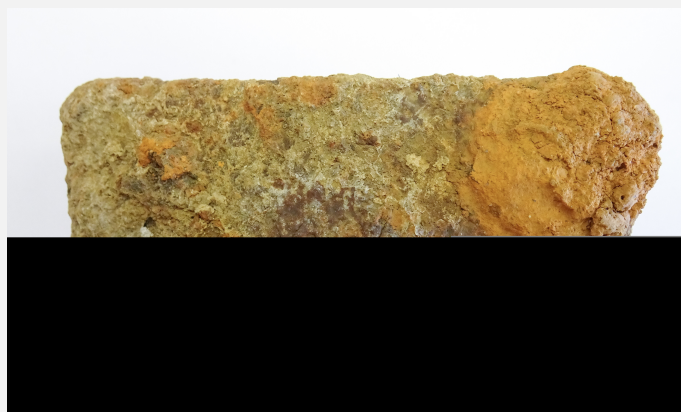
Fig. 1: Iron artefact (component of a furniture?) with soil and corrosion products (side view),

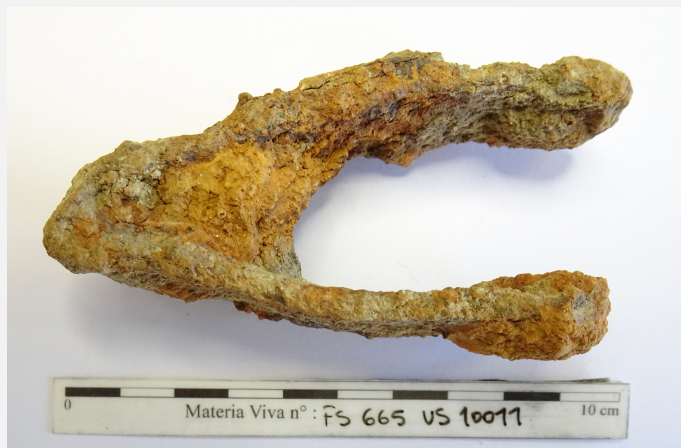
Fig. 2: Lateral view of the object,

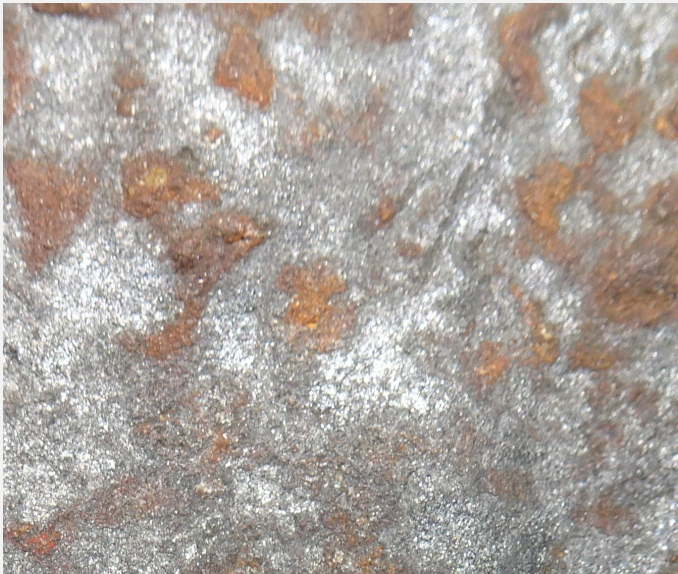
Fig. 4: Detail of the cleaned surface showing shiny grey/blue surface and red/brown spots,

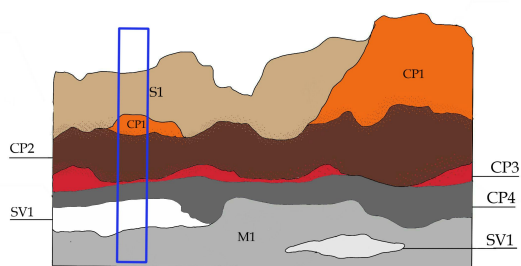
S1	Sediment	powdery and non adherent
CP1	Corrosion product	bright orange corrosion product or soil orange-coloured by corrosion products
CP2	Corrosion product	brown layer of corrosion products with silica grains
CP3	Corrosion product	very thin discontinuous layer of a red corrosion product without silica grains
CP4	Corrosion product	grey/blue continuous layer
SV1	Structural void	
M1	Metal	compact metal. Observation of stretched metal around the structural voids

Fig. 6: Stratigraphic representation of the corrosion structure of the object by macroscopic and binocular observation with indication of the corrosion structure used to build the MiCorr stratigraphy of Fig. 7 (blue rectangle),

This ferrous alloy object that may have belonged to a wooden box was found near a forge area. Among the observed corrosion strata and characteristic of the corrosion process of ferrous metals, two corrosion layers CP3 and CP4 appear atypical compared to other corrosion profiles of similar metals (cf [MiCorr | Knife with a groove on both sides DEV 995/814 PR - Fe Alloy - Early medieval times - Switzerland](#)). They could be related to high temperature exposure due to the proximity of a forging zone.

The limit of the original surface is probably between CP2/CP3 and CP3/CP4. Layer CP3 (in red) shows no more silica grain coming from the burial environment. CP3 can be removed, but this will eliminate certain elements relating to the history of the artefact.

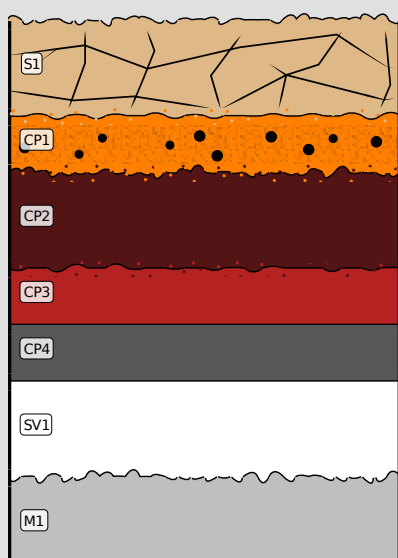
Fig. 7: Stratigraphic representation of the corrosion structure of the object observed macroscopically under binocular microscope using the MiCorr application with reference to Fig. 6. The characteristics of the strata are only accessible by clicking on the drawing that redirects you to the search tool by stratigraphy representation, credit Materia Viva, C.Moreau.
