## UNDETERMINED – FE ALLOY – EARLY MEDIEVAL TIMES

<b>Artefact name</b>	Undetermined
<b>Authors</b>	Moreau. Caroline (Laboratoire MATERIA VIVA, Toulouse, Midi-Pyrénées, France) & TOUZEAU. Julie (Laboratoire MATERIA VIVA, Toulouse, Midi-Pyrénées, France)
<b>Url</b>	/artefacts/1443/

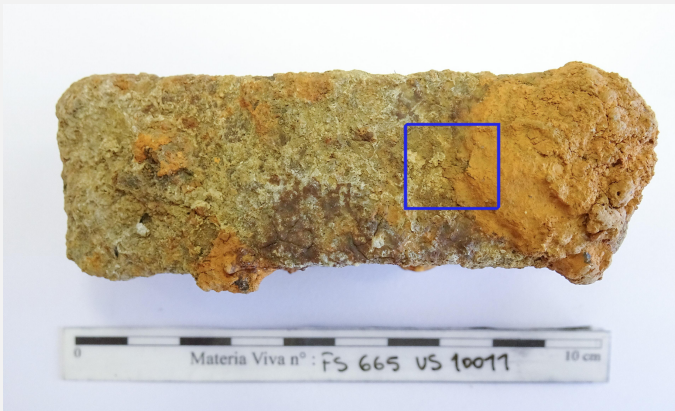
Fig. 5: The blue square indicates the location of the analysed area by binocular observation,

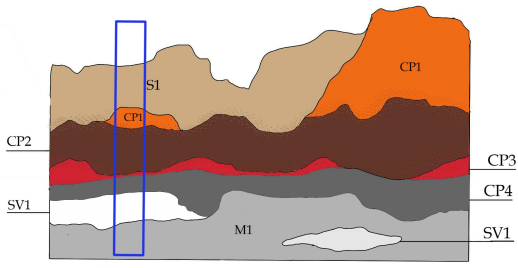
S1	Sediment	powdery and non adherent
CP1	Corrosion product	bright orange corrosion product or soil orange-coloured by corrosion products
CP2	Corrosion product	brown layer of corrosion products with silica grains
CP3	Corrosion product	very thin discontinuous layer of a red corrosion product without silica grains
CP4	Corrosion product	grey/blue continuous layer
SV1	Structural void	
M1	Metal	compact metal. Observation of stretched metal around the structural voids

Fig. 6: Stratigraphic representation of the corrosion structure of the object by macroscopic and binocular observation with indication of the corrosion structure used to build the MiCorr stratigraphy of Fig. 7 (blue rectangle),

This ferrous alloy object that may have belonged to a wooden box was found near a forge area. Among the observed corrosion strata and characteristic of the corrosion process of ferrous metals, two corrosion layers CP3 and CP4 appear atypical compared to other corrosion profiles of similar metals (cf [MiCorr | Knife with a groove on both sides DEV 995/814 PR - Fe Alloy - Early medieval times - Switzerland](#)). They could be related to high temperature exposure due to the proximity of a forging zone.

The limit of the original surface is probably between CP2/CP3 and CP3/CP4. Layer CP3 (in red) shows no more silica grain coming from the burial environment. CP3 can be removed, but this will eliminate certain elements relating to the history of the artefact.

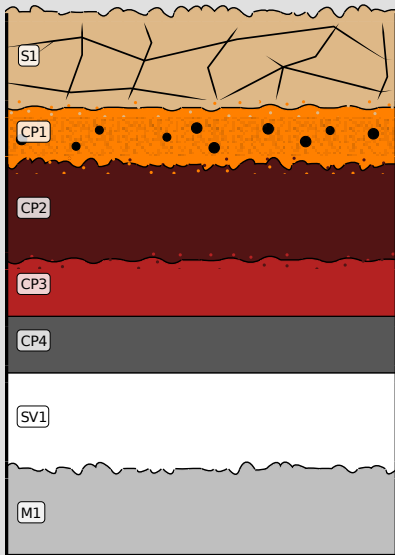
Fig. 7: Stratigraphic representation of the corrosion structure of the object observed macroscopically under binocular microscope using the MiCorr application with reference to Fig. 6. The characteristics of the strata are only accessible by clicking on the drawing that redirects you to the search tool by stratigraphy representation, credit Materia Viva, C.Moreau.
