UNDETERMINED - FE ALLOY - EARLY MEDIEVAL TIMES

Artefact name Undetermined

Authors Moreau. Caroline (Laboratoire MATERIA VIVA, Toulouse, Midi-Pyrénées, France) & TOUZEAU. Julie (Laboratoire MATERIA VIVA, Toulouse, Midi-Pyrénées, France)

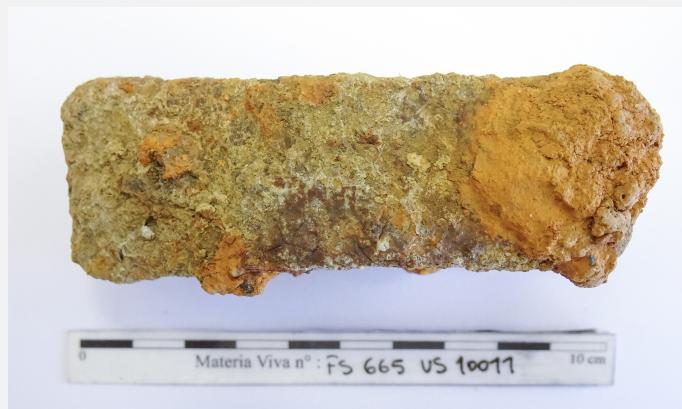
Fig. 1: Artefact (component of a furniture?) with soil and corrosion products (side view),

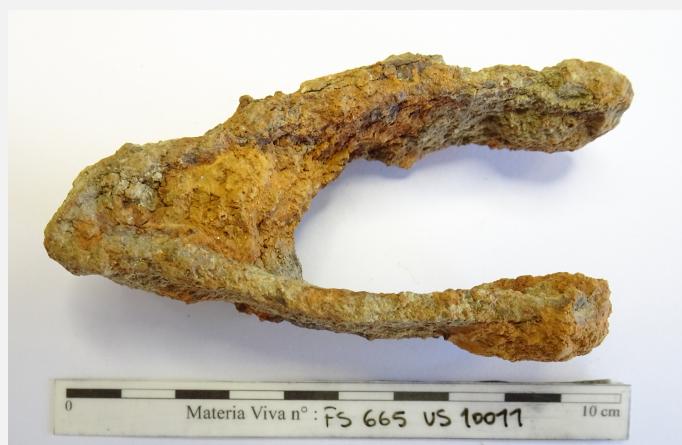
Fig. 2: Lateral view of the object,

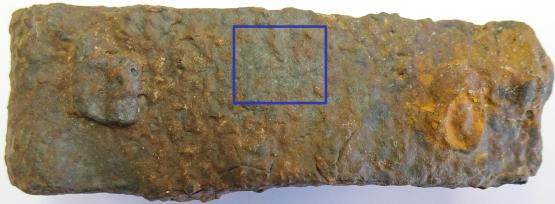
0 Materia Viva n° : FS 665 VS 10011 10 cm

Fig. 3: Artefact after restoration, the blue square indicates the detail of Fig.4.

Burial conditions / environment	Soil
Artefact location	Las Craviers, Fanjeaux (Favennec Benoît), Languedoc-Roussillon
Owner	None
Inv. number	FS665 US10011
Recorded conservation data	Mechanical removal of the corrosion products and protection with resin paraloid B72 in acetone.

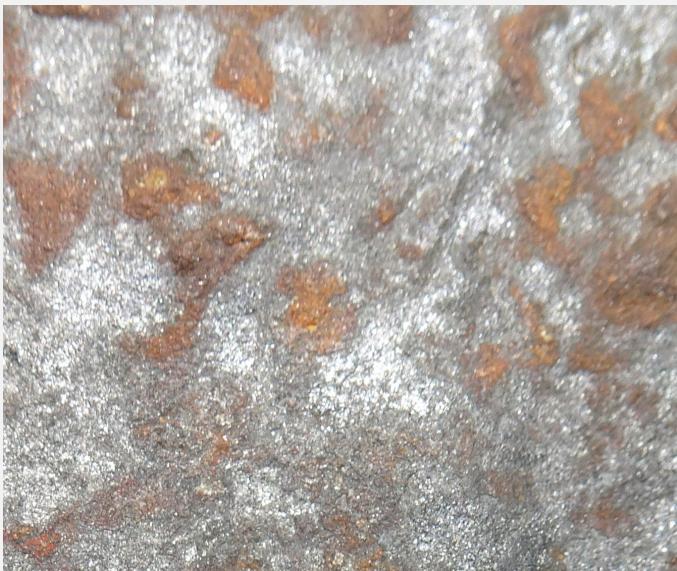
Fig. 4: Detail of the cleaned surface showing shiny grey/blue surface and red/brown spots.

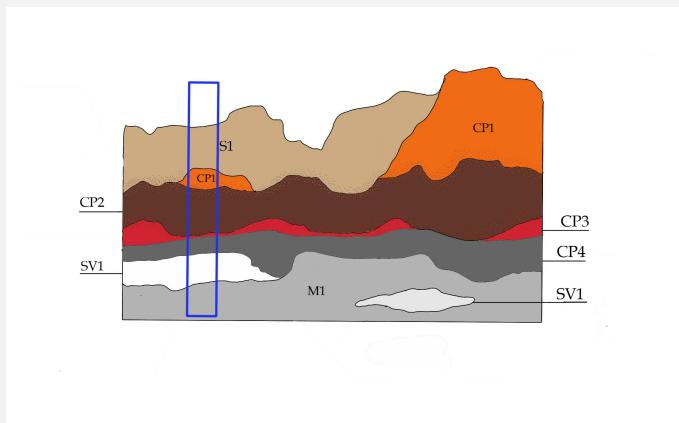
S1	Sediment	powdery and non adherent
CP1	Corrosion product	bright orange corrosion product or soil orange-coloured by corrosion products
CP2	Corrosion product	brown layer of corrosion products with silica grains
CP3	Corrosion product	very thin discontinuous layer of a red corrosion product without silica grains
CP4	Corrosion product	grey/blue continuous layer
SV1	Structural void	
M1	Metal	compact metal. Observation of stretched metal around the structural voids

Fig. 6: Stratigraphic representation of the corrosion structure of the object by macroscopic and binocular observation with indication of the corrosion structure used to build the MiCorr stratigraphy of Fig. 7 (blue rectangle), credit Materia Viva, C.Moreau.

This ferrous alloy object that may have belonged to a wooden box was found near a forge area. Among the observed corrosion strata and characteristic of the corrosion process of ferrous metals, two corrosion layers CP3 and CP4 appear atypical compared to other corrosion profiles of similar metals (cf [MiCorr | Knife with a groove on both sides DEV 995/814 PR - Fe Alloy - Early medieval times - Switzerland](#)). They could be related to high temperature exposure due to the proximity of a forging zone.

The limit of the original surface is probably between CP2/CP3 and CP3/CP4. Layer CP3 (in red) shows no more silica grain coming from the burial environment. CP3 can be removed, but this will eliminate certain elements relating to the history of the artefact.

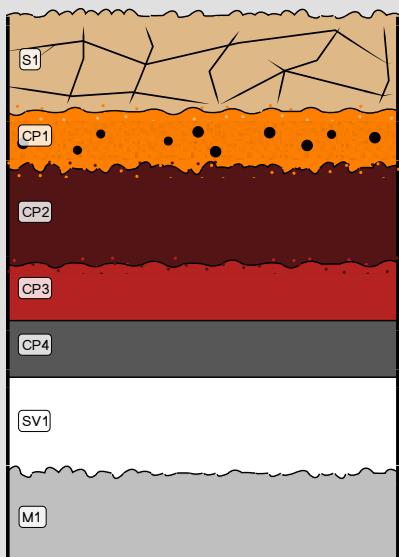
Fig. 7: Stratigraphic representation of the corrosion structure of the object observed macroscopically under binocular microscope using the MiCorr application with reference to Fig. 6. The characteristics of the strata are only accessible by clicking on the drawing that redirects you to the search tool by stratigraphy representation, credit Materia Viva, C.Moreau.
