UNDETERMINED – FE ALLOY – EARLY MEDIEVAL TIMES

Artefact name Undetermined

Authors Moreau. Caroline (Laboratoire MATERIA VIVA, Toulouse, Midi-Pyrénées, France) & TOUZEAU. Julie (Laboratoire MATERIA VIVA, Toulouse, Midi-Pyrénées, France)

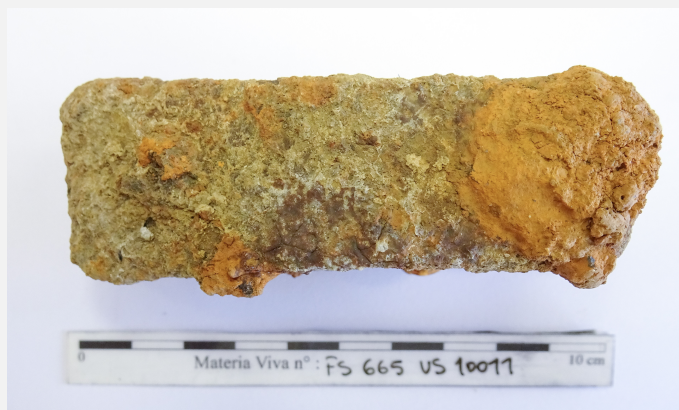
Fig. 1: Artefact (component of a furniture?) with soil and corrosion products (side view),

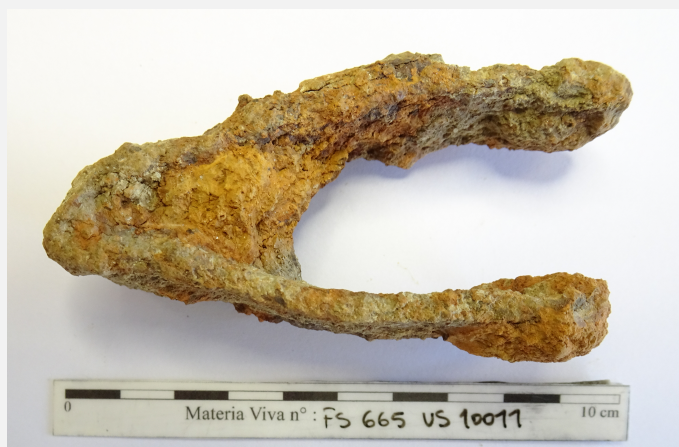
Fig. 2: Lateral view of the object,

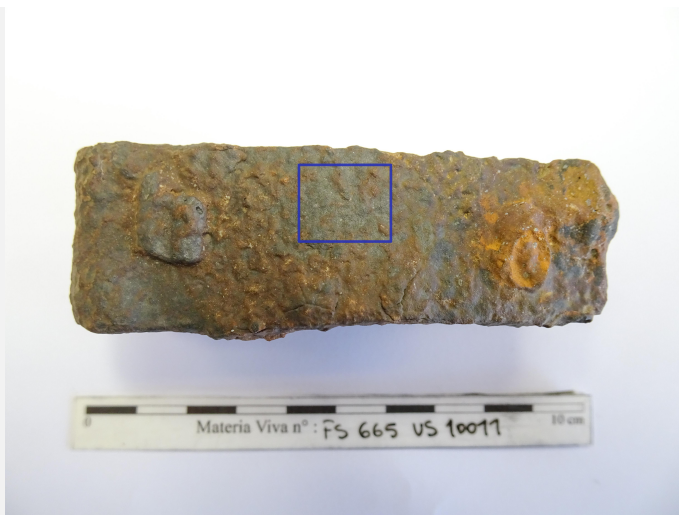
Fig. 3: Artefact after restoration, the blue square indicates the detail of Fig.4,

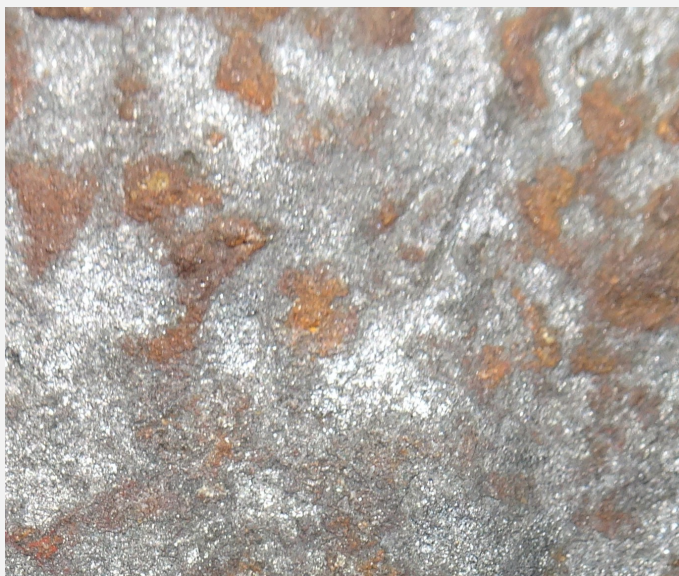
Fig. 4: Detail of the cleaned surface showing shiny grey/blue surface and red/brown spots,

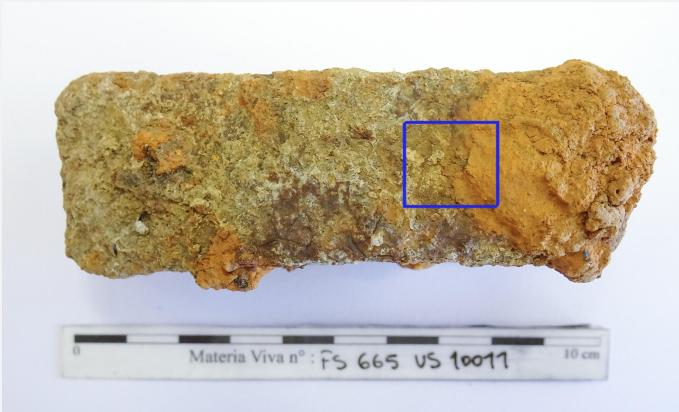
Fig. 5: The blue square indicates the location of the analysed area by binocular observation,

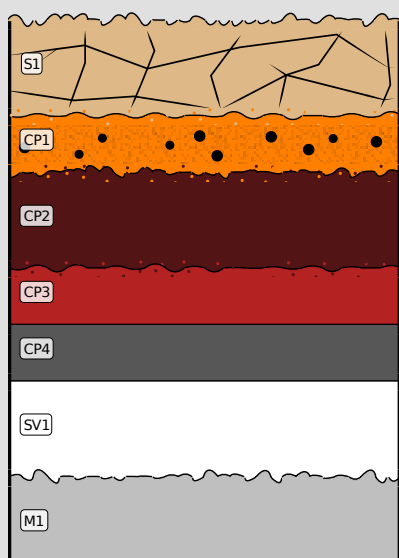
Fig. 7: Stratigraphic representation of the corrosion structure of the object observed macroscopically under binocular microscope using the MiCorr application with reference to Fig. 6. The characteristics of the strata are only accessible by clicking on the drawing that redirects you to the search tool by stratigraphy representation, credit Materia Viva, C.Moreau.
