## UNDETERMINED – FE ALLOY – EARLY MEDIEVAL TIMES

<b>Artefact name</b>	Undetermined
<b>Authors</b>	Moreau. Caroline (Laboratoire MATERIA VIVA, Toulouse, Midi-Pyrénées, France) & TOUZEAU. Julie (Laboratoire MATERIA VIVA, Toulouse, Midi-Pyrénées, France)
<b>Url</b>	/artefacts/1445/

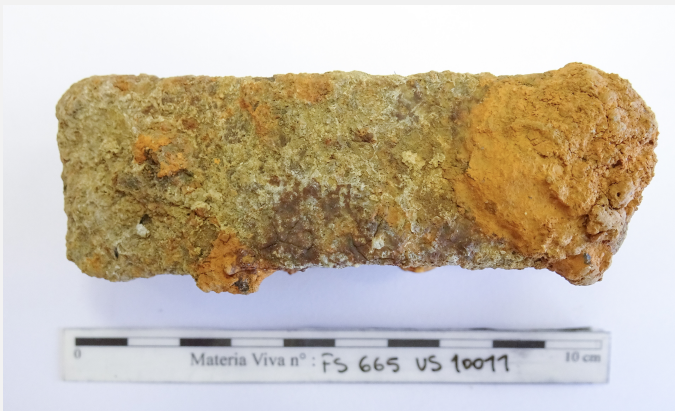
Fig. 1: Artefact (component of a furniture?) with soil and corrosion products (side view),

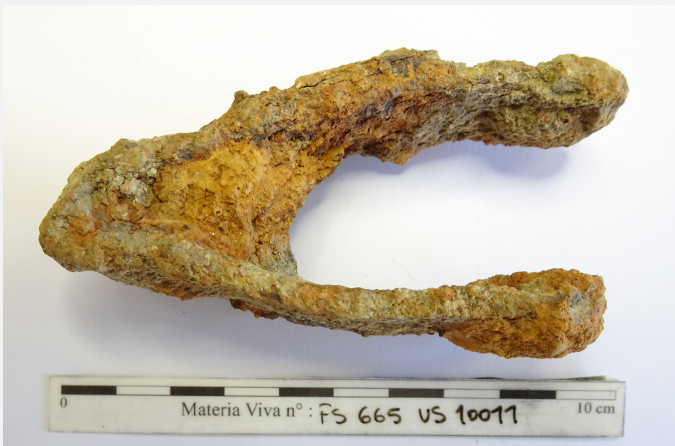
Fig. 2: Lateral view of the object,

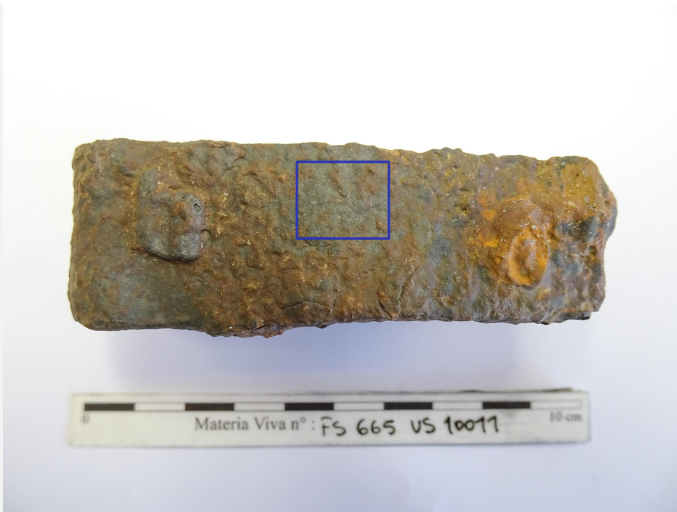
Fig. 3: Artefact after restoration, the blue square indicates the detail of Fig.4,

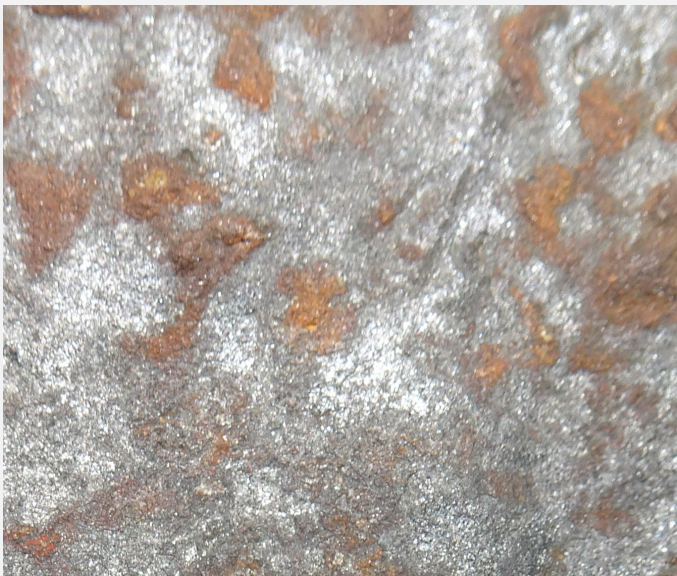
Fig. 4: Detail of the cleaned surface showing shiny grey/blue surface and red/brown spots,

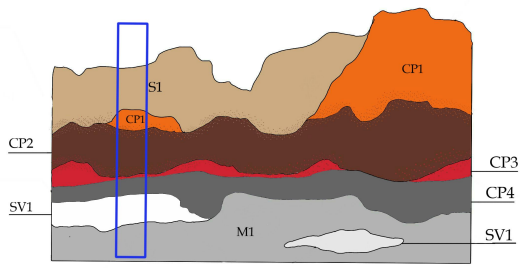
Fig. 6: Stratigraphic representation of the corrosion structure of the object by macroscopic and binocular observation with indication of the corrosion structure used to build the MiCorr stratigraphy of Fig. 7 (blue rectangle),

This ferrous alloy object that may have belonged to a wooden box was found near a forge area. Among the observed corrosion strata and characteristic of the corrosion process of ferrous metals, two corrosion layers CP3 and CP4 appear atypical compared to other corrosion profiles of similar metals (cf [MiCorr | Knife with a groove on both sides DEV 995/814 PR - Fe Alloy - Early medieval times - Switzerland](#)). They could be related to high temperature exposure due to the proximity of a forging zone.

The limit of the original surface is probably between CP2/CP3 and CP3/CP4. Layer CP3 (in red) shows no more silica grain coming from the burial environment. CP3 can be removed, but this will eliminate certain elements relating to the history of the artefact.

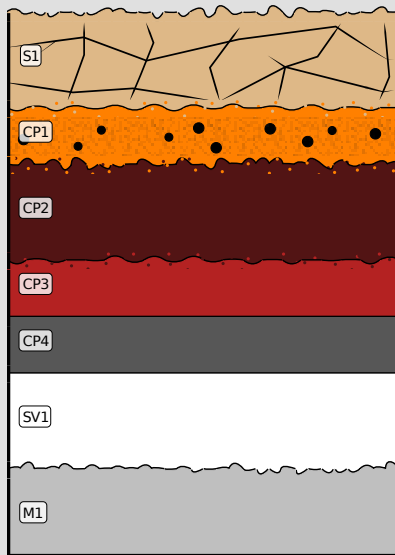
Fig. 7: Stratigraphic representation of the corrosion structure of the object observed macroscopically under binocular microscope using the MiCorr application with reference to Fig. 6. The characteristics of the strata are only accessible by clicking on the drawing that redirects you to the search tool by stratigraphy representation, credit Materia Viva, C.Moreau.
