## UNDETERMINED - FE ALLOY - EARLY MEDIEVAL TIMES

<b>Artefact name</b>	Undetermined
<b>Authors</b>	Moreau. Caroline (Laboratoire MATERIA VIVA, Toulouse, Midi-Pyrénées, France) & TOUZEAU. Julie (Laboratoire MATERIA VIVA, Toulouse, Midi-Pyrénées, France)
<b>Url</b>	/artefacts/1445/

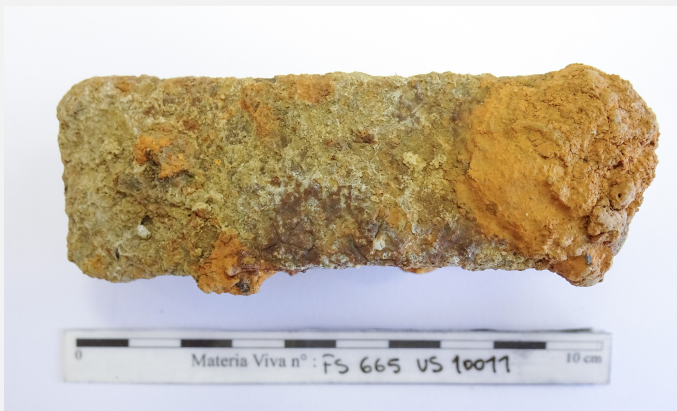
Fig. 1: Artefact (component of a furniture?) with soil and corrosion products (side view),

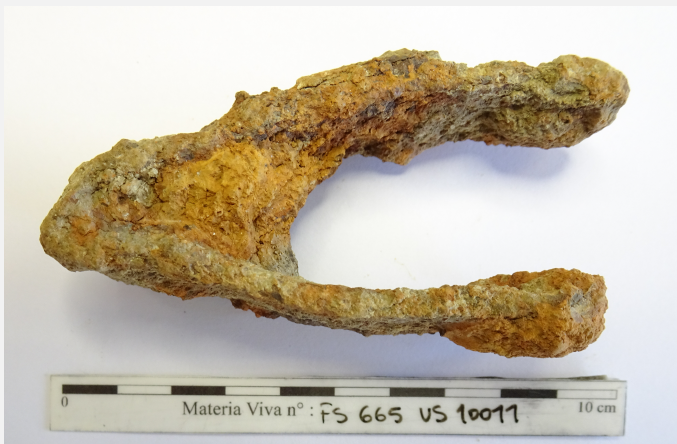
Fig. 2: Lateral view of the object,

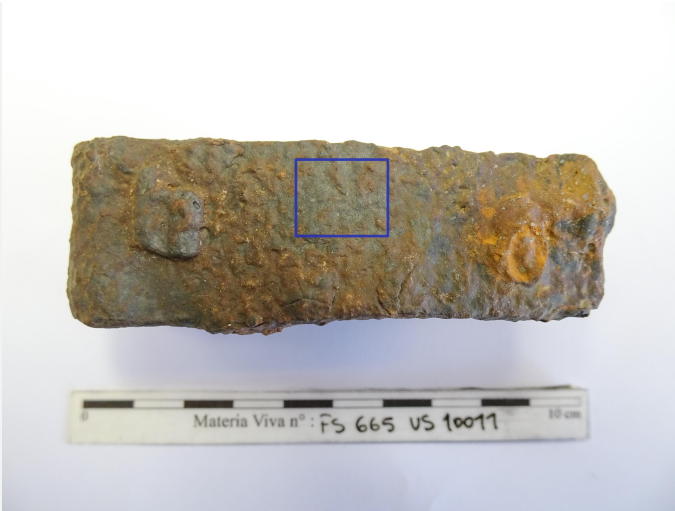
Fig. 3: Artefact after restoration, the blue square indicates the detail of Fig.4,

<b>Burial conditions / environment</b>	Soil
<b>Artefact location</b>	Las Cravieros, Fanjeaux (Favennec Benoît), Languedoc-Roussillon
<b>Owner</b>	None
<b>Inv. number</b>	FS665 US10011
<b>Recorded conservation data</b>	Mechanical removal of the corrosion products and protection with resin paraloid B72 in acetone.

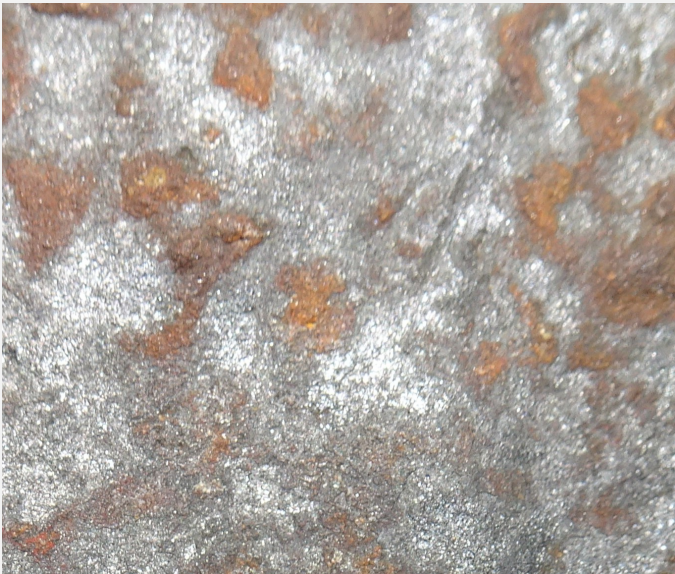
Fig. 4: Detail of the cleaned surface showing shiny grey/blue surface and red/brown spots,

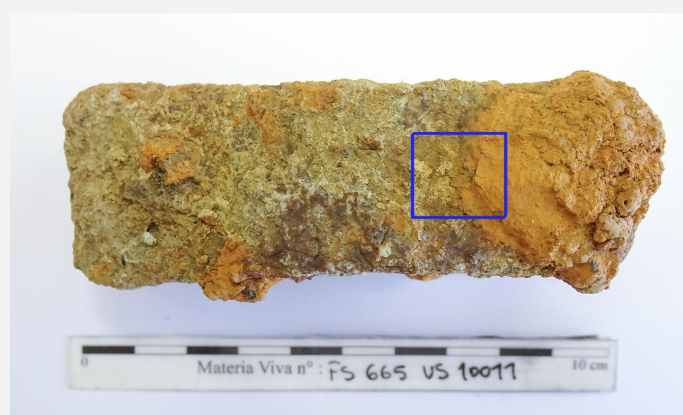
Fig. 5: The blue square indicates the location of the analysed area by binocular observation,

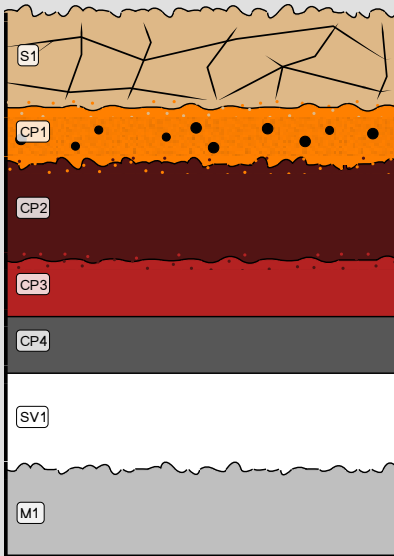
Fig. 7: Stratigraphic representation of the corrosion structure of the object observed macroscopically under binocular microscope using the MiCorr application with reference to Fig. 6. The characteristics of the strata are only accessible by clicking on the drawing that redirects you to the search tool by stratigraphy representation, credit Materia Viva, C.Moreau.
