ANTHROPOMORPHIC VASE – AG ALLOY – ROMAN TIMES

Artefact name Anthropomorphic vase

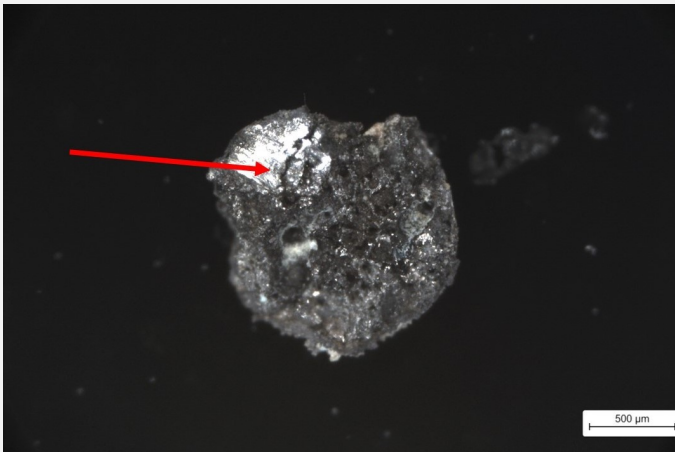
Fig. 5: Micrograph of sample 1 (Fig. 2) of the vase showing a blister (the red arrow corresponds to the area where EDX analysis was carried out),

Based on the elemental chemical distribution, we can interpret better the EDX results of samples from Figs. 5 to 8. Indeed, blisters (Fig. 5) consist mainly of silver polluted on its surface with bromine and chlorine (Fig. 17). As for the piece of mineralised metal (Fig. 8), it also consists largely of silver, bromine and chlorine (same corrosion products as the blister). This is rather typical for such an archaeological object recovered from the ground (Marchand et al., 2014). The concretion (Fig. 6) is made up of carbon, oxygen, sodium, silicon, aluminium, calcium, a little potassium and phosphorus, also from the burial context. The black element (Fig. 7) could be likened to mica or feldspath (Figs. 16 and 17 with detail in Fig. 12). There is magnesium, silicon and oxygen, again from the environment in which the object was buried.

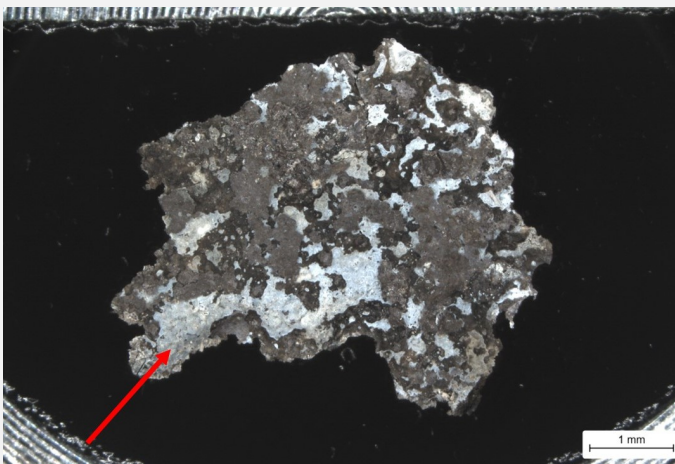
Fig. 6: Micrograph of sample 2 (Fig. 2) of the vase showing a concretion (the red arrow corresponds to the area where EDX analysis was carried out),

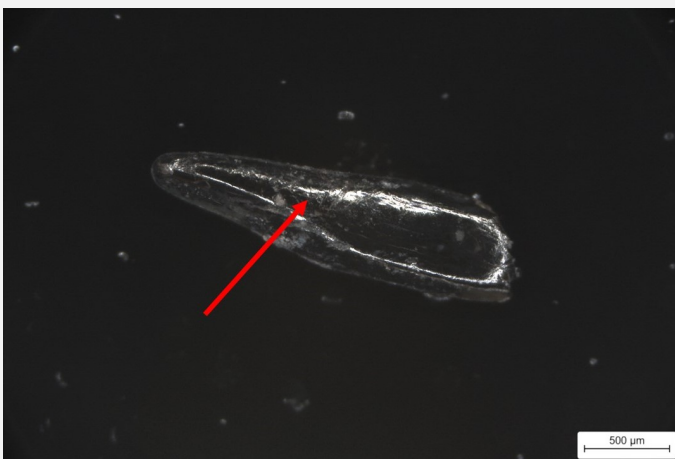
Fig. 7: Micrograph of sample 3 (Fig. 2) of the vase showing a small black element (the red arrow corresponds to the area where EDX analysis was carried out),

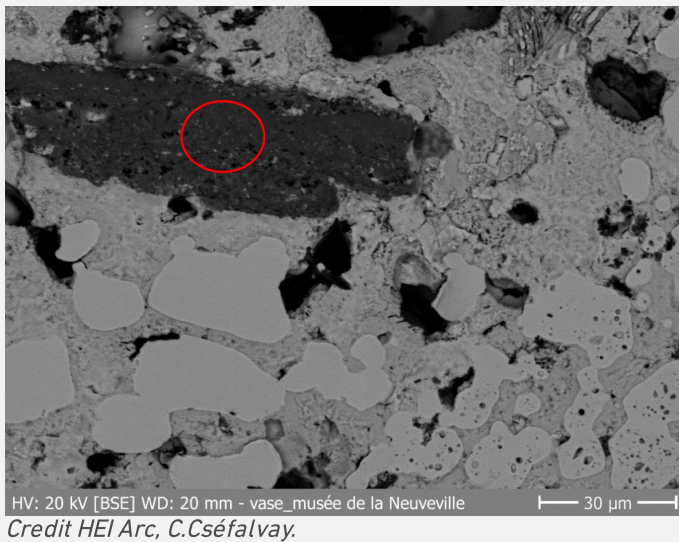
Fig. 12: SEM picture (BSE mode) of the metal sample from Fig. 9 (detail), with iron inclusion,

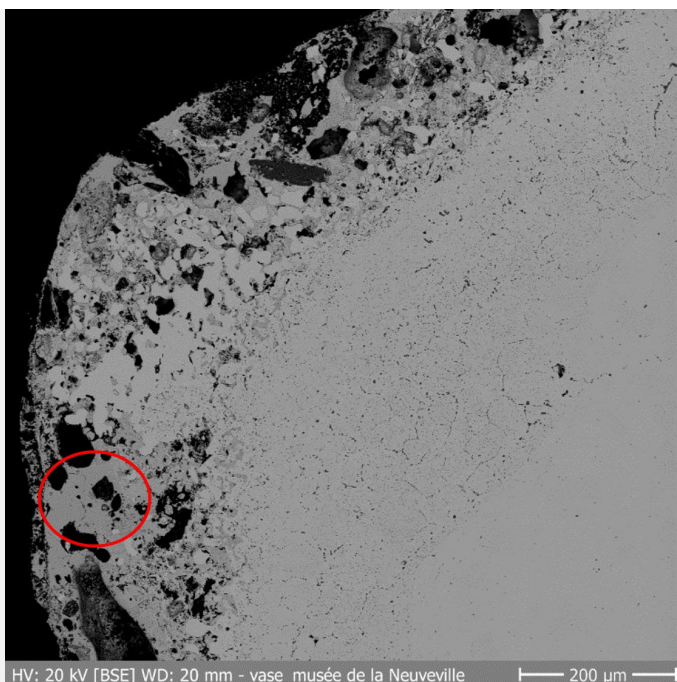
Fig. 13: SEM picture (BSE mode) of the metal sample from Fig. 9 (detail) with high amount of silver, bromine and chlorine in the red circle,

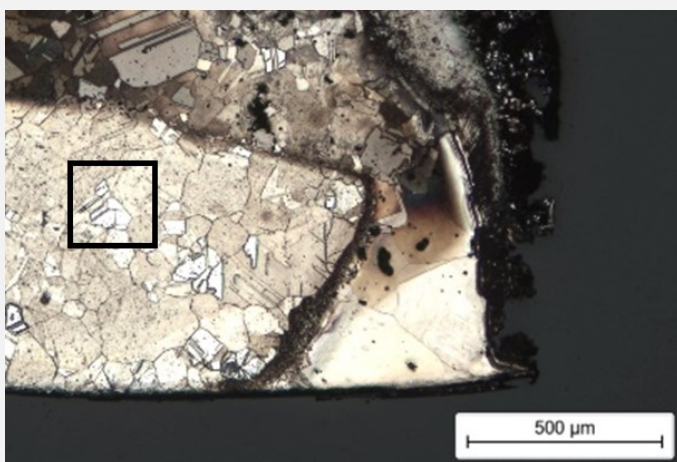
As a result of the chemical attack, various structures are visible. We can see twin lines (Fig. 14), which means that the structure has been several times annealed after hammering. We can also see in some places the presence of strain lines, which characterise the final hammering of a structure without annealing (Scott, 1991).

Fig.14 : Micrograph of the sample after etching. Twin lines are clearly visible in the black square,

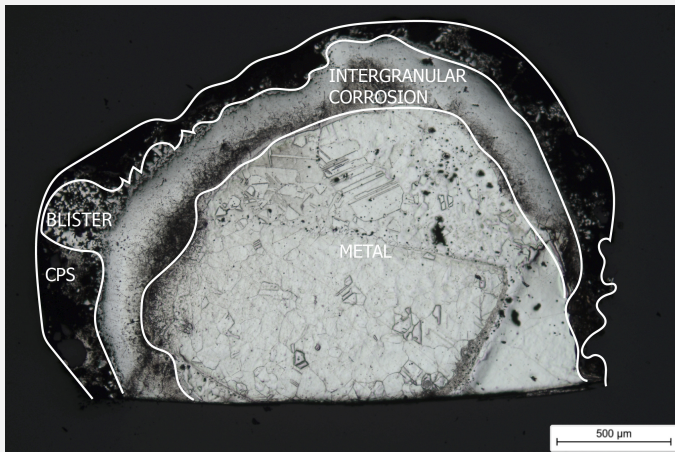
Observation of the cross-section under a microscope does not clearly distinguish the different corrosion layers on the vase. We can see a continuous, dark brown corrosion layer. The area where the sample was taken does not contain any light green or red corrosion. On the other hand, we can see that the silver forms a sort of blister which makes it difficult to distinguish the limit of the original surface (Fig. 15).

Fig. 15: Micrograph of the corrosion structure from Fig. 9 with the subdivision of the different strata,

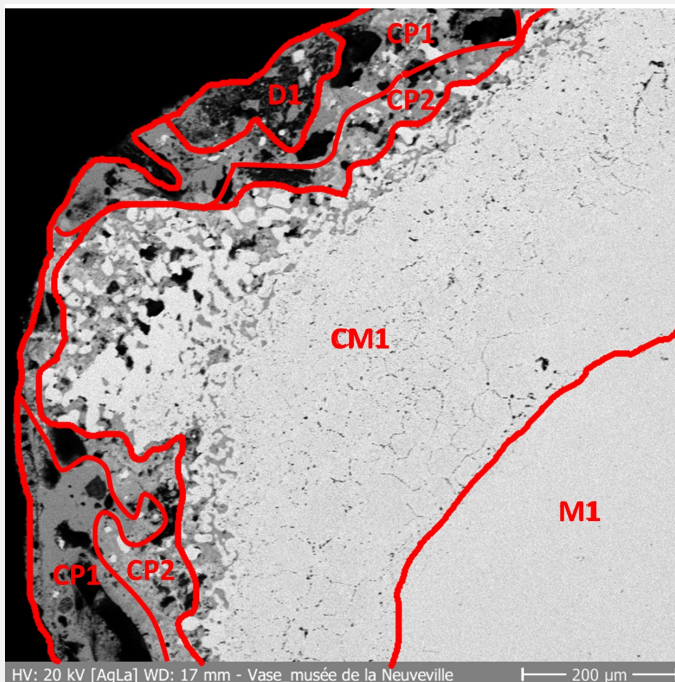
Mapping using SEM-EDS shows that the corrosion layer consists mainly of silver, bromine and chlorine, with a larger amount of chlorine next to the metal surface (CP2 in Fig. 16). There are also inclusions of calcium, iron, chromium

Fig. 16: Elemental distribution of Ag within the corrosion structure from Fig. 15 (detail) with the subdivision of the different strata,

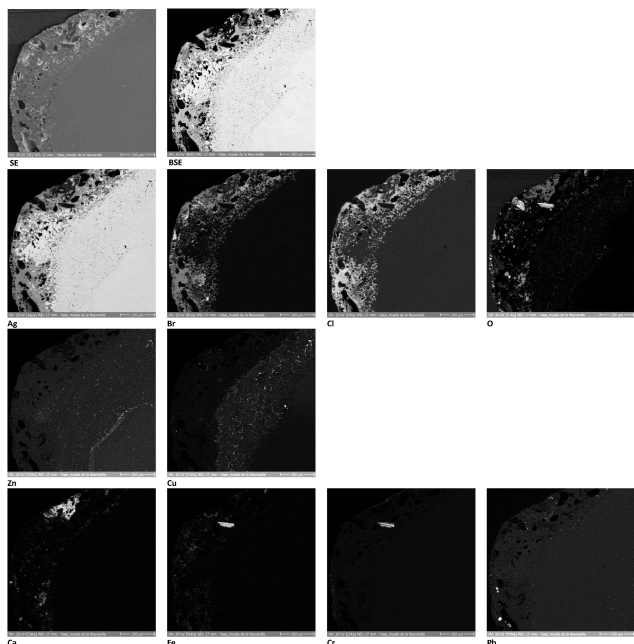
and lead combined with oxygen. Secondly, we can see the formation of intergranular corrosion with the presence of copper and zinc at the grain boundaries (Figs. 16 to 17).

Fig. 17: SEM picture (BSE-mode) similar to Fig. 16 (detail of Fig. 15) and elemental chemical distribution,
