ANTHROPOMORPHIC VASE – AG ALLOY – ROMAN TIMES

Artefact name Anthropomorphic vase

Authors (HE-Arc CR, Neuchâtel, Neuchâtel, Switzerland). (Christian Degriigny, None) & Solène. Béguelin (HE-Arc CR, Neuchâtel, Neuchâtel, Switzerland) & Valentin. Boissonnas (HE-Arc CR, Neuchâtel, Neuchâtel, Switzerland)

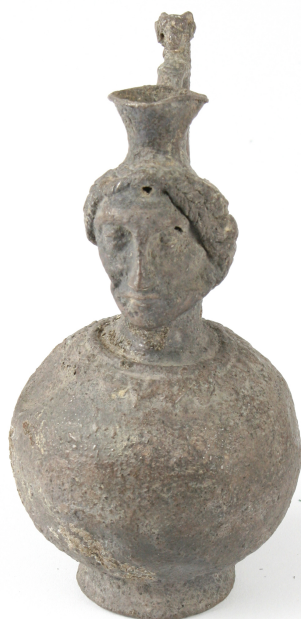
Fig. 1: Front of the vase,

This archaeological anthropomorphic vase has a round body topped by a woman's face. At the top of the handle is a ram's head. The object is covered with a brown-grey corrosion layer. The metal surface is deformed on the face and the body. H = 15.5cm ; Ø = 26cm.

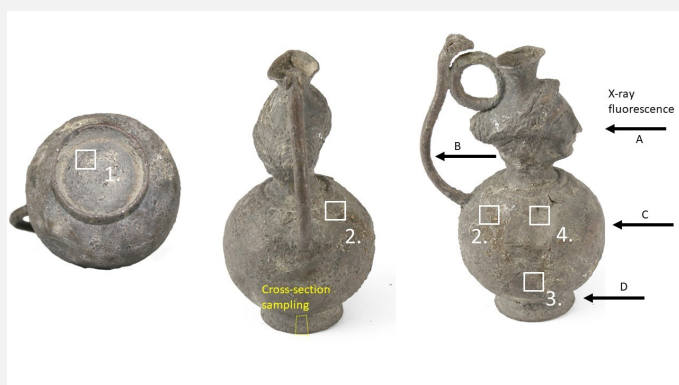
Fig. 2: Locations of the four points analysed with X-ray fluorescence (black arrows A-D), the four samples (numbers 1-4) and the cross-section (yellow) analysed with SEM-EDS,

The XRF analysis of the vase was carried out before sampling on four areas (Fig. 2). During the analysis, the layers of soil, corrosion and metal are analysed at the same time. The metal is probably a silver alloy with a small amount of Cu (and possibly Bi?). Some of the other elements detected are part of the burial environment (Al, Si, Fe, Cr) and corrosion products (Br, Cl). Titanium is probably an artefact.

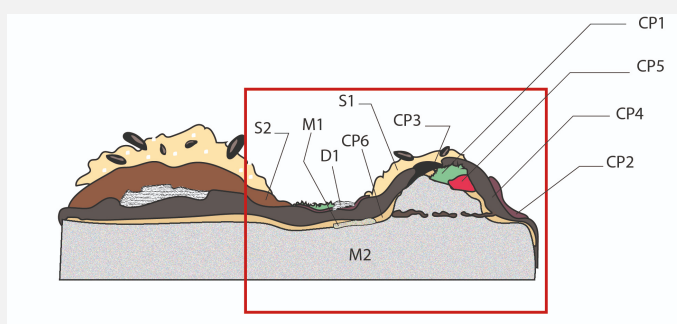
Fig. 3: Stratigraphic representation of the corrosion structure of the vase by macroscopic and binocular observation with indication of the corrosion structure used to build the MiCorr stratigraphy of Fig. 4 (red rectangle),

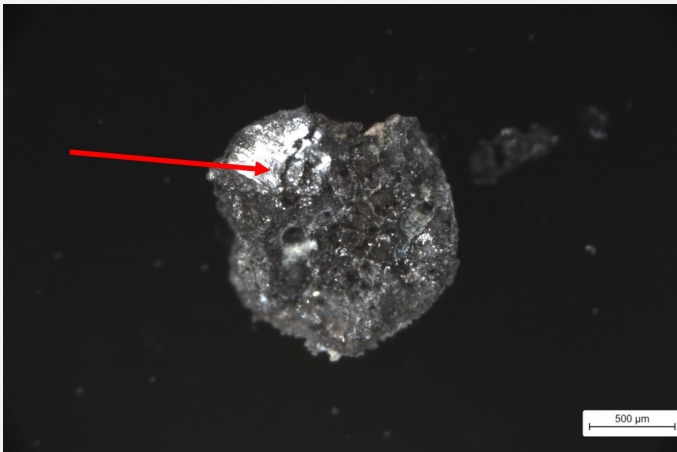
Fig. 5: Micrograph of sample 1 (Fig. 2) of the vase showing a blister (the red arrow corresponds to the area where EDX analysis was carried out),

Based on the elemental chemical distribution, we can interpret better the EDX results of samples from Figs. 5 to 8. Indeed, blisters (Fig. 5) consist mainly of silver polluted on its surface with bromine and chlorine (Fig. 17). As for the piece of mineralised metal (Fig. 8), it also consists largely of silver, bromine and chlorine (same corrosion products as the blister). This is rather typical for such an archaeological object recovered from the ground (Marchand et al., 2014). The concretion (Fig. 6) is made up of carbon, oxygen, sodium, silicon, aluminium, calcium, a little potassium and phosphorus, also from the burial context. The black element (Fig. 7) could be likened to mica or feldspath (Figs. 16 and 17 with detail in Fig. 12). There is magnesium, silicon and oxygen, again from the environment in which the object was buried.

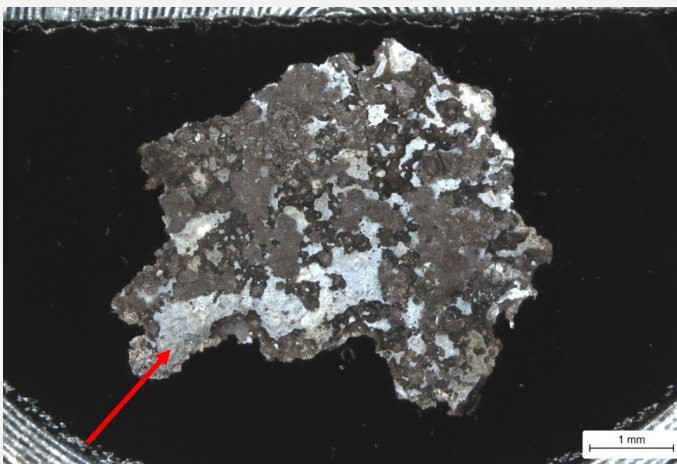
Fig. 6: Micrograph of sample 2 (Fig. 2) of the vase showing a concretion (the red arrow corresponds to the area where EDX analysis was carried out),

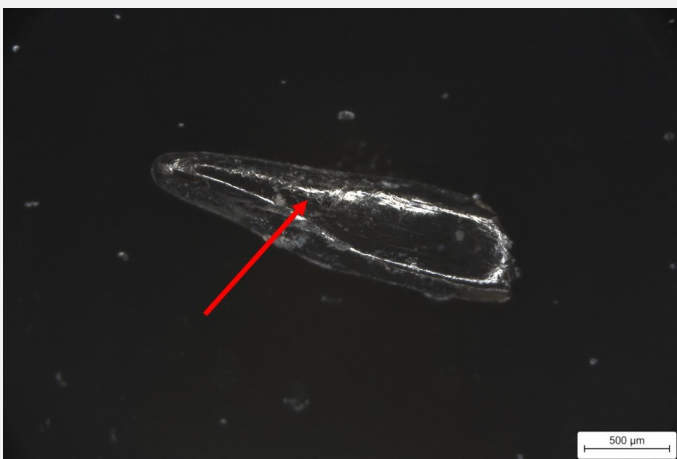
Fig. 7: Micrograph of sample 3 (Fig. 2) of the vase showing a small black element (the red arrow corresponds to the area where EDX analysis was carried out),

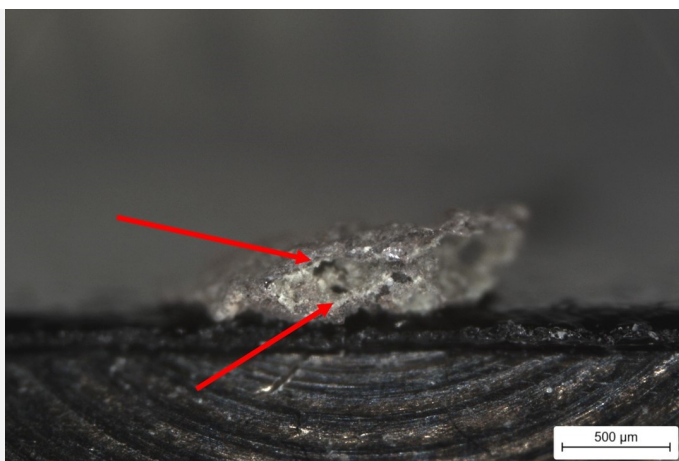
Fig. 8: Micrograph of sample 4 (Fig. 2) of the vase showing a piece of mineralized metal (the red arrows correspond to the areas where EDX analyses were carried out),

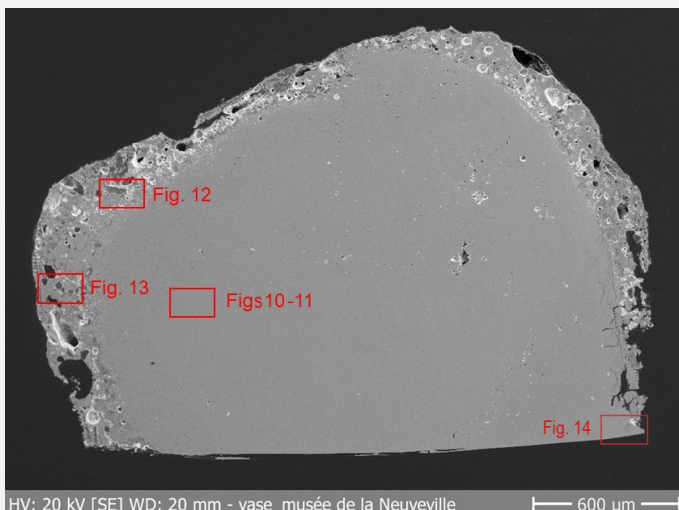
Fig. 9: SEM picture (SE mode) of the cross-section of the vase showing the location of Figs.10 to 14, unetched,

The cross-section embedded corresponds to a transversal cut made on the foot of the container (Fig. 2). A metallic core is present below the corrosion layers (Fig. 9).

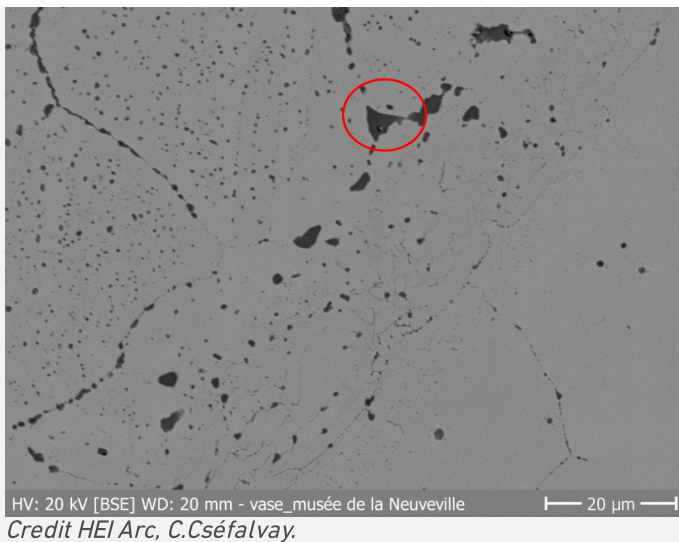
The base metal consists of 1.5% copper, 1.8% zinc and 96.7% silver by weight. Silver is therefore only lightly alloyed. The zinc and copper are in the form of inclusions (Figs. 10 and 11). The grains are clearly visible, copper and zinc have precipitated in the grain boundaries and develop intergranular corrosion (Fig. 13). Iron inclusions are also visible in places (Fig. 12). The presence of bromine and chlorine has been attested (Fig. 13).

Fig. 10: SEM picture (BSE mode) of the metal sample from Fig. 9 (detail), with zinc inclusion,

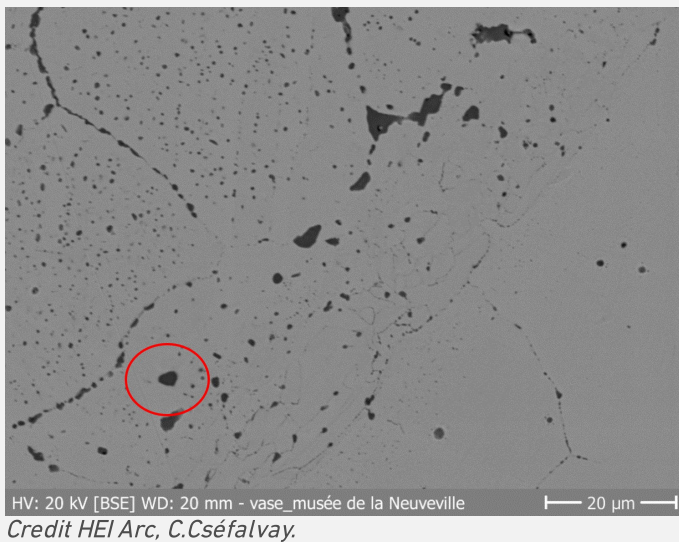
Fig. 11: SEM picture (BSE mode) of the metal sample from Fig. 9 (detail), with copper inclusion,

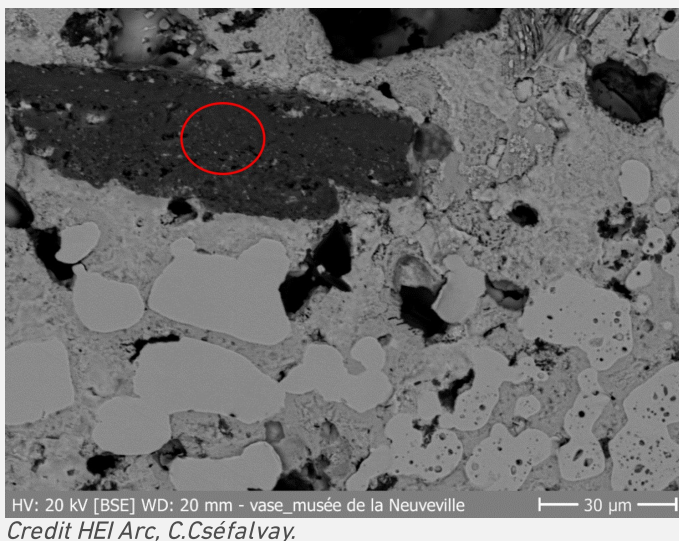
Fig. 12: SEM picture (BSE mode) of the metal sample from Fig. 9 (detail), with iron inclusion,

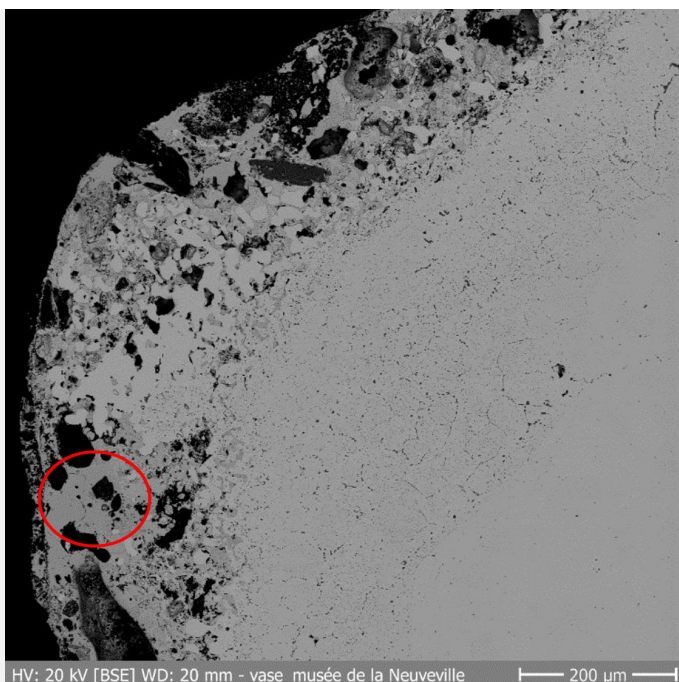
Fig. 13: SEM picture (BSE mode) of the metal sample from Fig. 9 (detail) with high amount of silver, bromine and chlorine in the red circle,

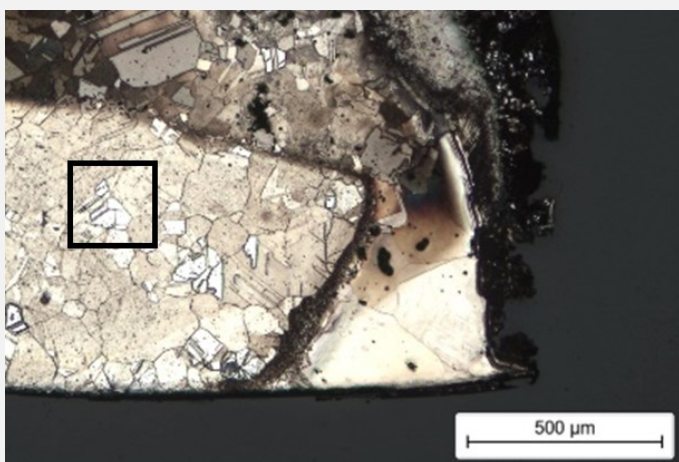
As a result of the chemical attack, various structures are visible. We can see twin lines (Fig. 14), which means that the structure has been several times annealed after hammering. We can also see in some places the presence of strain lines, which characterise the final hammering of a structure without annealing (Scott, 1991).

Fig.14 : Micrograph of the sample after etching. Twin lines are clearly visible in the black square,

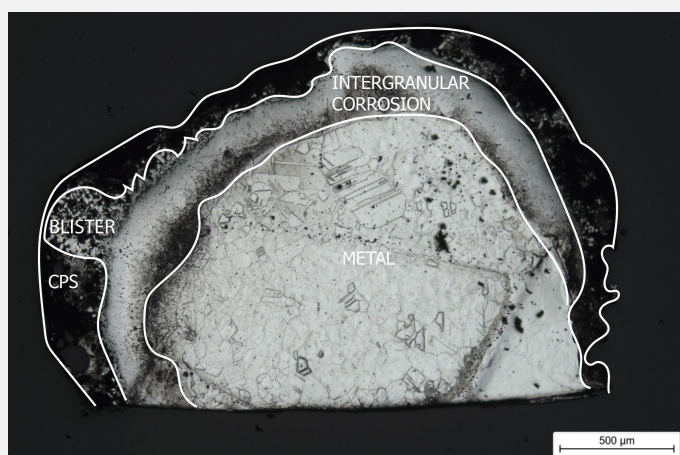
Observation of the cross-section under a microscope does not clearly distinguish the different corrosion layers on the vase. We can see a continuous, dark brown corrosion layer. The area where the sample was taken does not contain any light green or red corrosion. On the other hand, we can see that the silver forms a sort of blister which makes it difficult to distinguish the limit of the original surface (Fig. 15).

Fig. 15: Micrograph of the corrosion structure from Fig. 9 with the subdivision of the different strata,

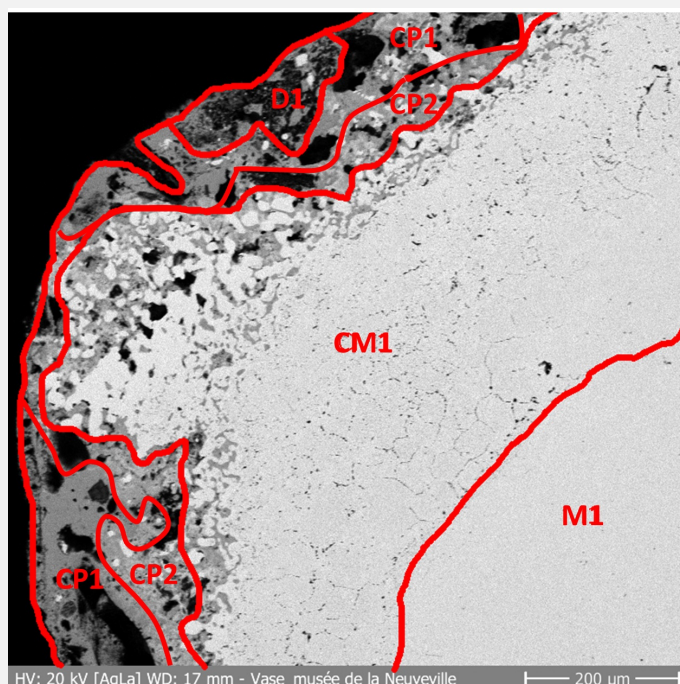
Mapping using SEM-EDS shows that the corrosion layer consists mainly of silver, bromine and chlorine, with a larger amount of chlorine next to the metal surface (CP2 in Fig. 16). There are also inclusions of calcium, iron, chromium

Fig. 16: Elemental distribution of Ag within the corrosion structure from Fig. 15 (detail) with the subdivision of the different strata,

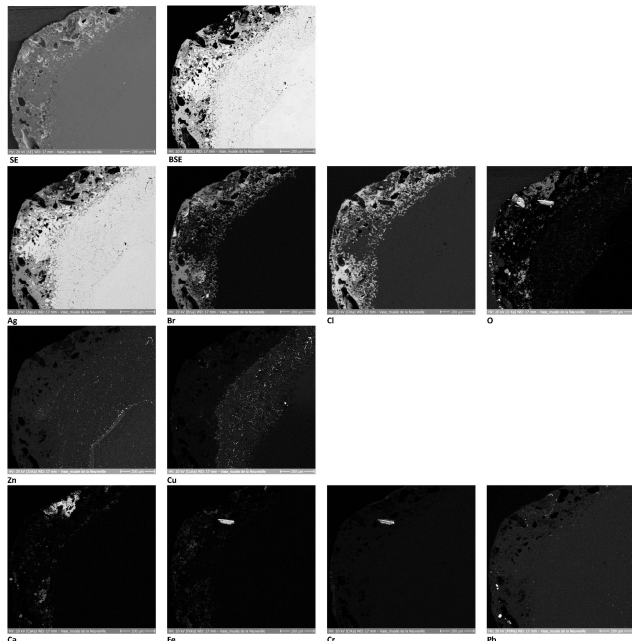
and lead combined with oxygen. Secondly, we can see the formation of intergranular corrosion with the presence of copper and zinc at the grain boundaries (Figs. 16 to 17).

Fig. 17: SEM picture (BSE-mode) similar to Fig. 16 (detail of Fig. 15) and elemental chemical distribution,

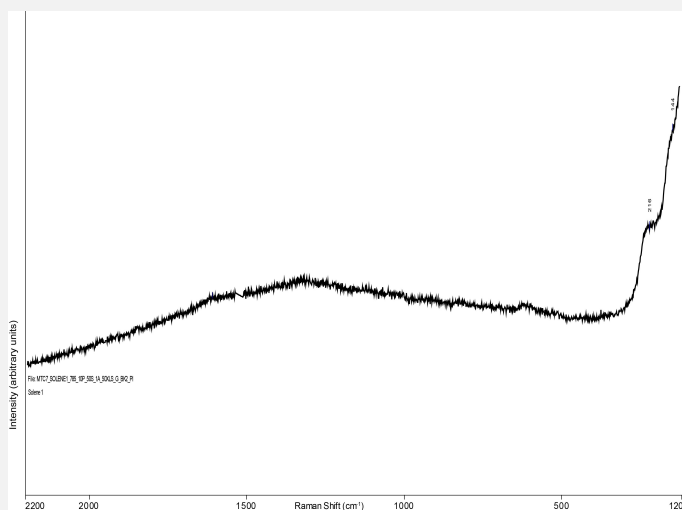
Raman analysis was carried out on a sample of mineralised metal (Fig. 18). The spectrum obtained does not correspond to those presented in the literature for silver chloride. Therefore, it remains a hypothesis.

Fig. 18: Raman spectrum of the mineralised metal sample (Fig. 8) possibly silver chloride,

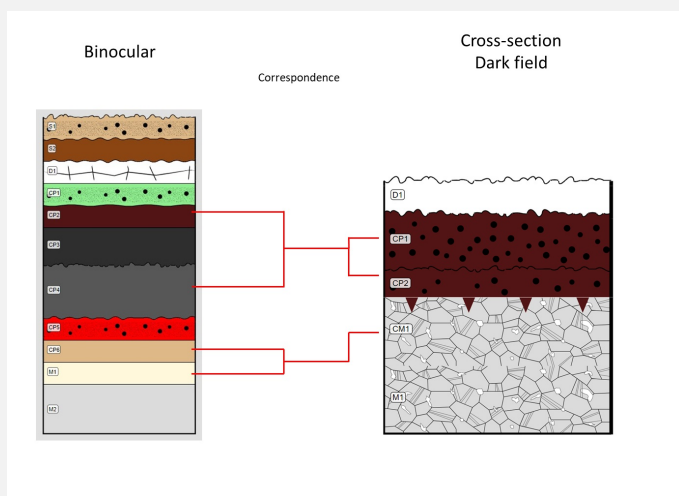
Compared with Figure 4, the amount of information is just limited to an area where there is only one blister. Observation of the cross-section did not reveal all the corrosion layers visible on the entire object when it was probed under binoculars. In fact, only two layers of corrosion are visible (CP1 and CP2) (Fig. 19). They correspond to two different corrosion layers of the Bi MiCorr stratigraphy (CP2 and CP4, Fig. 4). CM1 (Fig.19) could correspond to CP6 and M1 on Fig. 4. M2 on Fig. 4 corresponds to M1 on Fig. 19.

The lack of information when examining the cross-section is due to the fact that the colours of the layers are very close to each other. The sample is fairly representative of the object, showing mainly a layer of corrosion rich in Ag, Cl and Br on a metal that is subject to intergranular corrosion. The sample's location was chosen because it's a discrete area and it allowed us to analyse the metal at its core.

Fig. 20: Stratigraphic representation side by side of binocular view and cross-section (dark field),
