ANTHROPOMORPHIC VASE - AG ALLOY - ROMAN TIMES

Artefact name Anthropomorphic vase

Authors (HE-Arc CR, Neuchâtel, Neuchâtel, Switzerland). (Christian Degrigny, None) & Solène. Béguelin (HE-Arc CR, Neuchâtel, Neuchâtel, Switzerland) & Valentin. Boissonnas (HE-Arc CR, Neuchâtel, Neuchâtel, Switzerland)

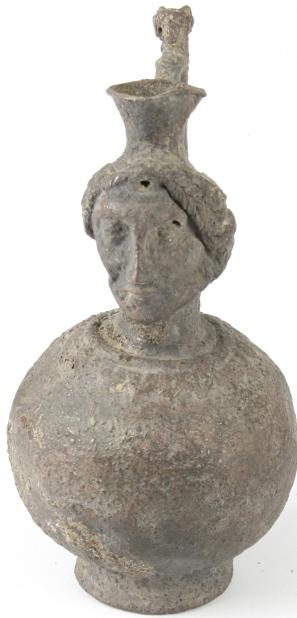
Fig. 1: Front of the vase,

Description of the artefact	This archaeological anthropomorphic vase has a round body topped by a woman's face. At the top of the handle is a ram's head. The object is covered with a brown-grey corrosion layer. The metal surface is deformed on the face and the body. H =15.5cm ; Ø = 26cm.
Type of artefact	Vessel
Origin	Unknown
Recovering date	Date unknown
Chronology category	Roman Times
chronology tpq	<input type="text"/> ---- <input type="button" value="▼"/>
chronology taq	<input type="text"/> ---- <input type="button" value="▼"/>
Chronology comment	
Burial conditions / environment	Soil
Artefact location	Musée d'Art et d'Histoire de la Neuveville, La Neuveville, Bern
Owner	Musée d'Art et d'Histoire de la Neuveville, La Neuveville, Bern
Inv. number	MHLN-2006-24.076
Recorded conservation data	A conservation-restoration treatment was carried out in 2023. The object underwent mechanical and chemical treatment (alkaline dithionite baths).

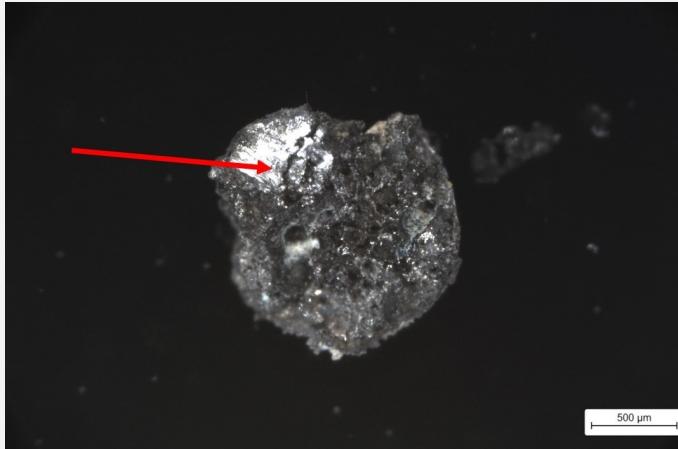
Fig. 5: Micrograph of sample 1 (Fig. 2) of the vase showing a blister (the red arrow corresponds to the area where EDX analysis was carried out),

Based on the elemental chemical distribution, we can interpret better the EDX results of samples from Figs. 5 to 8. Indeed, blisters (Fig. 5) consist mainly of silver polluted on its surface with bromine and chlorine (Fig. 17). As for the piece of mineralised metal (Fig. 8), it also consists largely of silver, bromine and chlorine (same corrosion products as the blister). This is rather typical for such an archaeological object recovered from the ground (Marchand et al., 2014). The concretion (Fig. 6) is made up of carbon, oxygen, sodium, silicon, aluminium, calcium, a little potassium and phosphorus, also from the burial context. The black element (Fig. 7) could be likened to mica or feldspar (Figs. 16 and 17 with detail in Fig. 12). There is magnesium, silicon and oxygen, again from the environment in which the object was buried.

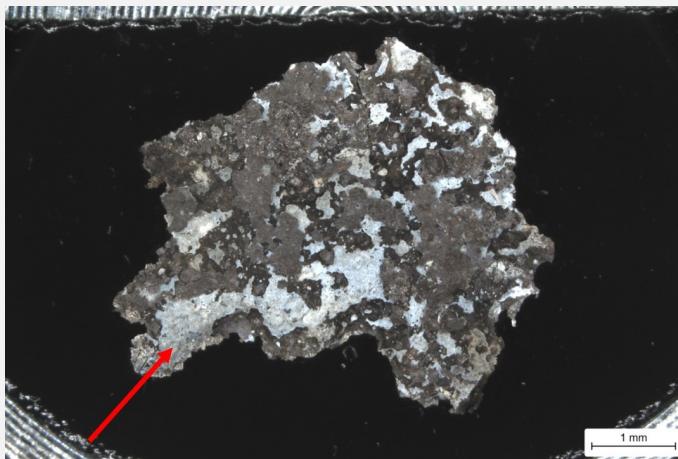
Fig. 6: Micrograph of sample 2 (Fig. 2) of the vase showing a concretion (the red arrow corresponds to the area where EDX analysis was carried out),

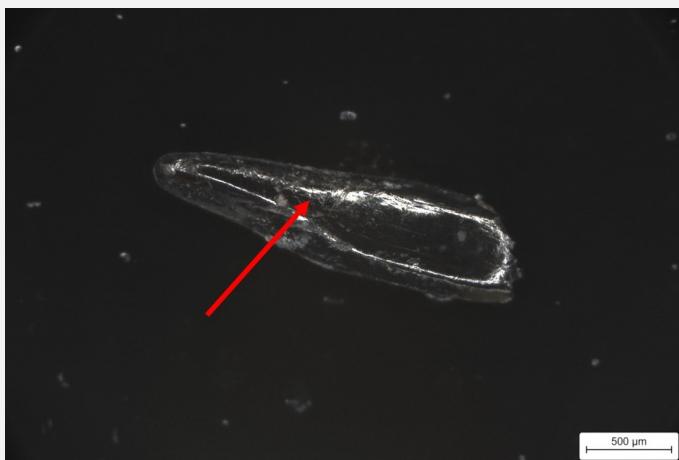
Fig. 7: Micrograph of sample 3 (Fig. 2) of the vase showing a small black element (the red arrow corresponds to the area where EDX analysis was carried out),

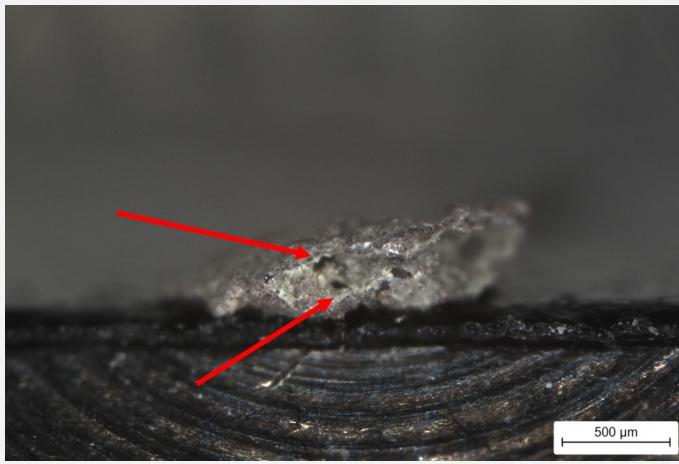
Fig. 8: Micrograph of sample 4 (Fig. 2) of the vase showing a piece of mineralized metal (the red arrows correspond to the areas where EDX analyses were carried out),

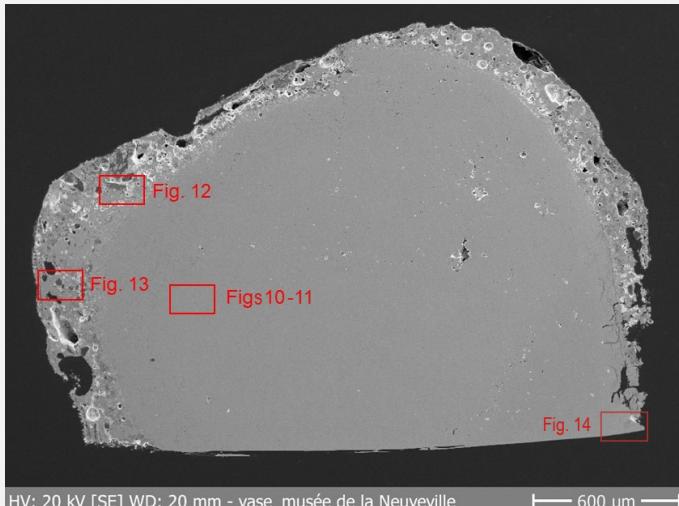
Fig. 9: SEM picture (SE mode) of the cross-section of the vase showing the location of Figs.10 to 14, unetched,

The cross-section embedded corresponds to a transversal cut made on the foot of the container (Fig. 2). A metallic core is present below the corrosion layers (Fig. 9).

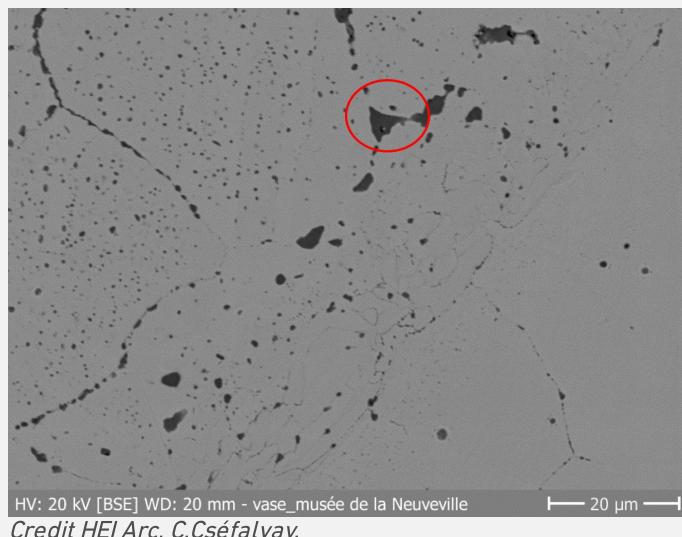
The base metal consists of 1.5% copper, 1.8% zinc and 96.7% silver by weight. Silver is therefore only lightly alloyed. The zinc and copper are in the form of inclusions (Figs. 10 and 11). The grains are clearly visible, copper and zinc have precipitated in the grain boundaries and develop intergranular corrosion (Fig. 13). Iron inclusions are also visible in places (Fig. 12). The presence of bromine and chlorine has been attested (Fig. 13).

Fig. 10: SEM picture (BSE mode) of the metal sample from Fig. 9 (detail), with zinc inclusion,

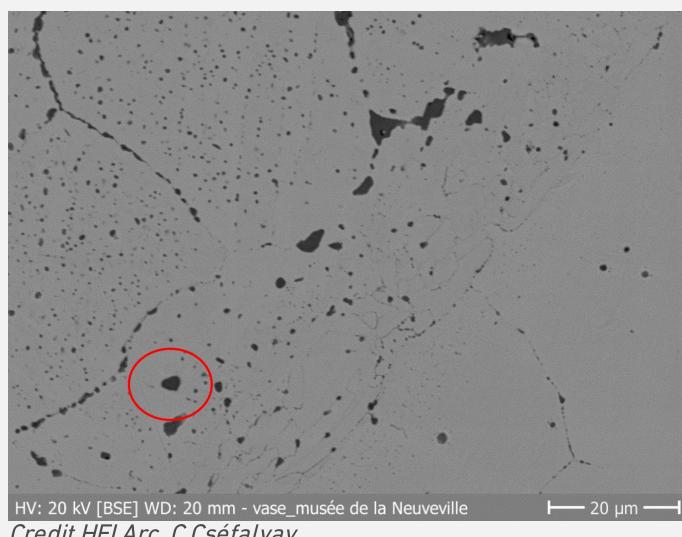
Fig. 11: SEM picture (BSE mode) of the metal sample from Fig. 9 (detail), with copper inclusion,

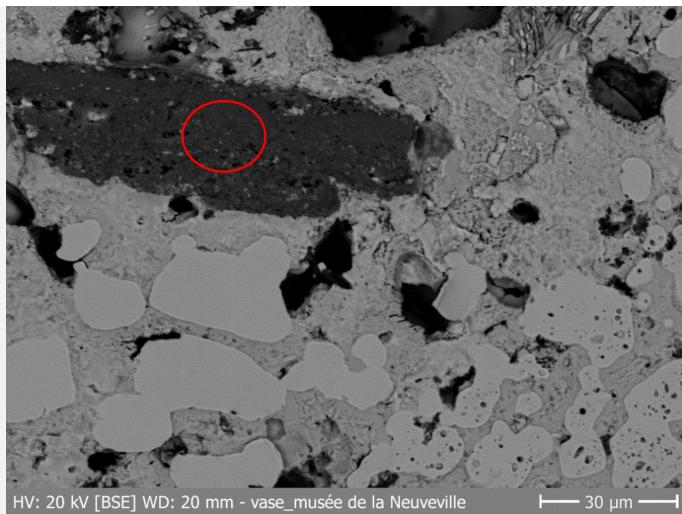
Fig. 12: SEM picture (BSE mode) of the metal sample from Fig. 9 (detail), with iron inclusion,

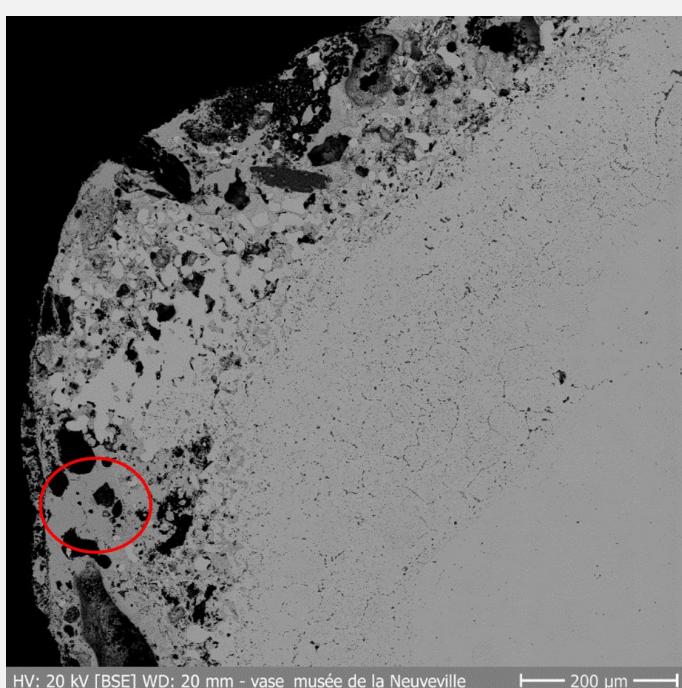
Fig. 13: SEM picture (BSE mode) of the metal sample from Fig. 9 (detail) with high amount of silver, bromine and chlorine in the red circle,

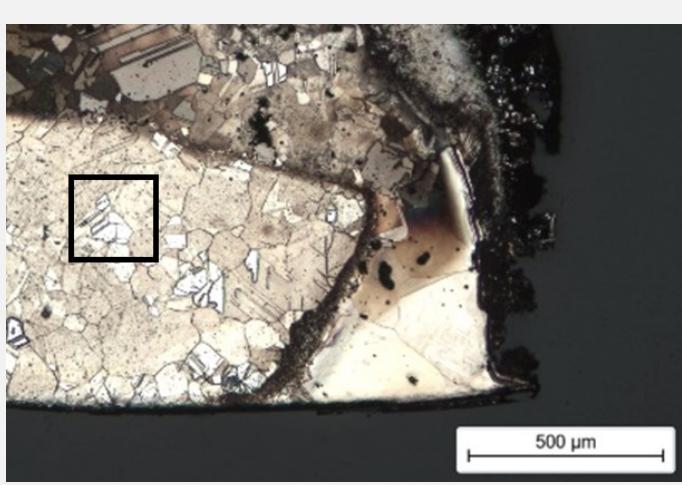
As a result of the chemical attack, various structures are visible. We can see twin lines (Fig. 14), which means that the structure has been several times annealed after hammering. We can also see in some places the presence of strain lines, which characterise the final hammering of a structure without annealing (Scott, 1991).

Fig.14 : Micrograph of the sample after etching. Twin lines are clearly visible in the black square,

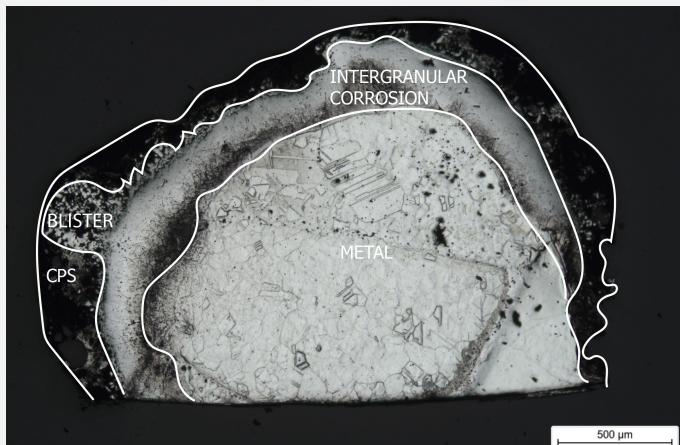
Observation of the cross-section under a microscope does not clearly distinguish the different corrosion layers on the vase. We can see a continuous, dark brown corrosion layer. The area where the sample was taken does not contain any light green or red corrosion. On the other hand, we can see that the silver forms a sort of blister which makes it difficult to distinguish the limit of the original surface (Fig. 15).

Fig. 15: Micrograph of the corrosion structure from Fig. 9 with the subdivision of the different strata,

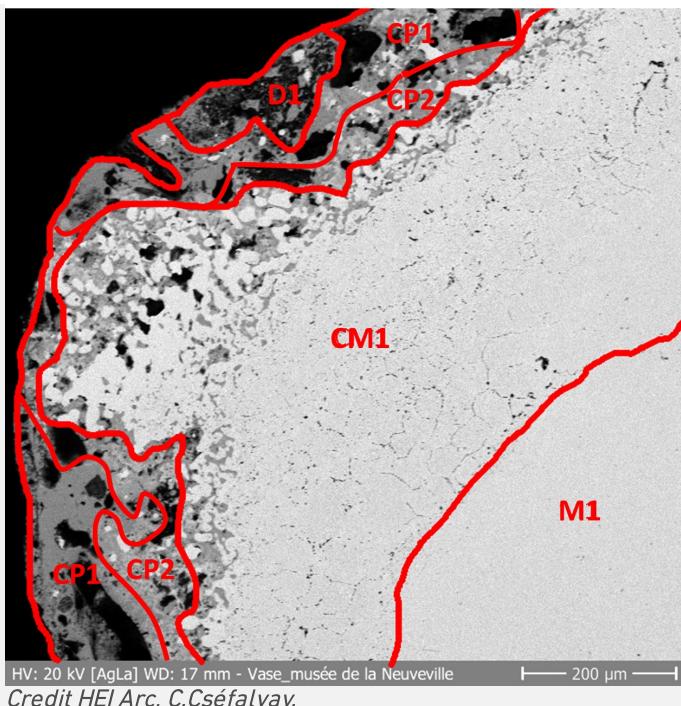
Mapping using SEM-EDS shows that the corrosion layer consists mainly of silver, bromine and chlorine, with a larger amount of chlorine next to the metal surface (CP2 in Fig. 16). There are also inclusions of calcium, iron, chromium and lead combined with oxygen. Secondly, we can see the formation of intergranular corrosion with the presence of copper and zinc at the grain boundaries (Figs. 16 to 17).

Fig. 16: Elemental distribution of Ag within the corrosion structure from Fig. 15 (detail) with the subdivision of the different strata,

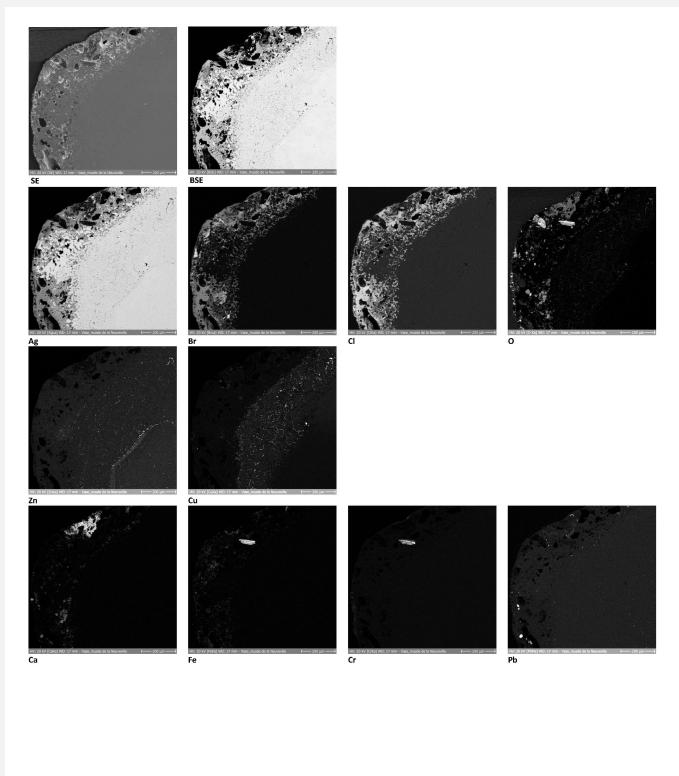
Fig. 17: SEM picture (BSE-mode) similar to Fig. 16 (detail of Fig. 15) and elemental chemical distribution,

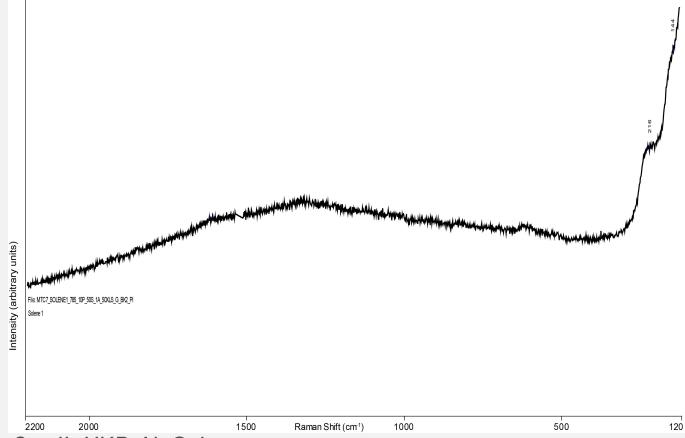
Raman analysis was carried out on a sample of mineralised metal (Fig. 18). The spectrum obtained does not correspond to those presented in the literature for silver chloride. Therefore, it remains a hypothesis.

Fig. 18: Raman spectrum of the mineralised metal sample (Fig. 8) possibly silver chloride,
