ANTHROPOMORPHIC VASE – AG ALLOY – ROMAN TIMES

Artefact name Anthropomorphic vase

Authors (HE-Arc CR, Neuchâtel, Neuchâtel, Switzerland). (Christian Degrigny, None) & Solène. Béguelin (HE-Arc CR, Neuchâtel, Neuchâtel, Switzerland) & Valentin. Boissonnas (HE-Arc CR, Neuchâtel, Neuchâtel, Switzerland)

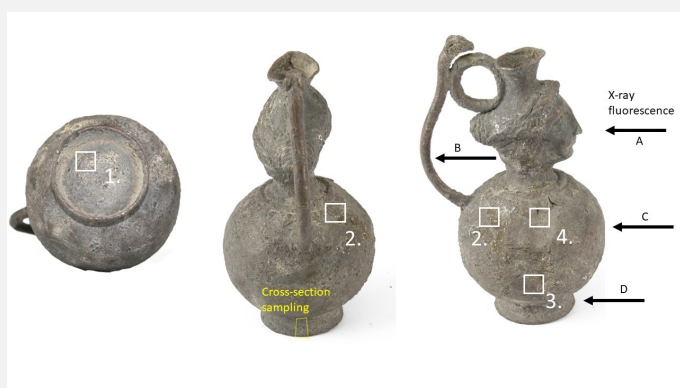
Fig. 2: Locations of the four points analysed with X-ray fluorescence (black arrows A-D), the four samples (numbers 1-4) and the cross-section (yellow) analysed with SEM-EDS,

The XRF analysis of the vase was carried out before sampling on four areas (Fig. 2). During the analysis, the layers of soil, corrosion and metal are analysed at the same time. The metal is probably a silver alloy with a small amount of Cu (and possibly Bi?). Some of the other elements detected are part of the burial environment (Al, Si, Fe, Cr) and corrosion products (Br, Cl). Titanium is probably an artefact.
