CHISEL POINT DEV 995 1069 PR – EUTECTOID TO HYPEREUTECTOID STEEL – EARLY MEDIEVAL TIMES – SWITZERLAND

Artefact name Chisel point DEV 995 1069 PR

Authors Marianne. Senn (Empa, Dübendorf, Zurich, Switzerland) & Christian. Degrigny (HE-Arc CR, Neuchâtel, Neuchâtel, Switzerland)

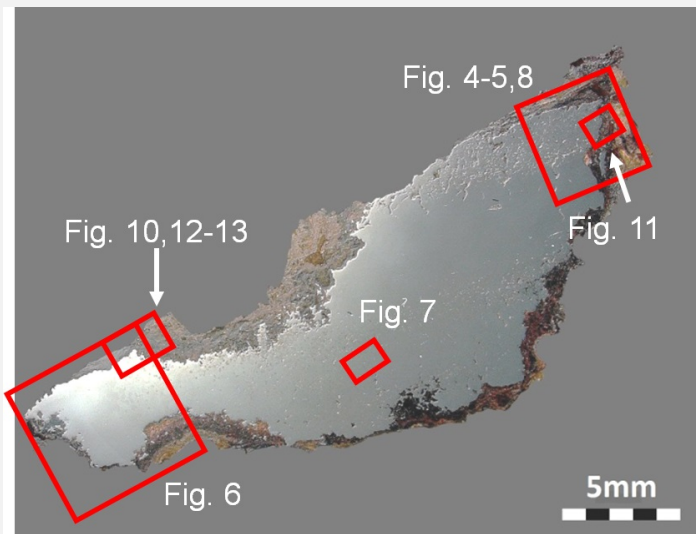
Fig. 3: Micrograph of the cross-section of the chisel point showing the location of Figs. 4 to 8 and 10 to 13,

A longitudinal cut from a chisel point (Figs. 2 and 3) after restoration. Dimensions: L = 30mm; W = 11 mm (approximately).

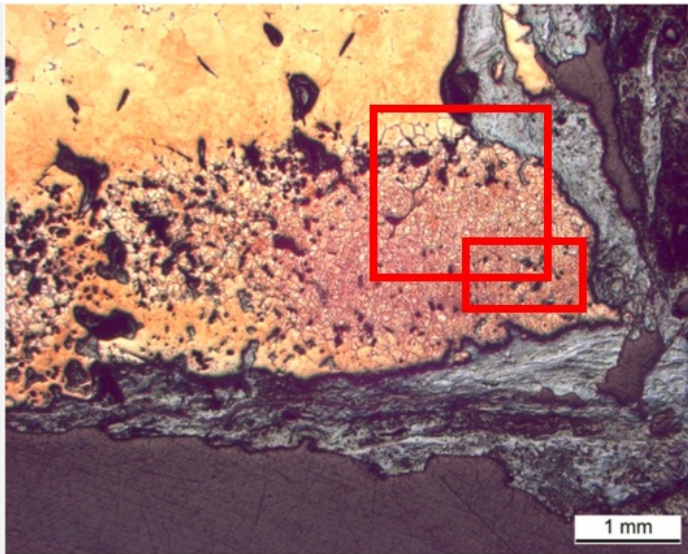
The remaining metal is a eutectoid to hypereutectoid steel (C 0.8-1 mass%) with cracks and porosity (Figs. 4 and 5). Its composition is given in Table 1 (except Fe). Of the trace elements, only Ni reaches a medium concentration (Ni 0.07 mass%). The composition and the high Ni/Co ratio are atypical for iron worked in smithies of the settlement at Develier-Courtételle JU, CH. The few slag inclusions and their chemical composition confirm this (Table 2). The slag is rich in CaO whereas the pisolithic or bean ore worked in the Central Jura smelting district is rich in Al_2O_3 . The slag inclusions cannot be smithing slag because the artefact is formed from one piece of metal. The slag probably incorporated while refining the bloom or during the bloom smelting process. The ore from which this metal was smelted cannot yet be identified. Intergranular corrosion has developed, penetrating into the metal structure (Fig. 5). The etched metal shows a dominant martensitic structure, typical of quench hardened steel (Figs. 4, 6, 7 and 8). The characteristic forms of the martensite are non-organised needles (Fig. 7). In restricted areas bainite nodules occur (Figs. 6 and 7). In the centre of the point, hypereutectoid steel is composed of cementite in the grain boundaries and in needle like shapes within the grains (Fig. 9). Hypereutectoid regions also occur in the centre of the shaft and on its left surface (Fig. 4). Here the hypereutectoid steel is composed of martensite and cementite in the grain boundaries and in needle form within the grains (Figs. 5 and 8). Nevertheless, most of the chisel is dominated by eutectoid steel. The average hardness of the quench hardened eutectoid steel is about HV1 690. In the bainite nodules the average hardness drops to about HV1 350, the martensite has an average hardness of HV1 750.

Fig. 4: Micrograph of the metal sample from Fig. 3 (inverted picture, detail), etched, bright field. The metal contains porosity and cracks (in black). The micrographs of Figs. 5 and 8 are marked by the top and bottom rectangles respectively,

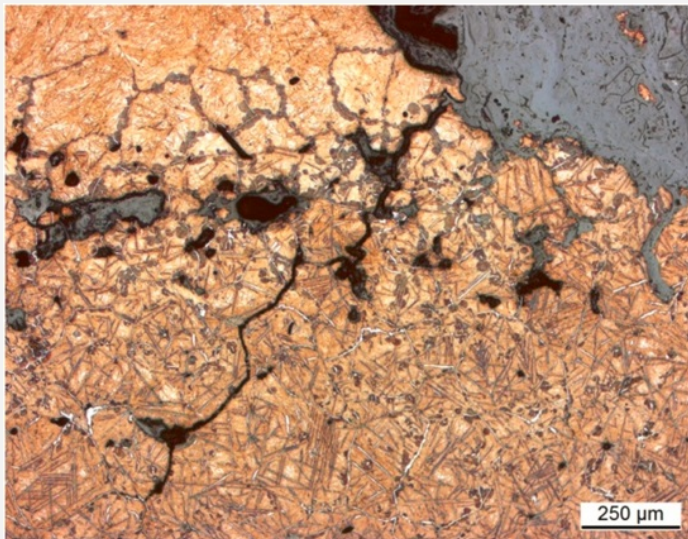
Fig. 5: Micrograph of the metal sample, detail from Fig. 4, etched, bright field. We observe martensite (in orange), cementite (in grey), porosity and intergranular cracks (in black) and corrosion,

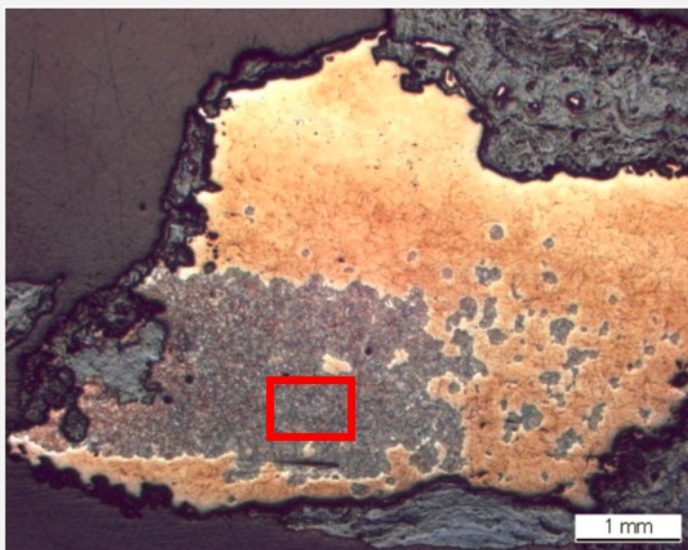
Fig. 6: Micrograph of the metal sample from Fig. 3 (inverted picture, detail), etched, bright field. We observe the metal with martensite (orange) and bainite nodules (blue). The micrograph of Fig. 9 is marked by a rectangle,

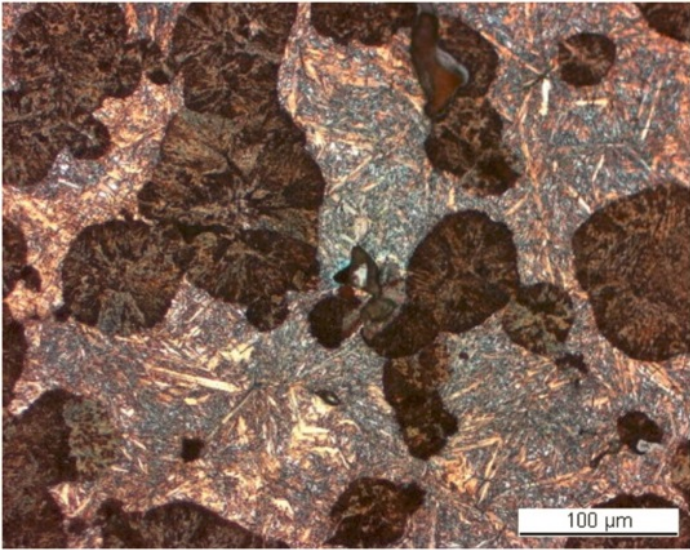
Fig. 7: Micrograph of the metal sample from Fig. 3 (detail), etched, bright field. We observe dark bainite nodules combined with martensite needles,

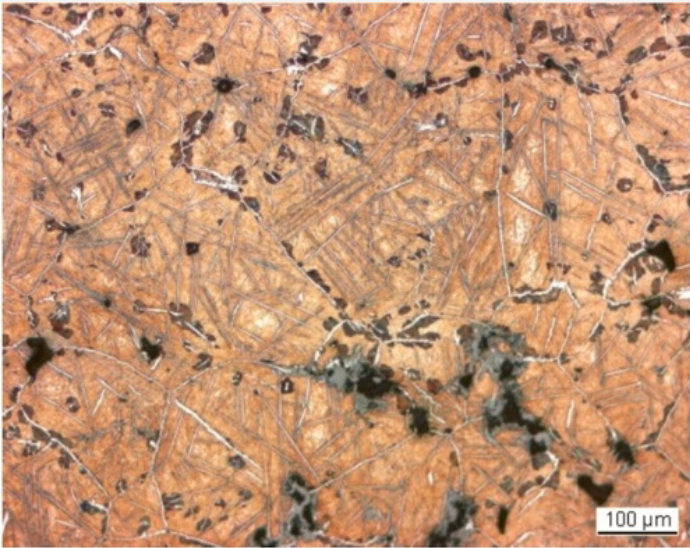
Fig. 8: Micrograph of the metal sample, detail from Fig. 4, etched, bright field. Hypereutectoid steel with a structure of cementite in white in the grain boundaries and in needle form combined with martensite (pink). Some bainite occurs around the grain boundaries,

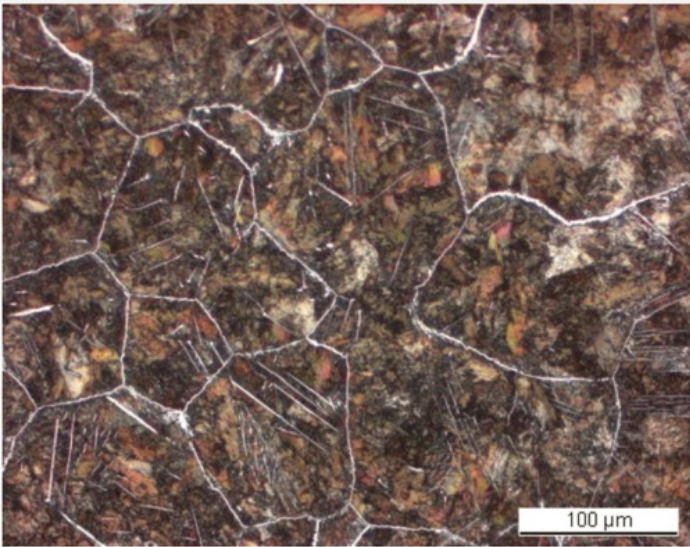
Fig. 9: Micrograph of the metal sample, detail from Fig. 6, etched, bright field. Hypereutectoid steel with a structure of cementite in white in the grain boundaries and in needle form combined with bainite (dark),

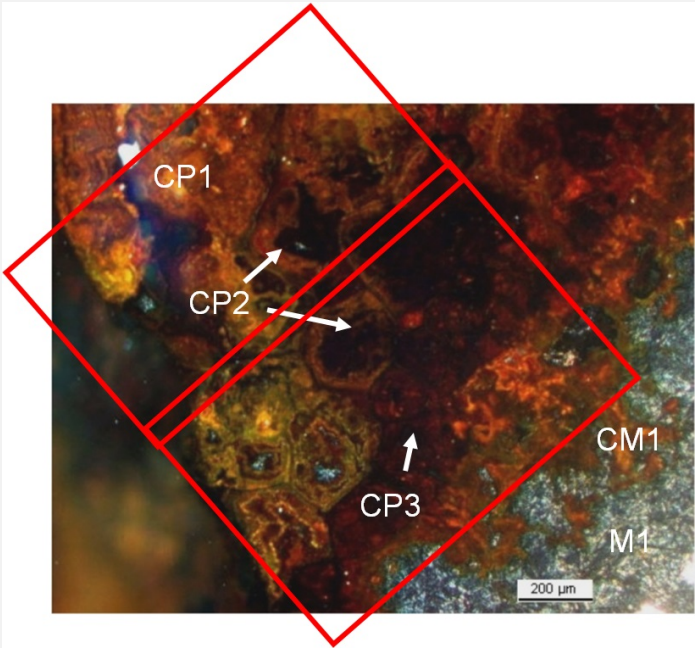
The metal is heavily corroded and the thickness of the corrosion crust is irregular, but averages about 0.5mm. The corrosion products enclose different ghost structures: the corrosion crust has preserved the shape of polygonal grains (Figs. 10 and 12) and cementite needles (Fig. 11). Under polarised light, the corrosion products at the metal - corrosion crust interface are dark-red and form an inner S-rich layer (CP3, Figs. 10 and 12). Cl occurs locally (CP3) and C is present in layers CP2 and CP3 (Fig. 12). The outer layer of the corrosion products (CP1) is orange and contains more O than the inner layer CP3 (Figs. 10 and 13).

Fig. 10: Micrograph showing the metal - corrosion crust interface from Fig. 3 (rotated by 270°, detail) and corresponding to the stratigraphy of Fig. 14, unetched, polarised light. Polygonal grains are visible as ghost structure in the corrosion crust. The selected areas for elemental chemical distribution (Figs. 12 and 13) are marked by two rectangles (bottom: Fig. 12 and top: Fig. 13),

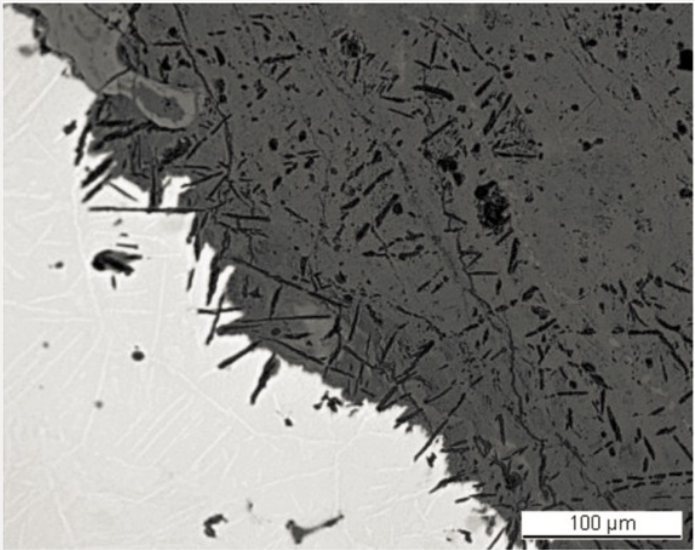
Fig. 11: Micrograph showing the metal - corrosion crust interface from Fig. 3 (detail), unetched, bright field. The cementite is visible as white needles in the metal and its ghost structure as black needles in the corrosion crust,

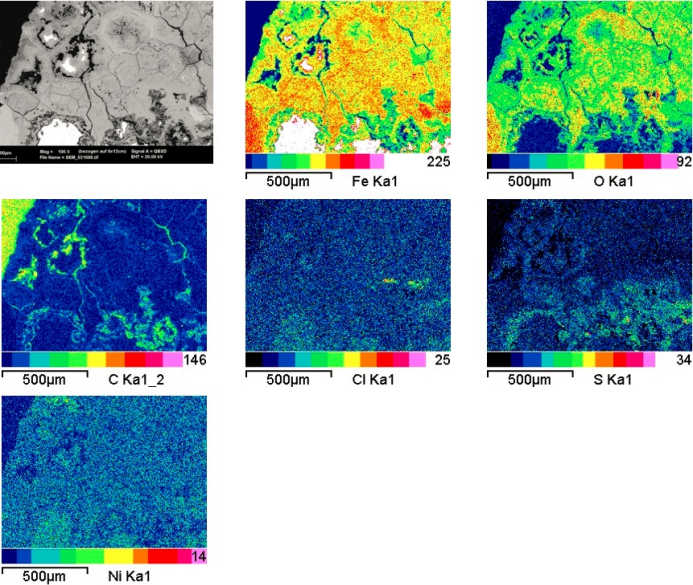
Fig. 12: SEM image, BSE-mode, and elemental chemical distribution of the selected area from Fig. 10 (rotated by 45°). Method of examination: SEM/EDS, Laboratory of Analytical Chemistry, Empa,

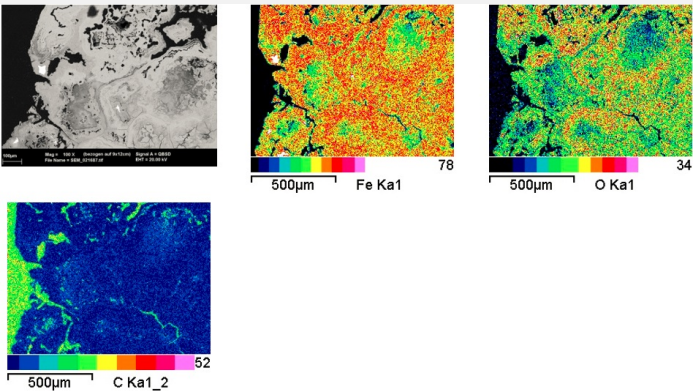
Fig. 13: SEM image, BSE-mode, and elemental chemical distribution of the selected area from Fig. 10 (rotated by 45°). Method of examination: SEM/EDS, Laboratory of Analytical Chemistry, Empa,

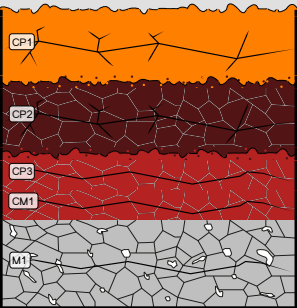
Fig. 14: Stratigraphic representation of the chisel point in cross-section (dark field) using the MiCorr application. The characteristics of the strata are only accessible by clicking on the drawing that redirects you to the search tool by stratigraphy representation. This representation can be compared to Fig. 10, Credit HE-Arc CR.
