SITULA EMT09-554.665 - TIN BRONZE - IRON AGE - SWITZERLAND

Artefact name	Situla EMT09-554.665
Authors	Christian. Degriigny (HE-Arc CR, Neuchâtel, Neuchâtel, Switzerland) & Marie-Jeanne. Scholl (HE-Arc CR, Neuchâtel, Neuchâtel, Switzerland) & Valentin. Boissonnas (HE-Arc CR, Neuchâtel, Neuchâtel, Switzerland)
Url	/artefacts/1506/

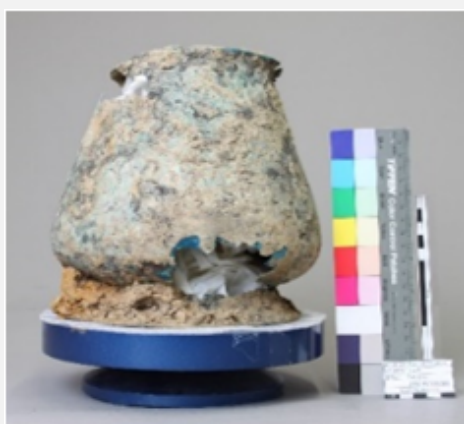
Fig. 1: Situla (Archeodunum (Gollion), 2009) inverted as found in situ,

Description of the artefact	Situla (Fig. 1) covered with blue-green corrosion products and sediments. Attached to two riveted iron loops is an iron handle terminating in two swan heads (not shown here). Dimensions of the main body: Hmax = 340mm, Ømax = 220mm.
Type of artefact	Vessel
Origin	Mormont sanctuary, La Sarraz, Vaud, Switzerland
Recovering date	Excavated in 2011
Chronology category	Iron Age
chronology tpq	<input type="text" value="140"/> B.C. ∨
chronology taq	<input type="text" value="30"/> B.C. ∨
Chronology comment	La Tène D

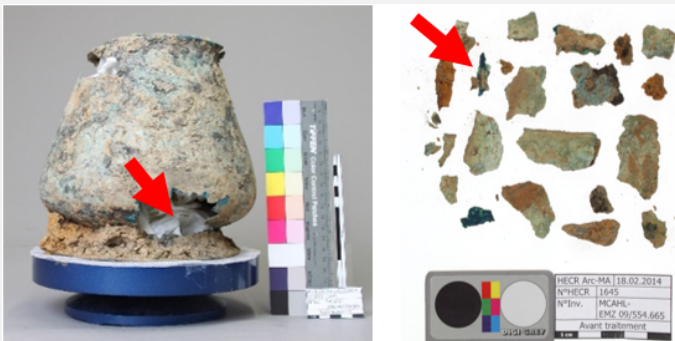
Fig. 2: Location of sampling area and sample selected from detached fragments,

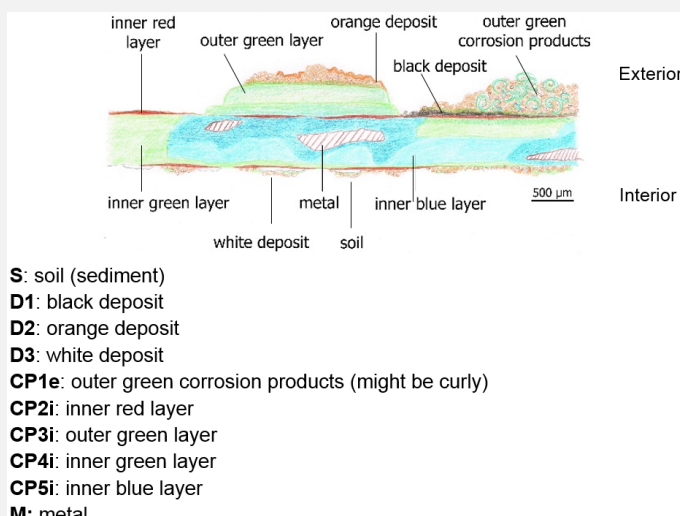
The schematic representation below gives an overview of the corrosion layers encountered on the situla from a first visual macroscopic observation (additional e and i within the coding correspond to strata in contact with the environment (e) and internal strata (i)).

Fig. 3: Stratigraphic representation of the situla by macroscopic observation,

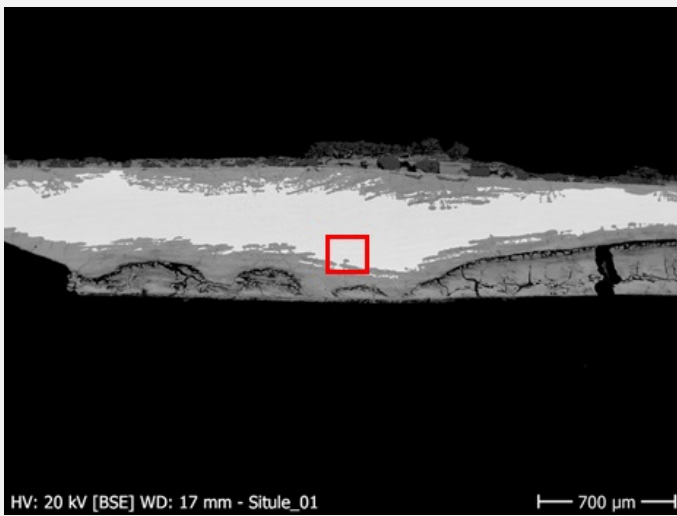
The remaining metal is a dense tin bronze (Fig. 5, Table 1), showing no inclusion. In bright field, the etched alloy shows a structure principally consisting of polygonal alpha phase grains (Fig. 6). Some of the grains include twin lines (Fig. 7). The presence of strain lines (slip lines) indicates a final cold work without annealing.

Fig. 5: SEM image, BSE-mode, of the metal sample from Fig. 4. Area of Fig. 6 is marked by a red square,

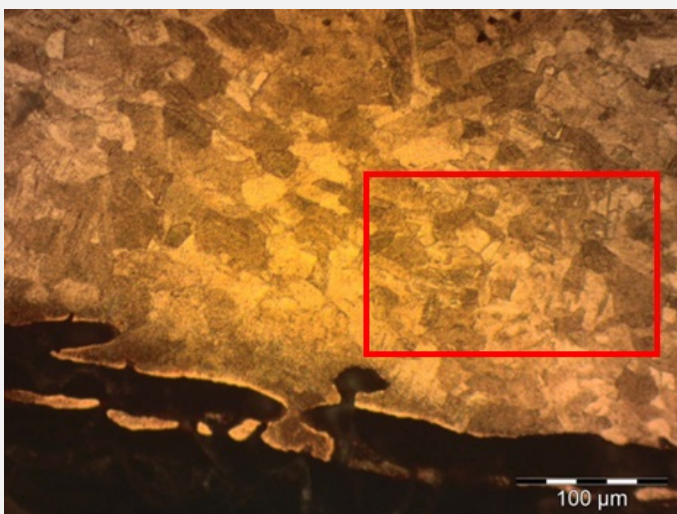
Fig. 6: Micrograph of the metal structure from Fig. 5 (detail), etched, bright field, 50x. The alpha phase of the alloy shows polygonal grains. Area of Fig. 7 is marked by a red rectangle,

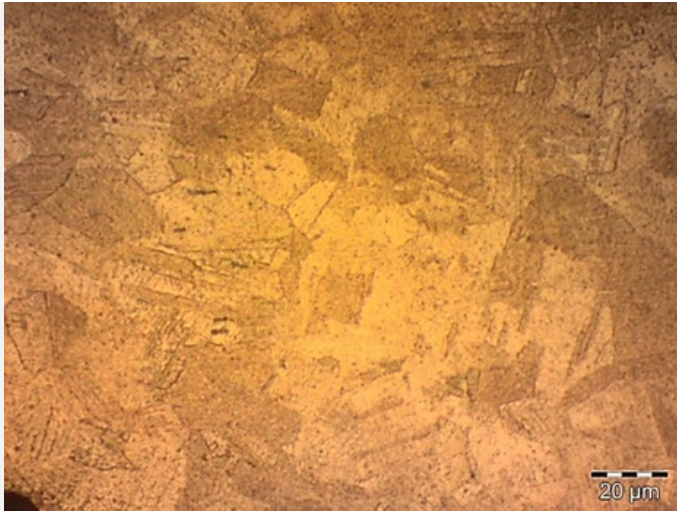
Fig. 7: Micrograph of the selected area of Fig. 6, etched, bright field, 500x. The grains show both twin and strain lines,

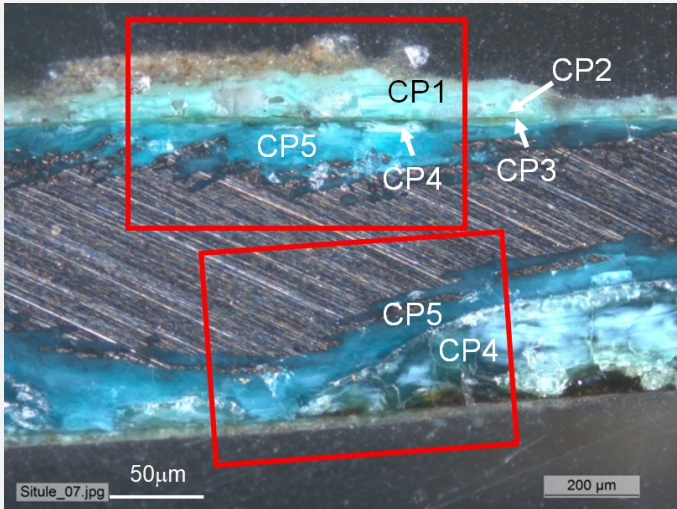
Fig. 8: Micrograph of the metal sample from Fig. 4, unetched, dark field, 50x. Areas of Fig. 9 (bottom, corresponding to the stratigraphy of Fig. 14) and Figs. 10 and 11 (top, corresponding to the stratigraphy of Fig. 15) are marked by a rectangle. Codes are those of Fig. 15,

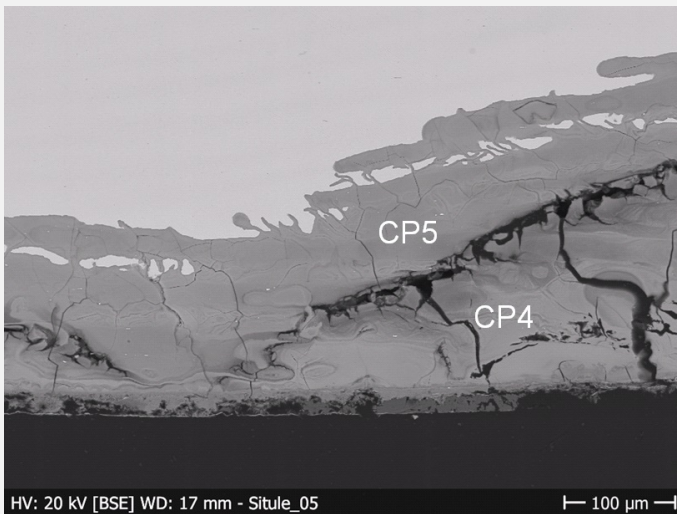
Fig. 9: SEM image, BSE-mode of the metal sample from Fig. 8 (detail) showing cleavage between the inner blue (CP5) and green (CP4) layers of Fig. 15,

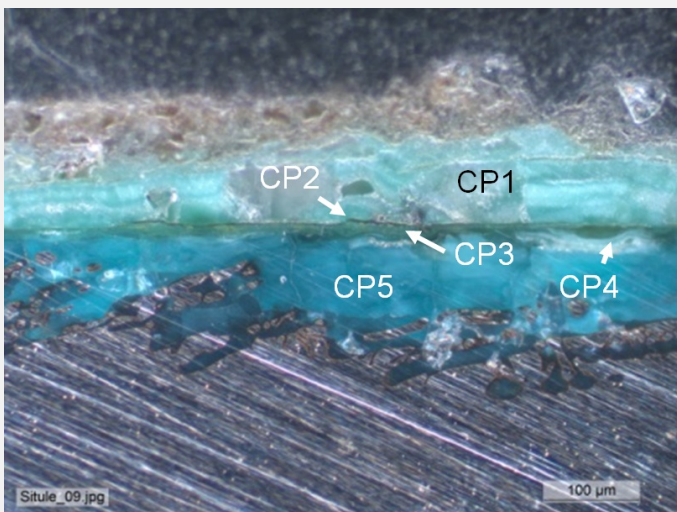
The limit of the original surface is well defined (interface of CP1 and CP2) but due to the fragility of the inner corrosion layers it was difficult to uncover.

Fig. 10: Micrograph of the metal / corrosion interface (detail of Fig. 8) unetched, dark field, 100x. The outer layer (CP1 of Fig. 15) incorporates soil material and the thin dark layer (CP2 of Fig. 15) highlights the limit of the original surface,

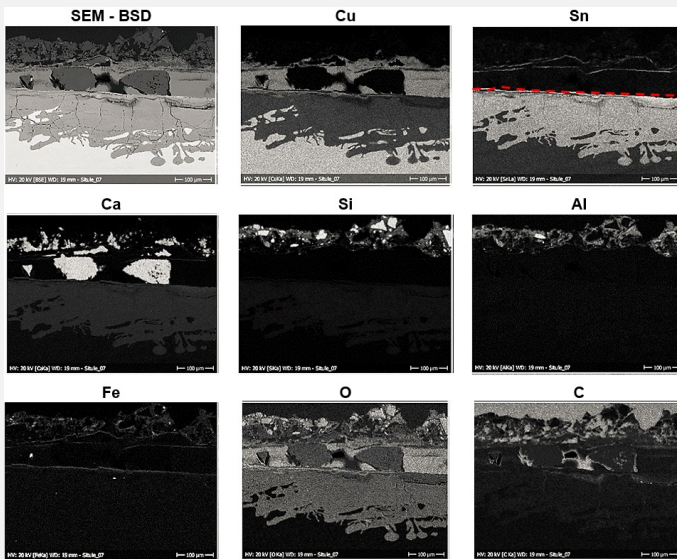
The inner layers (CP3-CP5) are Sn and O-rich and depleted in Cu (Table 2). The outer layers (CP1 and CP2) are Cu and O-rich, contain no Sn, and are contaminated with Ca, Si, Al and Fe coming from the soil (Fig. 11). The colour of the corrosion crust varies according to the content of Sn (the more Sn, the darker green or blue the corrosion). FTIR on the inner blue (CP5 and Fig. 12) and outer green (CP1 and Fig. 13) layers were difficult to interpret. Only malachite could be identified in both cases. XRD spectra could not be interpreted because of the deficiency of peaks.

Fig. 11: SEM image, SE-mode, and elemental chemical distribution of Fig. 10. In red: the limit of the original surface highlighted by the enriched tin layer. Method of examination: SEM-EDS, Lab of Electronic Microscopy and Microanalysis, IMA (Néode), HEI Arc,

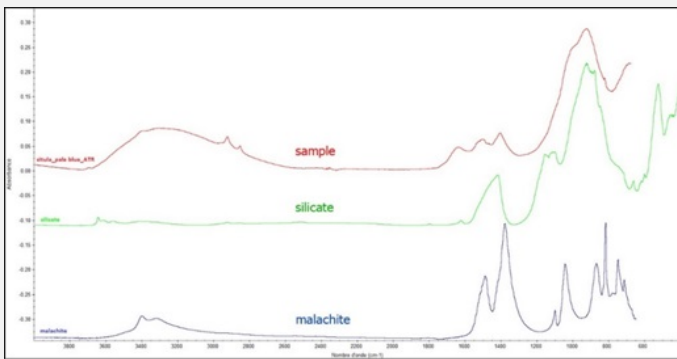
Fig. 12: FTIR spectrum (ATR mode) of the inner blue layer (CP5) compared to the silicate and malachite standard spectrum. Method of analysis: FTIR spectroscopy, HE- Arc CR,

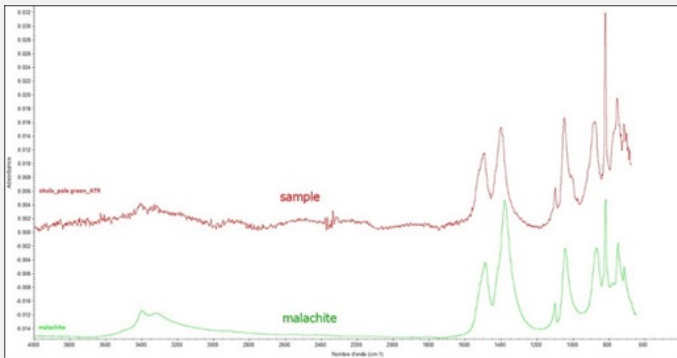
Fig. 13: FTIR spectrum (ATR mode) of the outer green layer (CP1) compared to the malachite standard spectrum. Method of analysis: FTIR spectroscopy, HE-Arc CR,

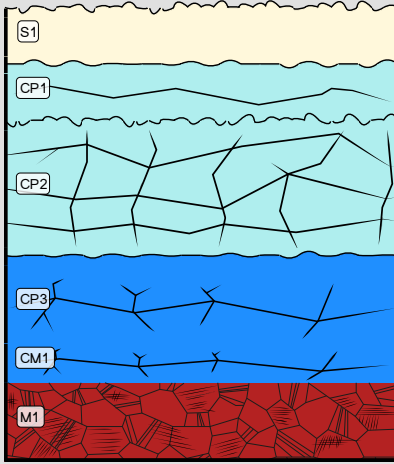
There are 2 stratigraphies (Fig. 14 corresponding to the interior face of the situla and Fig. 15 to its exterior face). The strata are similar in composition but their coding is different: CP1 to CP3 in Fig. 14 correspond to CP3 to CP5 in Fig. 15. Since the stratigraphy of Fig. 15 is more complete, the composition of each of its strata is given below.

Fig. 14: Stratigraphic representation of the sample taken from the detached fragment of the situla in cross-section (dark field) using the MiCorr application. The characteristics of the strata are only accessible by clicking on the drawing that redirects you to the search tool by stratigraphy representation. This representation shows the interior face and can be compared to Fig. 8 (bottom red rectangle), Credit HE-Arc CR, M-J.Scholl.

Fig. 15: Stratigraphic representation of the sample taken from the detached fragment of the situla in cross-section (dark field) using the MiCorr application. The characteristics of the strata are only accessible by clicking on the drawing that redirects you to the search tool by stratigraphy representation. This representation shows the exterior face and can be compared to Fig. 8 (top red rectangle), Credit HE-Arc CR, M-J.Scholl.

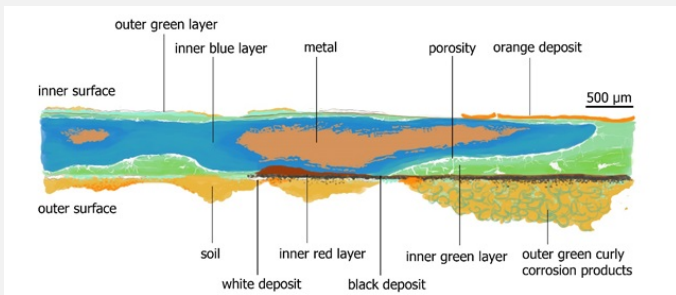
Fig. 16: Improved stratigraphic representation of the situla from visual observations and analyses,

Strata	Composition
Soil (S)	Ca, Si, Al, Fe
Black deposit (D1)	C
Orange deposit (D2)	Ferrous oxides
White deposit (D3)	Ca
Outer green curly corrosion product (CP1e)	Copper carbonates (curly malachite)
Inner red (CP2i)	Copper oxide (cuprite ?)
Outer green layer (CP3i)	Copper carbonates (malachite)
Inner green layer (CP4i)	Copper carbonates (?) + Sn
Inner blue layer (CP5i)	Copper carbonates (?) + Sn
Remnant metal phase (M)	Bronze (90%Cu, 10% Sn)
