SITULA EMT09-554.665 - TIN BRONZE - IRON AGE - SWITZERLAND

Artefact name	Situla EMT09-554.665
Authors	Christian. Degriigny (HE-Arc CR, Neuchâtel, Neuchâtel, Switzerland) & Marie-Jeanne. Scholl (HE-Arc CR, Neuchâtel, Neuchâtel, Switzerland) & Valentin. Boissonnas (HE-Arc CR, Neuchâtel, Neuchâtel, Switzerland)
Url	/artefacts/1506/

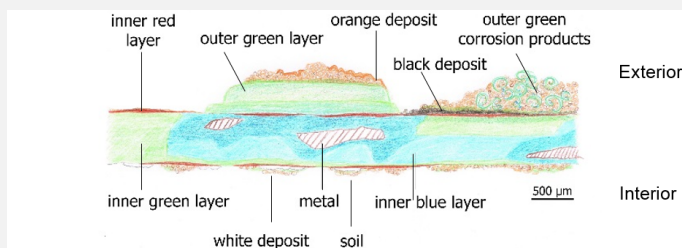
Fig. 3: Stratigraphic representation of the situla by macroscopic observation,

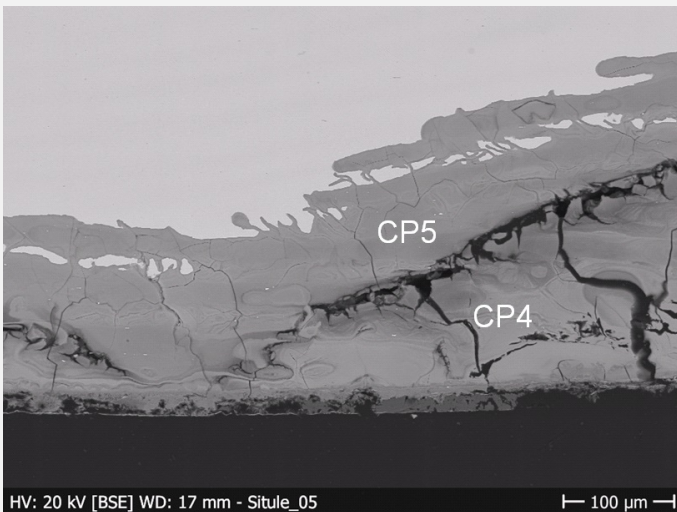
Fig. 9: SEM image, BSE-mode of the metal sample from Fig. 8 (detail) showing cleavage between the inner blue (CP5) and green (CP4) layers of Fig. 15,

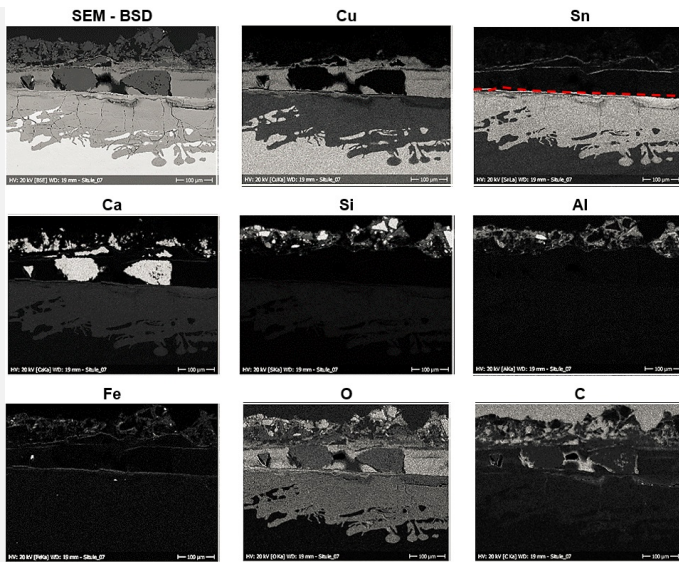
Fig. 11: SEM image, SE-mode, and elemental chemical distribution of Fig. 10. In red: the limit of the original surface highlighted by the enriched tin layer. Method of examination: SEM-EDS, Lab of Electronic Microscopy and Microanalysis, IMA (Néode), HEI Arc,

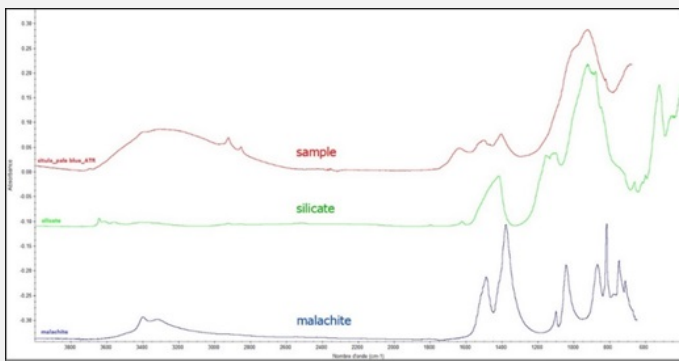
Fig. 12: FTIR spectrum (ATR mode) of the inner blue layer (CP5) compared to the silicate and malachite standard spectrum. Method of analysis: FTIR spectroscopy, HE- Arc CR,

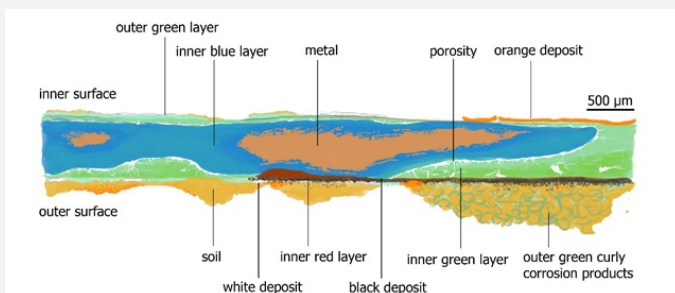
Fig. 16: Improved stratigraphic representation of the situla from visual observations and analyses,

Strata	Composition
Soil (S)	Ca, Si, Al, Fe
Black deposit (D1)	C
Orange deposit (D2)	Ferrous oxides
White deposit (D3)	Ca
Outer green curly corrosion product (CP1e)	Copper carbonates (curly malachite)
Inner red (CP2i)	Copper oxide (cuprite ?)
Outer green layer (CP3i)	Copper carbonates (malachite)
Inner green layer (CP4i)	Copper carbonates (?) + Sn
Inner blue layer (CP5i)	Copper carbonates (?) + Sn
Remnant metal phase (M)	Bronze (90%Cu, 10% Sn)
