## SITULA EMT09-554.665 - TIN BRONZE - IRON AGE - SWITZERLAND

<b>Artefact name</b>	Situla EMT09-554.665
<b>Authors</b>	Christian. Degriigny (HE-Arc CR, Neuchâtel, Neuchâtel, Switzerland) & Marie-Jeanne. Scholl (HE-Arc CR, Neuchâtel, Neuchâtel, Switzerland) & Valentin. Boissonnas (HE-Arc CR, Neuchâtel, Neuchâtel, Switzerland)
<b>Url</b>	/artefacts/1506/

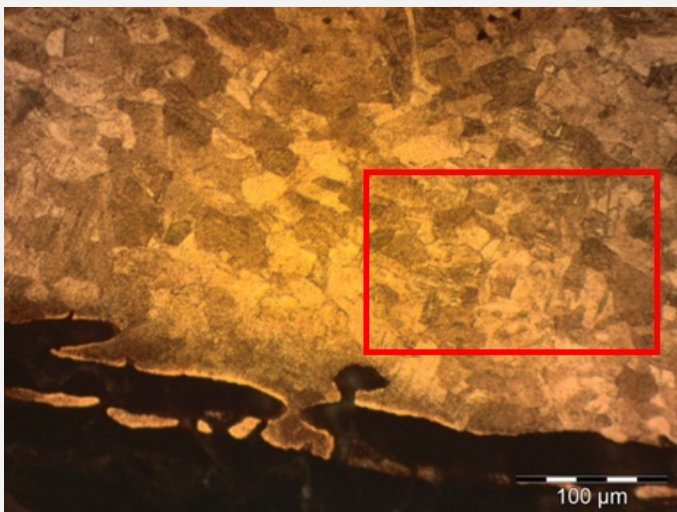
The remaining metal is a dense tin bronze (Fig. 5, Table 1), showing no inclusion. In bright field, the etched alloy shows a structure principally consisting of polygonal alpha phase grains (Fig. 6). Some of the grains include twin lines (Fig. 7). The presence of strain lines (slip lines) indicates a final cold work without annealing.

Fig. 6: Micrograph of the metal structure from Fig. 5 (detail), etched, bright field, 50x. The alpha phase of the alloy shows polygonal grains. Area of Fig. 7 is marked by a red rectangle,

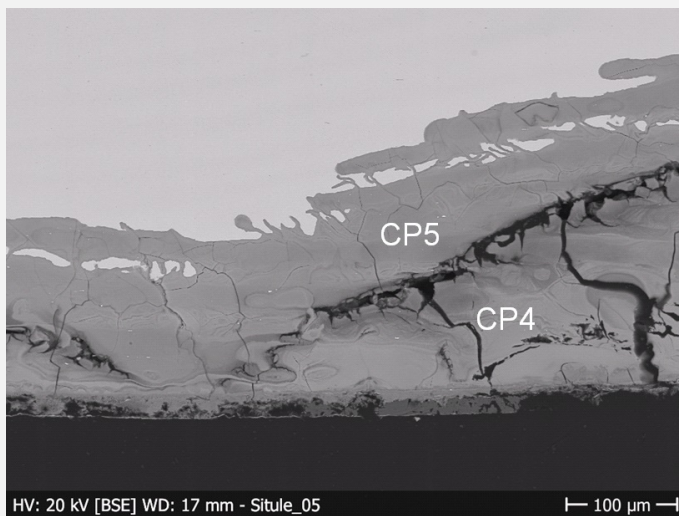
The corrosion crust is heterogeneous and has in places completely replaced the metal. The metal – corrosion products interface is irregular due to transgranular corrosion (Figs 5-6). In most cases, the corrosion crust can be divided in three main layers: first, an inner compact blue layer directly on the metal core (CP5, Figs. 8, 10 and 15 and CP3, Fig. 14). In areas of extensive corrosion this blue layer coexists with a friable light blue-green layer (CP4, Figs. 8, 10 and 15 and CP2, Fig. 14). Secondly, and depending on the area, either a very fine dark green (CP3, Figs. 8 and 15) or red corrosion layer (CP2, Figs. 10 and 15) marks the limit of the original surface. Finally, there is a fourth outer layer, consisting of friable and sometimes curly pale green corrosion products, interspersed with soil products (CP1, Figs. 8, 10 and 15). In heavily worked and fragile parts of the object a cleavage between the inner layers of blue and light blue-green corrosion is present, rendering the light blue-green corrosion vulnerable to loss (Fig. 9).

Fig. 9: SEM image, BSE-mode of the metal sample from Fig. 8 (detail) showing cleavage between the inner blue (CP5) and green (CP4) layers of Fig. 15,

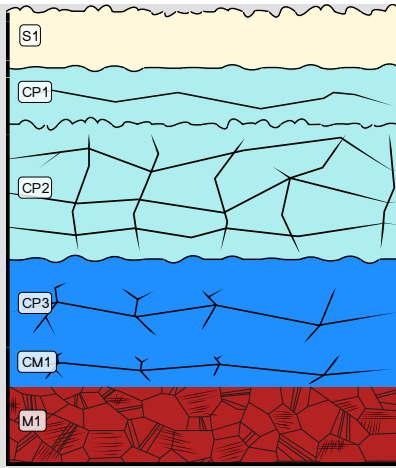
There are 2 stratigraphies (Fig. 14 corresponding to the interior face of the situla and Fig. 15 to its exterior face). The strata are similar in composition but their coding is different: CP1 to CP3 in Fig. 14 correspond to CP3 to CP5 in Fig. 15. Since the stratigraphy of Fig. 15 is more complete, the composition of each of its strata is given below.

Fig. 14: Stratigraphic representation of the sample taken from the detached fragment of the situla in cross-section (dark field) using the MiCorr application. The characteristics of the strata are only accessible by clicking on the drawing that redirects you to the search tool by stratigraphy representation. This representation shows the interior face and can be compared to Fig. 8 (bottom red rectangle), Credit HE-Arc CR, M-J.Scholl.

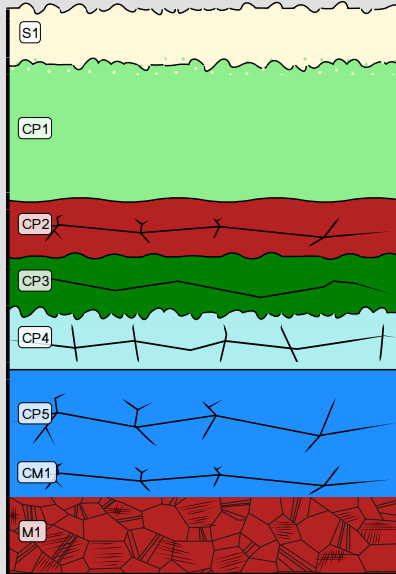
The inner layers (CP3-CP5) are Sn and O-rich and depleted in Cu (Table 2). The outer layers (CP1 and CP2) are Cu and O-rich, contain no Sn, and are contaminated with Ca, Si, Al and Fe coming from the soil (Fig. 11). The colour of the corrosion crust varies according to the content of Sn (the more Sn, the darker green or blue the corrosion). FTIR on the inner blue (CP5 and Fig. 12) and outer green (CP1 and Fig. 13) layers were difficult to interpret. Only malachite could be identified in both cases. XRD spectra could not be interpreted because of the deficiency of peaks.

Fig. 15: Stratigraphic representation of the sample taken from the detached fragment of the situla in cross-section (dark field) using the MiCorr application. The characteristics of the strata are only accessible by clicking on the drawing that redirects you to the search tool by stratigraphy representation. This representation shows the exterior face and can be compared to Fig. 8 (top red rectangle), Credit HE-Arc CR, M-J.Scholl.

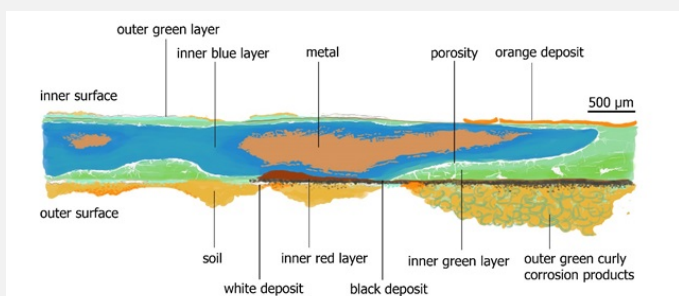
The schematic representation of corrosion layers of Fig. 3 integrating additional information (e and i within the coding correspond to strata in contact with the environment (e) and internal strata (i) based on the analyses carried out is given in Fig. 16.

Fig. 16: Improved stratigraphic representation of the situla from visual observations and analyses,

Strata	Composition
Soil (S)	Ca, Si, Al, Fe
Black deposit (D1)	C
Orange deposit (D2)	Ferrous oxides
White deposit (D3)	Ca
Outer green curly corrosion product (CP1e)	Copper carbonates (curly malachite)
Inner red (CP2i)	Copper oxide (cuprite ?)
Outer green layer (CP3i)	Copper carbonates (malachite)
Inner green layer (CP4i)	Copper carbonates (?) + Sn
Inner blue layer (CP5i)	Copper carbonates (?) + Sn
Remnant metal phase (M)	Bronze (90%Cu, 10% Sn)
