FUNERAL MASK IVC 11595 – CU/AG, WITH SURFACE ENRICHMENT (AG) – UNKNOWN – PERU

Artefact name Funeral mask Ivc 11595

Authors Christian. Degrygn (HE-Arc CR, Neuchâtel, Neuchâtel, Switzerland) & Naima. Gutknecht (HE-Arc CR, Neuchâtel, Neuchâtel, Switzerland) & Valentin. Boissonnas (HE-Arc CR, Neuchâtel, Neuchâtel, Switzerland)

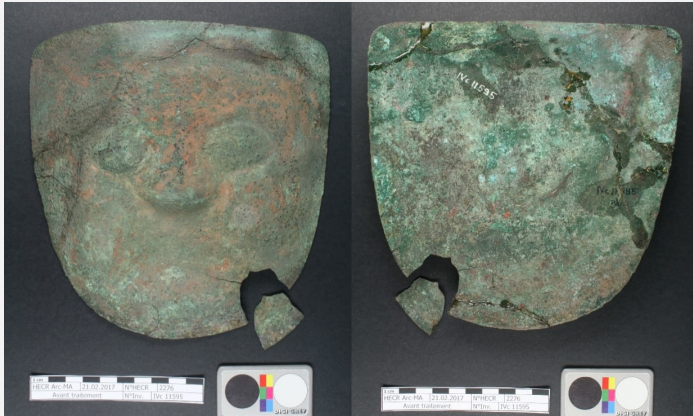
Fig. 1: Funeral mask, front and back face to the left and right respectively,

Description of the artefact	Peruvian funeral mask (Fig. 1). There are remains of red pigment and of a mineralised textile on both sides of the object. It is heavily corroded in green and red corrosion layers. It is deformed and broken. Dimensions: Length = 180mm; Width = 170mm; Height = 20 mm; WT = 158,6g.
Type of artefact	Funeral mask
Origin	Funeral mask, Peru
Recovering date	Date of excavation unknown, acquisition in 1967
Chronology category	Unknown
chronology tpq	<input type="text"/> ---- ∨
chronology taq	<input type="text" value="1500"/> A.D. ∨
Chronology comment	Tpq: unknown.
Burial conditions / environment	Unknown
Artefact location	Museum der Kulturen, Basel
Owner	Museum der Kulturen, Basel
Inv. number	Ivc 11595
Recorded conservation data	N/A

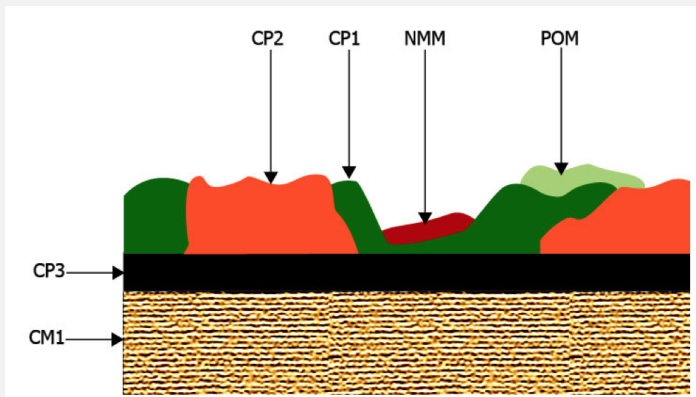
Fig. 3a: Stratigraphic representation of the front face of the funeral mask by visual macroscopic observation,

POM: Textile remains, **NMM:** Pigments, **CP1:** Green corrosion products, **CP2:** Red corrosion products, **CP4:** Black corrosion products, **CM1:** Remaining metal

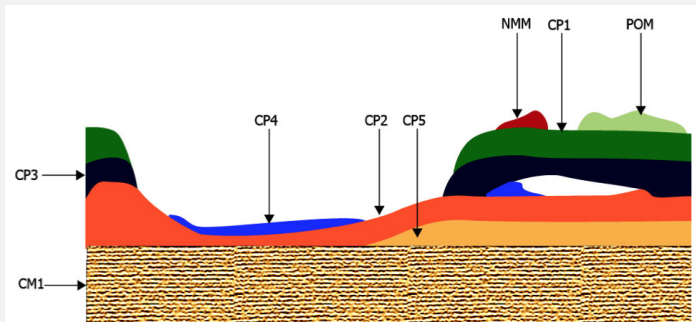
Fig. 3b: Stratigraphic representation of the back face of the funeral mask by visual macroscopic observation,

POM: Textile remains, **NMM:** Pigments, **CP1:** Green corrosion products, **CP2:** Red/orange corrosion products, **CP3:** Black corrosion product, **CP4:** blue corrosion product, **CP5:** Orange corrosion, **CM1:** Remaining metal

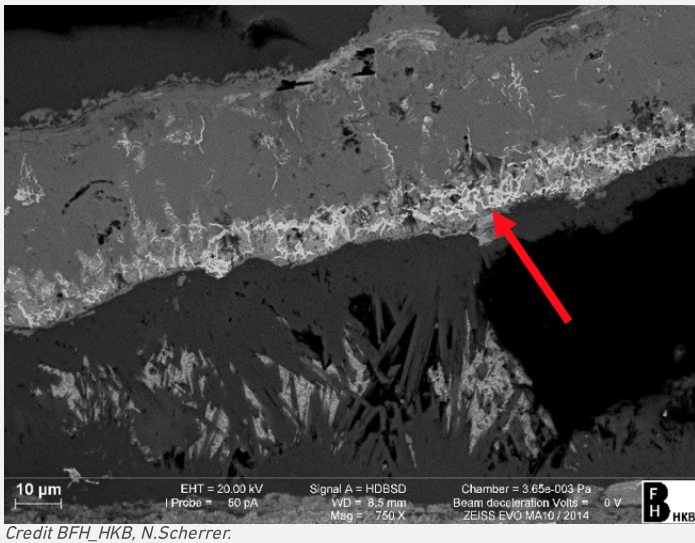
Fig. 7: SEM image of a partially refilled structural void with a silver-, copper- and mercury-rich layer (red arrow),

The silver sulphide (HgS, cinnabar, Fig. 13), present as a red pigment on the silver surface, could have been reduced through an electrochemical process in the presence of chlorides (Keune 2005). The released sulfur recombined with the silver to form black silver sulphide. Above that layer a porous mercury- and silver rich stratum has formed (see Hg & Ag on cartography Fig. 8). It remains unclear if the limitos is located in the silver enriched surface or within this silver-mercury compound (Fig. 7).

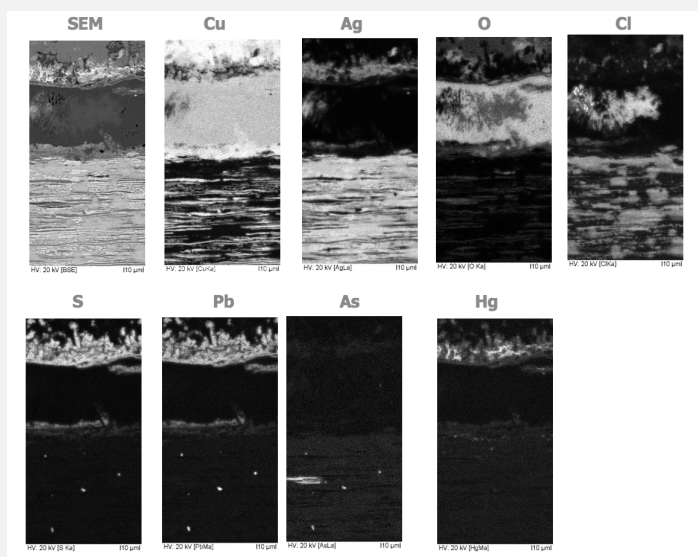
The remaining metal shows a preferential corrosion of copper and the presence of chlorides throughout the entire corroded metal, most likely in the form of Cu and Ag corrosion products (Fig. 8, Table 1). There is a preferential corrosion of copper that has fragilized the structure of the sheet metal.

Fig. 8: SEM image (BSE-mode) and elemental chemical distribution of the selected area on Fig. 6. Method of examination: SEM/EDS,

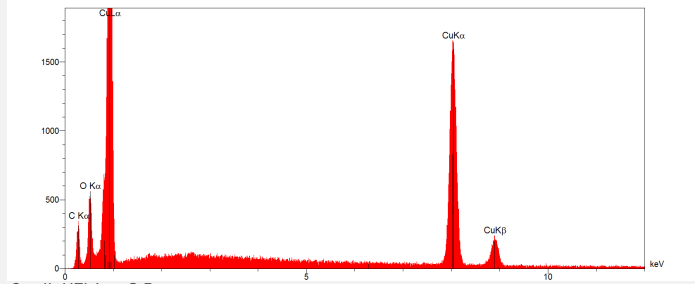
Fig. 9: EDS analysis of the red corrosion layer (Fig. 4). Method of analysis: SEM-EDS, Lab of Electronic Microscopy and Microanalysis, IMA (Néode), HEI Arc,

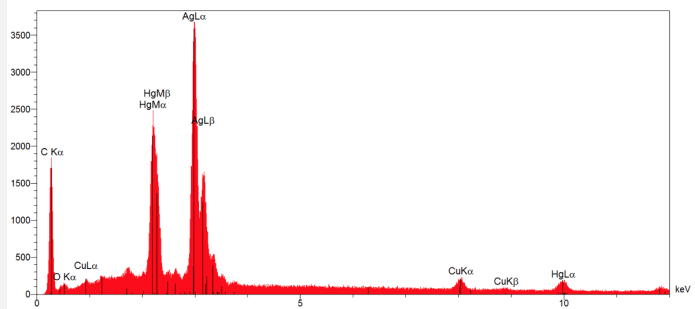
Figs. 10: EDS analysis of the layer that appears light grey under polarized light, situated below the red layer (Fig. 4). Method of analysis: SEM-EDS, Lab of Electronic Microscopy and Microanalysis, IMA (Néode), HEI Arc,

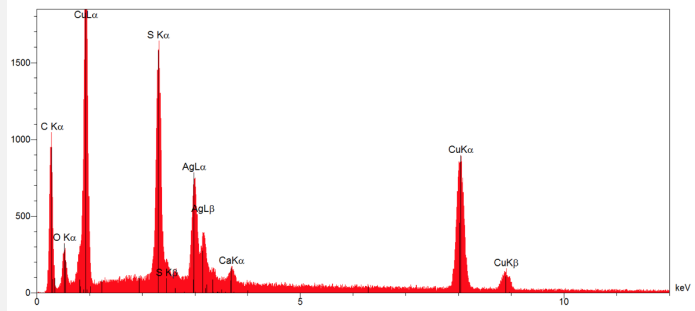
Fig. 11: EDS analysis of the green corrosion layer that has filled the structural void (Fig. 4). Method of analysis: SEM-EDS, Lab of Electronic Microscopy and Microanalysis, IMA (Néode), HEI Arc,

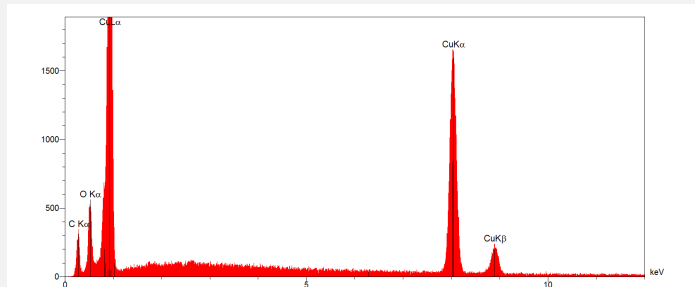
Fig. 12: EDS analysis of the red surface pigment from a surface sample. Method of analysis: SEM-EDS, Lab of Electronic Microscopy and Microanalysis, IMA (Néode), HEI Arc,

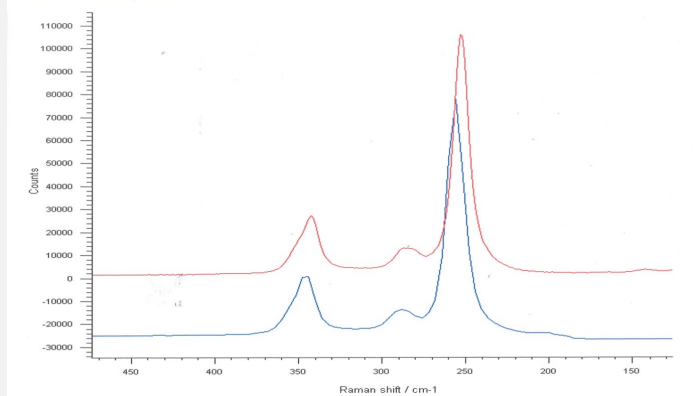
Fig. 13: Raman analysis of the red pigment on the surface (red line) and the references for cinnabar (blue line). Method of analysis: Raman spectroscopy, HKB,

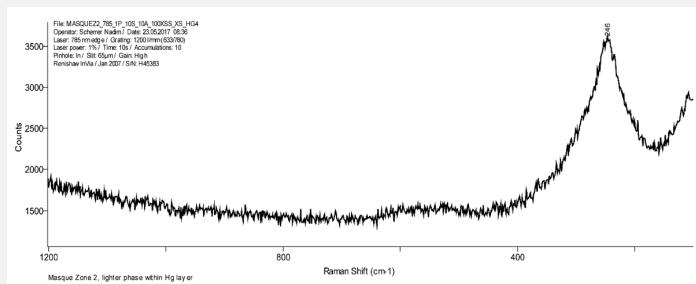
Fig. 14: Raman analysis of the mercury compounds from the cross section. Method of analysis: Raman spectroscopy, HKB,

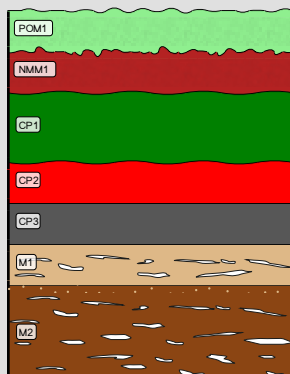
Fig. 15: Stratigraphic representation of the cross-section (dark field) from Figs. 3a or 4 (front of the object) using the MiCorr application. The characteristics of the strata are only accessible by clicking on the drawing that redirects you to the search tool by stratigraphy representation, Credit HE-Arc CR, N. Gutknecht.

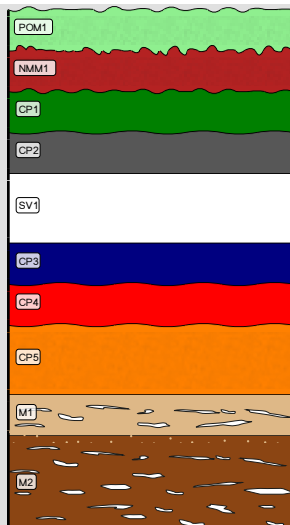
Fig. 16: Stratigraphic representation of the cross-section (dark field) from Figs. 3b and 4 (back of the object) using the MiCorr application. CP2 is CP3 while CP3 is CP4 and CP4 is CP2 in Fig. 3b. The characteristics of the strata are only accessible by clicking on the drawing that redirects you to the search tool by stratigraphy representation, Credit HE-Arc CR, N. Gutknecht.
