## FUNERAL MASK IVC 11595 – CU/AG, WITH SURFACE ENRICHMENT (AG) – UNKNOWN – PERU

| <b>Artefact name</b> | Funeral mask Ivc 11595 |
| <b>Authors</b> | Christian. Degrygn (HE-Arc CR, Neuchâtel, Neuchâtel, Switzerland) & Naima. Gutknecht (HE-Arc CR, Neuchâtel, Neuchâtel, Switzerland) & Valentin. Boissonnas (HE-Arc CR, Neuchâtel, Neuchâtel, Switzerland) |

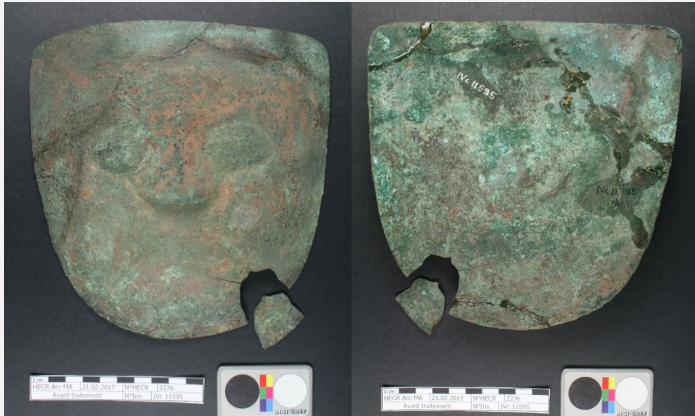
Fig. 1: Funeral mask, front and back face to the left and right respectively,

| <b>Description of the artefact</b> | Peruvian funeral mask (Fig. 1). There are remains of red pigment and of a mineralised textile on both sides of the object. It is heavily corroded in green and red corrosion layers. It is deformed and broken. Dimensions: Length = 180mm; Width = 170mm; Height = 20 mm; WT = 158,6g. |

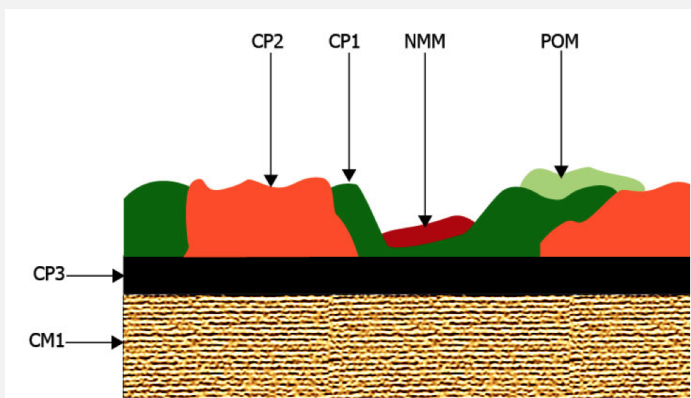
Fig. 3a: Stratigraphic representation of the front face of the funeral mask by visual macroscopic observation,

**POM:** Textile remains, **NMM:** Pigments, **CP1:** Green corrosion products, **CP2:** Red corrosion products, **CP4:** Black corrosion products, **CM1:** Remaining metal

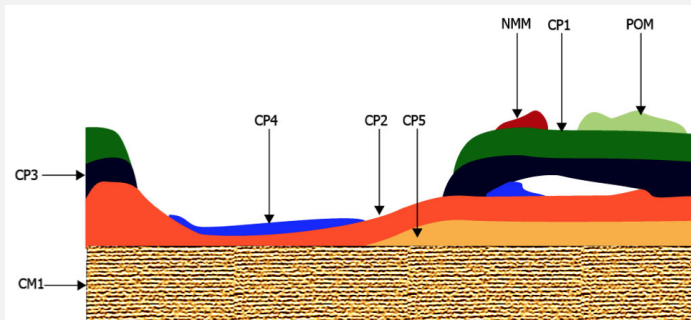
Fig. 3b: Stratigraphic representation of the back face of the funeral mask by visual macroscopic observation,

**POM:** Textile remains, **NMM:** Pigments, **CP1:** Green corrosion products, **CP2:** Red/orange corrosion products, **CP3:** Black corrosion product, **CP4:** blue corrosion product, **CP5:** Orange corrosion, **CM1:** Remaining metal

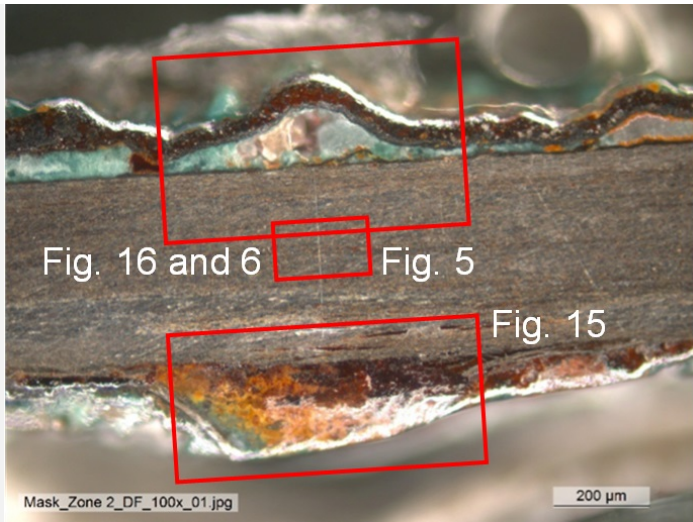
Fig. 4: Micrograph of the cross-section of the sample temporarily taken from the detached fragment of Fig. 2 showing the locations of Figs. 15 (corresponding to the front of the funeral mask), 16 (back of the funeral mask), 5 and 6,

A polished section was made from an already detached fragment that was temporarily embedded in resin (Fig. 2). On Fig. 4 the upper part of the sample corresponds to the back face of the funeral mask while the lower part corresponds to its front face. Both sides have developed subsequent layers of corrosion. In areas, these have buckled and become detached.

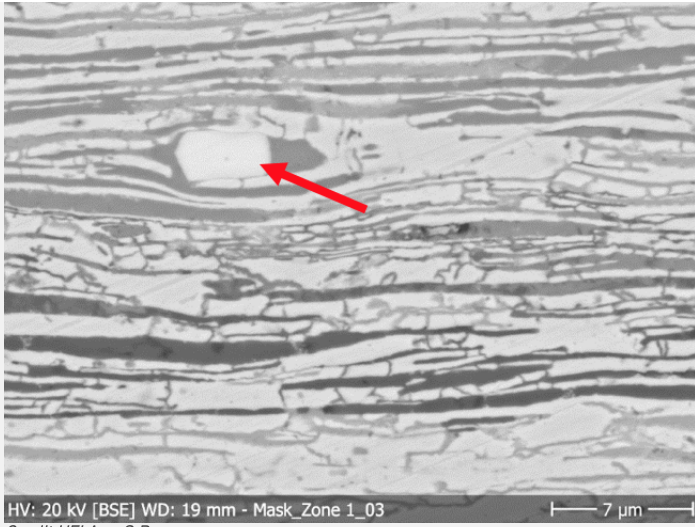
The SEM/EDS analysis of the core metal shows that there are Cu-rich phases alternating with Ag-rich phases. There are inclusions of Pb and As (Fig. 5). The surface of the metal has been decuprified (Fig. 6) according to the tumbaga making process (Scott 2000 and McEwan 2000). This pre-Columbian repeatedly hammered and annealed the metal, which would create a copper oxide scale on the surface. The latter was then dissolved in acidic plant juices (Scott 2000). This process was repeated until the surface was enriched with silver, giving it the appearance of a silver artefact.

Fig. 5: SEM image (BSE-mode) of the metal sample from Fig. 4 (detail), the elongated grains are the result of repeated hammering. Absence of strain lines indicates that the metal is annealed. The darker areas are Cu-rich phases and the lighter areas are Ag-rich phases. The arrow shows an As- and Pb inclusion,

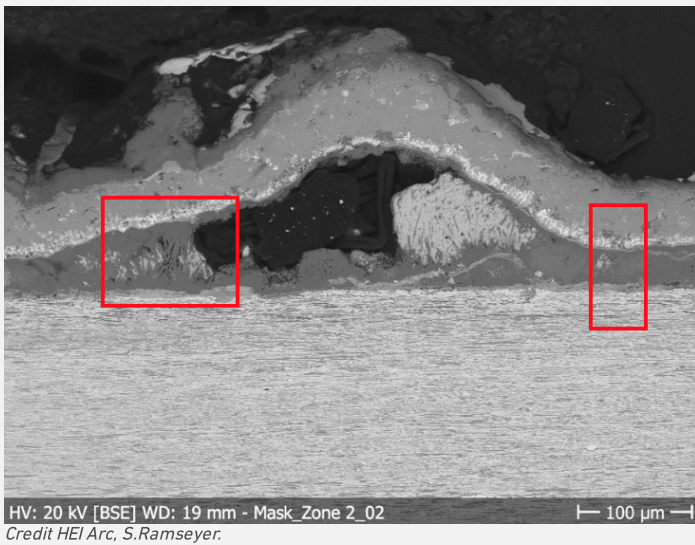
A layer of mercury can be seen with EDS (Figs. 6 and 7). Mercury was not used by the pre-Columbians in metallic form (Scott 2000 and McEwan 2000) but was common as a pigment in form of mercury sulfide (cinnabar).

Fig. 6: SEM image (BSE-mode) of the metal sample from Fig. 4 with detail (Fig. 7) indicated by the left red rectangle. The selected area for elemental chemical distribution (Fig. 8) is marked by the right red rectangle,

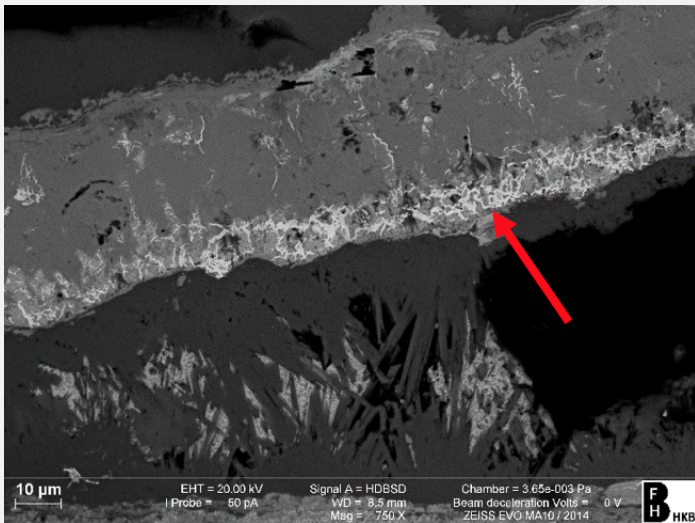
Fig. 7: SEM image of a partially refilled structural void with a silver-, copper- and mercury-rich layer (red arrow),

The silver sulphide (HgS, cinnabar, Fig. 13), present as a red pigment on the silver surface, could have been reduced through an electrochemical process in the presence of chlorides (Keune 2005). The released sulfur recombined with the silver to form black silver sulphide. Above that layer a porous mercury- and silver rich stratum has formed (see Hg & Ag on cartography Fig. 8). It remains unclear if the limitos is located in the silver enriched surface or within this silver-mercury compound (Fig. 7).

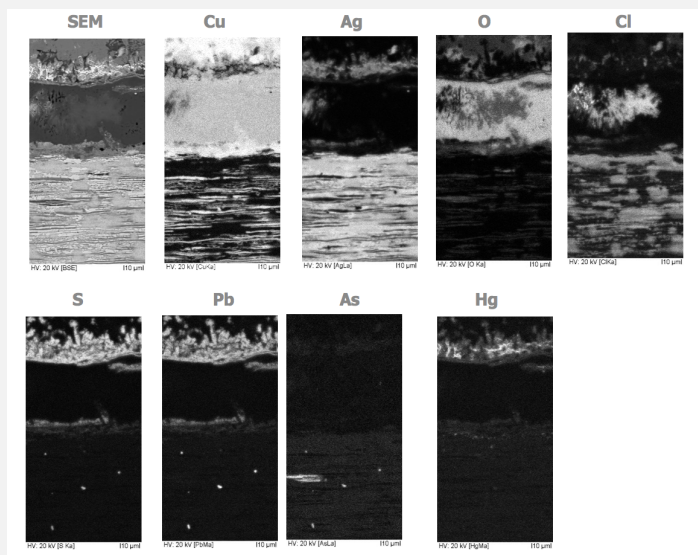
The remaining metal shows a preferential corrosion of copper and the presence of chlorides throughout the entire corroded metal, most likely in the form of Cu and Ag corrosion products (Fig. 8, Table 1). There is a preferential corrosion of copper that has fragilized the structure of the sheet metal.

Fig. 8: SEM image (BSE-mode) and elemental chemical distribution of the selected area on Fig. 6. Method of examination: SEM/EDS,

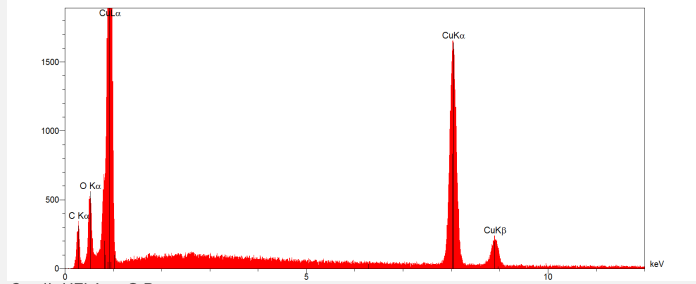
Fig. 9: EDS analysis of the red corrosion layer (Fig. 4). Method of analysis: SEM-EDS, Lab of Electronic Microscopy and Microanalysis, IMA (Néode), HEI Arc,

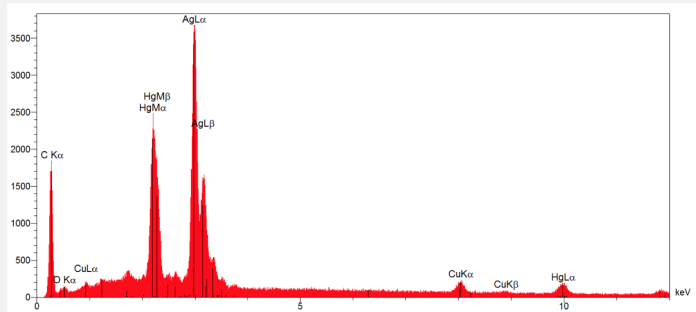
Figs. 10: EDS analysis of the layer that appears light grey under polarized light, situated below the red layer (Fig. 4). Method of analysis: SEM-EDS, Lab of Electronic Microscopy and Microanalysis, IMA (Néode), HEI Arc,

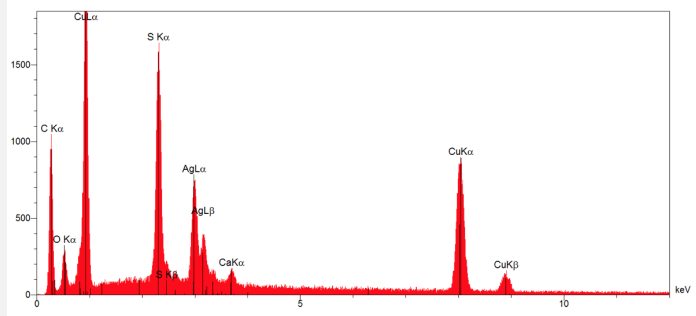
Fig. 11: EDS analysis of the green corrosion layer that has filled the structural void (Fig. 4). Method of analysis: SEM-EDS, Lab of Electronic Microscopy and Microanalysis, IMA (Néode), HEI Arc,

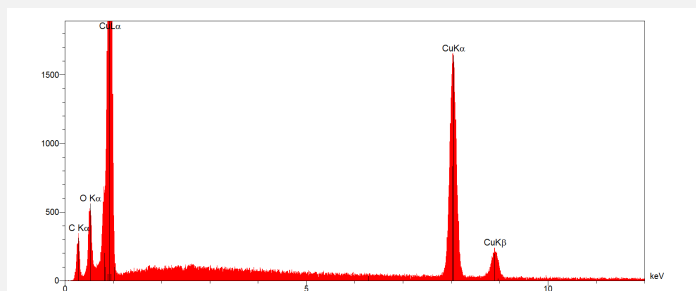
Fig. 12: EDS analysis of the red surface pigment from a surface sample. Method of analysis: SEM-EDS, Lab of Electronic Microscopy and Microanalysis, IMA (Néode), HEI Arc,

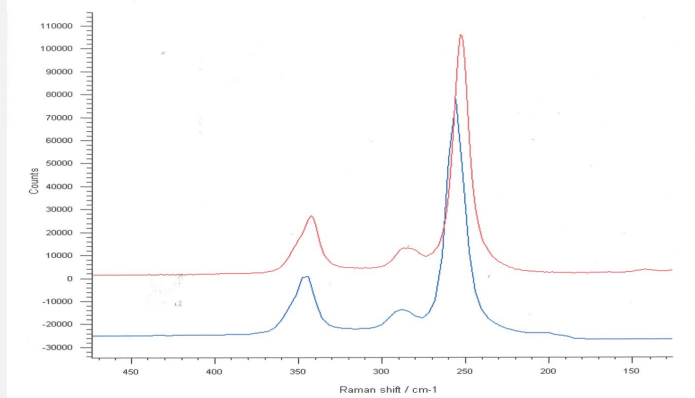
Fig. 13: Raman analysis of the red pigment on the surface (red line) and the references for cinnabar (blue line). Method of analysis: Raman spectroscopy, HKB,

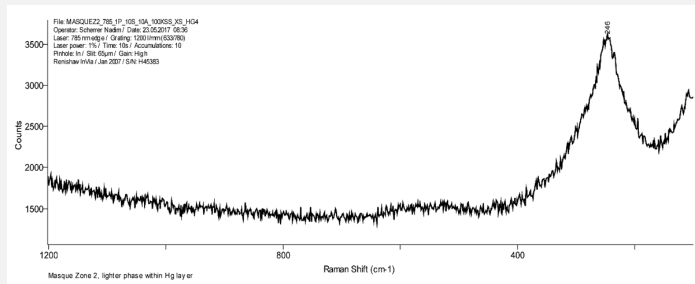
Fig. 14: Raman analysis of the mercury compounds from the cross section. Method of analysis: Raman spectroscopy, HKB,

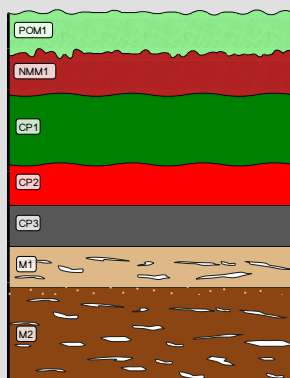
Fig. 15: Stratigraphic representation of the cross-section (dark field) from Figs. 3a or 4 (front of the object) using the MiCorr application. The characteristics of the strata are only accessible by clicking on the drawing that redirects you to the search tool by stratigraphy representation, Credit HE-Arc CR, N. Gutknecht.

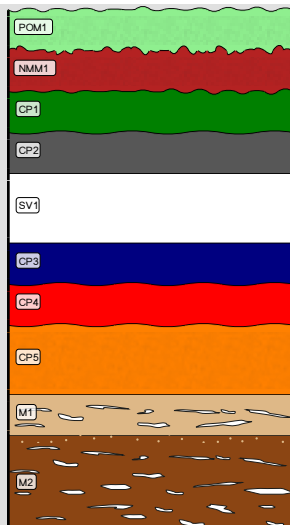
Fig. 16: Stratigraphic representation of the cross-section (dark field) from Figs. 3b and 4 (back of the object) using the MiCorr application. CP2 is CP3 while CP3 is CP4 and CP4 is CP2 in Fig. 3b. The characteristics of the strata are only accessible by clicking on the drawing that redirects you to the search tool by stratigraphy representation, Credit HE-Arc CR, N. Gutknecht.

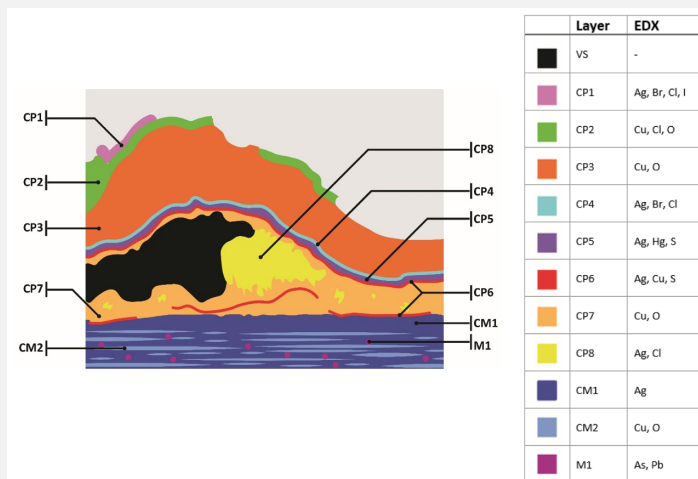
Fig. 17: Improved stratigraphic representation of the funeral mask (Fig. 3) based on the results from the SEM-EDS analyses,

The artefact is a repeatedly hammered, annealed and pickled Cu-Ag tumbaga. The cuprite and hydroxycarbonate layers and the presence of chlorides are typical for the corrosion of tumbaga alloys in an archaeological context. Cinnabar has been identified as pigment applied to the surface before burial. Over the centuries, it was partially incorporated into the growing copper corrosion layers.

Close to the enriched silver surface and below the cuprite layer a silver- and mercury-rich stratum has formed. Only one publication mentions the reaction of cinnabar with a gold-enriched tumbaga surface but does not go into details about the possible mechanism involved (Masuda 1997).

The presence of a silver-sulphur compound below this silver-mercury stratum could indicate that the cinnabar was reduced by electrochemical processes to mercury, releasing sulphur that reacted with the silver enriched surface. The mercury itself formed a silver-mercury layer above the latter. More research is needed to fully comprehend this phenomenon.
