FUNERAL MASK IVC 11595 – CU/AG, WITH SURFACE ENRICHMENT (AG) – UNKNOWN – PERU

Artefact name	Funeral mask Ivc 11595
Authors	Christian. Degrygn (HE-Arc CR, Neuchâtel, Neuchâtel, Switzerland) & Naima. Gutknecht (HE-Arc CR, Neuchâtel, Neuchâtel, Switzerland) & Valentin. Boissonnas (HE-Arc CR, Neuchâtel, Neuchâtel, Switzerland)
Url	/artefacts/1555/

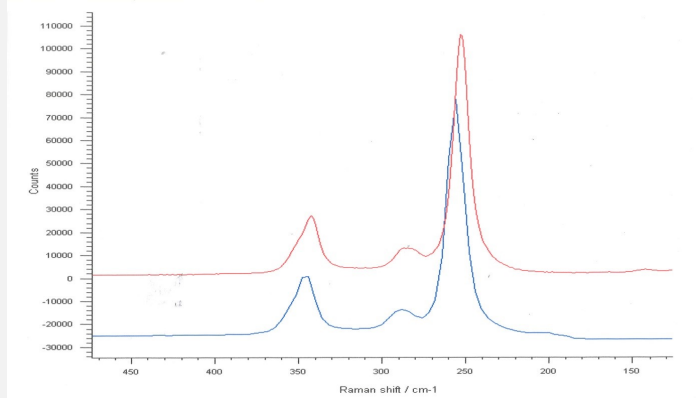
Fig. 13: Raman analysis of the red pigment on the surface (red line) and the references for cinnabar (blue line). Method of analysis: Raman spectroscopy, HKB,

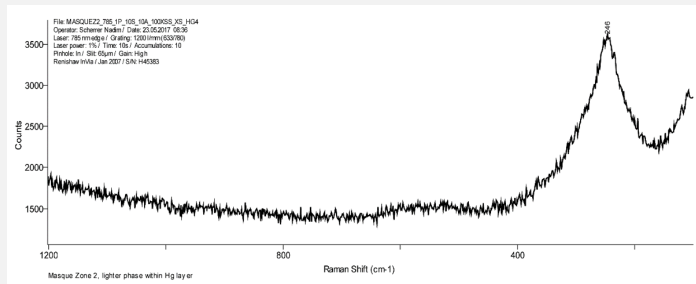
Fig. 14: Raman analysis of the mercury compounds from the cross section. Method of analysis: Raman spectroscopy, HKB,

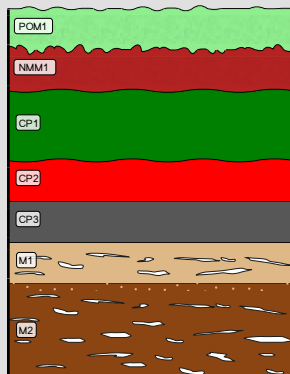
Fig. 15: Stratigraphic representation of the cross-section (dark field) from Figs. 3a or 4 (front of the object) using the MiCorr application. The characteristics of the strata are only accessible by clicking on the drawing that redirects you to the search tool by stratigraphy representation, Credit HE-Arc CR, N. Gutknecht.

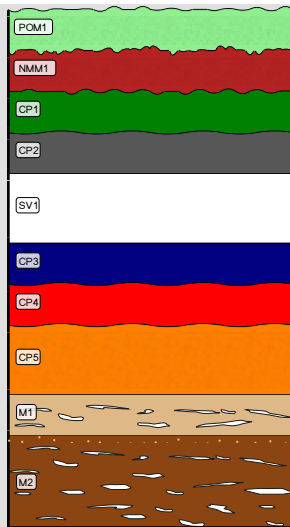
Fig. 16: Stratigraphic representation of the cross-section (dark field) from Figs. 3b and 4 (back of the object) using the MiCorr application. CP2 is CP3 while CP3 is CP4 and CP4 is CP2 in Fig. 3b. The characteristics of the strata are only accessible by clicking on the drawing that redirects you to the search tool by stratigraphy representation, Credit HE-Arc CR, N. Gutknecht.

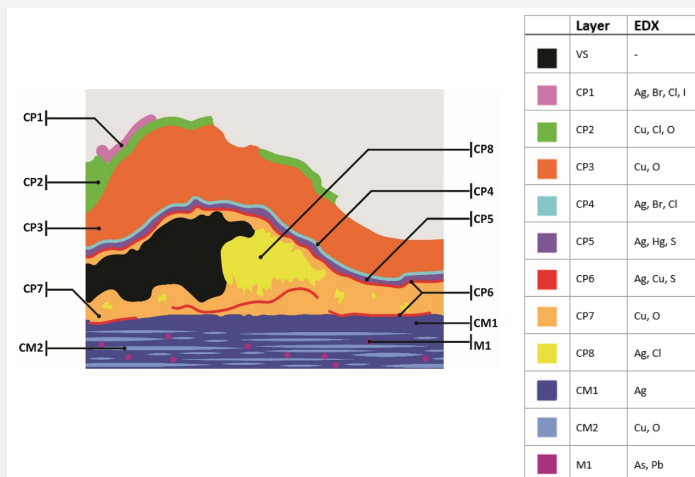
Fig. 17: Improved stratigraphic representation of the funeral mask (Fig. 3) based on the results from the SEM-EDS analyses,

The artefact is a repeatedly hammered, annealed and pickled Cu-Ag tumbaga. The cuprite and hydroxycarbonate layers and the presence of chlorides are typical for the corrosion of tumbaga alloys in an archaeological context. Cinnabar has been identified as pigment applied to the surface before burial. Over the centuries, it was partially incorporated into the growing copper corrosion layers.

Close to the enriched silver surface and below the cuprite layer a silver- and mercury-rich stratum has formed. Only one publication mentions the reaction of cinnabar with a gold-enriched tumbaga surface but does not go into details about the possible mechanism involved (Masuda 1997).

The presence of a silver-sulphur compound below this silver-mercury stratum could indicate that the cinnabar was reduced by electrochemical processes to mercury, releasing sulphur that reacted with the silver enriched surface. The mercury itself formed a silver-mercury layer above the latter. More research is needed to fully comprehend this phenomenon.
