FUNERAL MASK IVC 11595 – CU/AG, WITH SURFACE ENRICHMENT (AG) – UNKNOWN – PERU

Artefact name	Funeral mask Ivc 11595
Authors	Christian. Degrygn (HE-Arc CR, Neuchâtel, Neuchâtel, Switzerland) & Naima. Gutknecht (HE-Arc CR, Neuchâtel, Neuchâtel, Switzerland) & Valentin. Boissonnas (HE-Arc CR, Neuchâtel, Neuchâtel, Switzerland)
Url	/artefacts/1556/

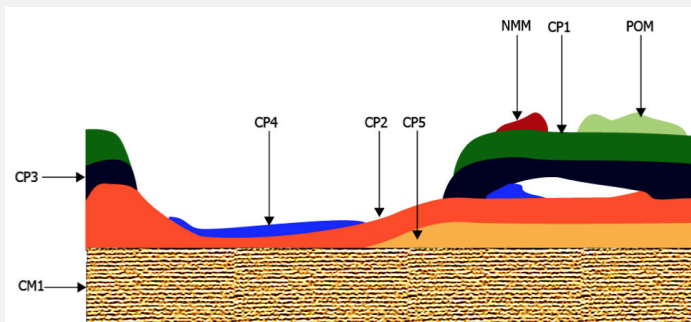
POM: Textile remains, **NMM:** Pigments, **CP1:** Green corrosion products, **CP2:** Red/orange corrosion products, **CP3:** Black corrosion product, **CP4:** blue corrosion product, **CP5:** Orange corrosion, **CM1:** Remaining metal
Credit HE-Arc CR, N.Gutknecht.

Fig. 3b: Stratigraphic representation of the back face of the funeral mask by visual macroscopic observation,

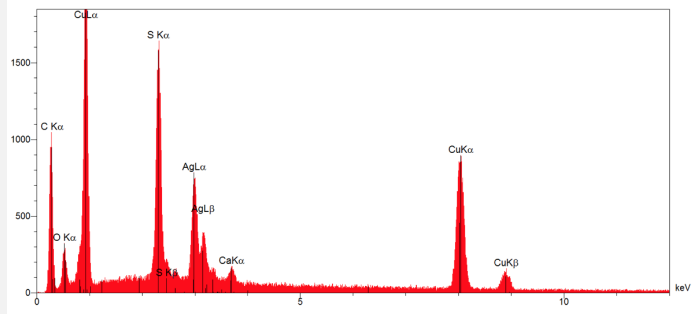
The silver enriched surface is entirely covered with copper corrosion products. The outer green layer (CP1) is a copper carbonate (Fig. 11, Table 1), while the red layers (CP2 in Fig. 15 ; CP4 and CP5 in Fig. 16) are consisting of a copper oxide, most likely cuprite (Fig. 9). Below the cuprite and above the silver enriched surface on the front face a thin black layer is present (appears grey under polarized light). SEM-EDS analysis shows that in that stratum the mercury of the pigment (Fig. 14) has been transformed into a mercury-silver compound (Figs. 7 and 10) which according to Raman spectrometry (Fig. 14) is not cinnabar anymore. In areas this silver- and mercury-rich surface has been pulled off by raising the corrosion layers, leaving structural voids that were subsequently filled by secondary corrosion products, most likely copper carbonates (Figs. 6 and 7).

Fig. 11: EDS analysis of the green corrosion layer that has filled the structural void (Fig. 4). Method of analysis: SEM-EDS, Lab of Electronic Microscopy and Microanalysis, IMA (Néode), HEI Arc,

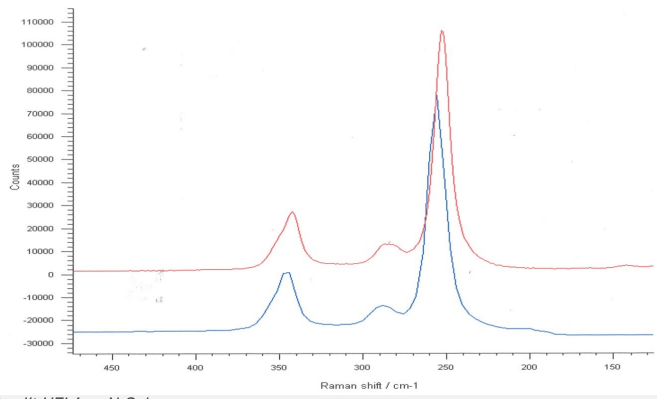
The silver sulphide (HgS, cinnabar, Fig. 13), present as a red pigment on the silver surface, could have been reduced through an electrochemical process in the presence of chlorides (Keune 2005). The released sulfur recombined with the silver to form black silver sulphide. Above that layer a porous mercury- and silver rich stratum has formed (see Hg & Ag on cartography Fig. 8). It remains unclear if the limitos is located in the silver enriched surface or within this silver-mercury compound (Fig. 7).

Fig. 13: Raman analysis of the red pigment on the surface (red line) and the references for cinnabar (blue line). Method of analysis: Raman spectroscopy, HKB,

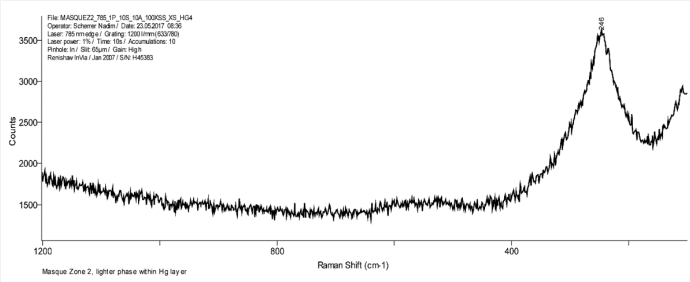
Fig. 14: Raman analysis of the mercury compounds from the cross section. Method of analysis: Raman spectroscopy, HKB,
