# FUNERAL MASK IVC 11595 – CU/AG, WITH SURFACE ENRICHMENT (AG) – UNKNOWN – PERU

**Artefact name** Funeral mask Ivc 11595

**Authors** Christian. Degrygn (HE-Arc CR, Neuchâtel, Neuchâtel, Switzerland) & Naima. Gutknecht (HE-Arc CR, Neuchâtel, Neuchâtel, Switzerland) & Valentin. Boissonnas (HE-Arc CR, Neuchâtel, Neuchâtel, Switzerland)

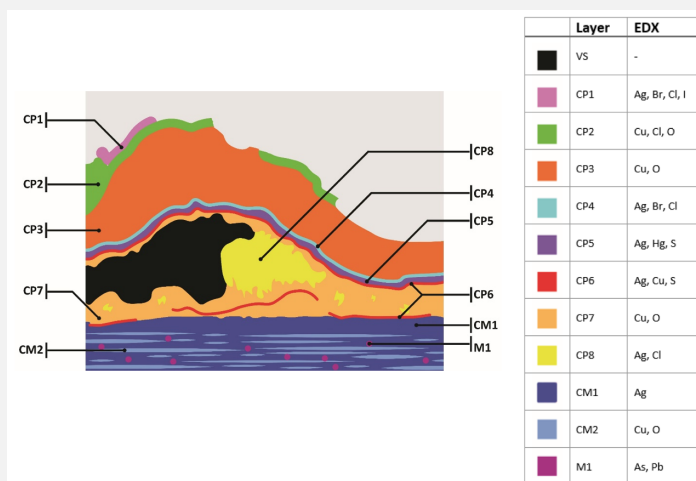
Fig. 17: Improved stratigraphic representation of the funeral mask (Fig. 3) based on the results from the SEM-EDS analyses,
