## FUNERAL MASK IVC 11595 – CU/AG, WITH SURFACE ENRICHMENT (AG) – UNKNOWN – PERU

<b>Artefact name</b>	Funeral mask Ivc 11595
<b>Authors</b>	Christian. Degrygn (HE-Arc CR, Neuchâtel, Neuchâtel, Switzerland) & Naima. Gutknecht (HE-Arc CR, Neuchâtel, Neuchâtel, Switzerland) & Valentin. Boissonnas (HE-Arc CR, Neuchâtel, Neuchâtel, Switzerland)
<b>Url</b>	/artefacts/1557/

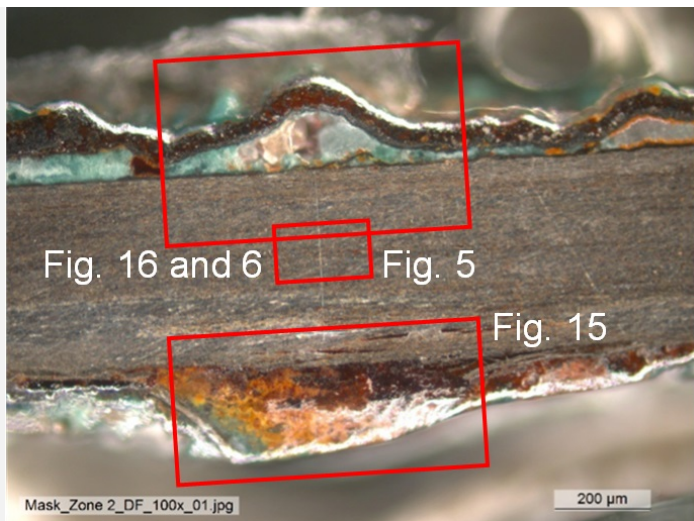
Fig. 4: Micrograph of the cross-section of the sample temporarily taken from the detached fragment of Fig. 2 showing the locations of Figs. 15 (corresponding to the front of the funeral mask), 16 (back of the funeral mask), 5 and 6,

A polished section was made from an already detached fragment that was temporarily embedded in resin (Fig. 2). On Fig. 4 the upper part of the sample corresponds to the back face of the funeral mask while the lower part corresponds to its front face. Both sides have developed subsequent layers of corrosion. In areas, these have buckled and become detached.

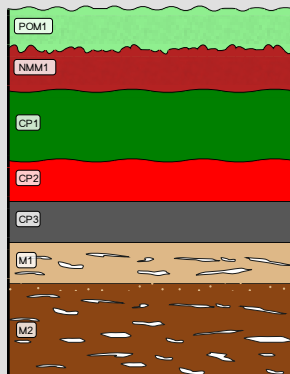
Fig. 15: Stratigraphic representation of the cross-section (dark field) from Figs. 3a or 4 (front of the object) using the MiCorr application. The characteristics of the strata are only accessible by clicking on the drawing that redirects you to the search tool by stratigraphy representation, Credit HE-Arc CR, N. Gutknecht.

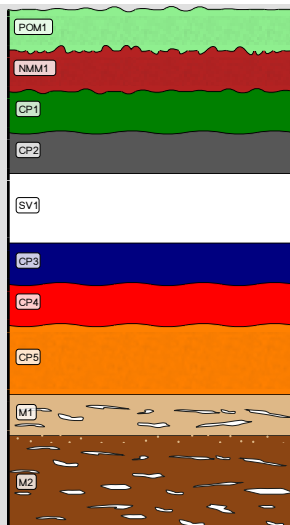
Fig. 16: Stratigraphic representation of the cross-section (dark field) from Figs. 3b and 4 (back of the object) using the MiCorr application. CP2 is CP3 while CP3 is CP4 and CP4 is CP2 in Fig. 3b. The characteristics of the strata are only accessible by clicking on the drawing that redirects you to the search tool by stratigraphy representation, Credit HE-Arc CR, N. Gutknecht.
