## FUNERAL MASK IVC 11595 – CU/AG, WITH SURFACE ENRICHMENT (AG) – UNKNOWN – PERU

Artefact name	Funeral mask IVC 11595
Authors	Christian. Degriy (HE-Arc CR, Neuchâtel, Neuchâtel, Switzerland) & Naima. Gutknecht (HE-Arc CR, Neuchâtel, Neuchâtel, Switzerland) & Valentin. Boissonnas (HE-Arc CR, Neuchâtel, Neuchâtel, Switzerland)
Url	/artefacts/1557/

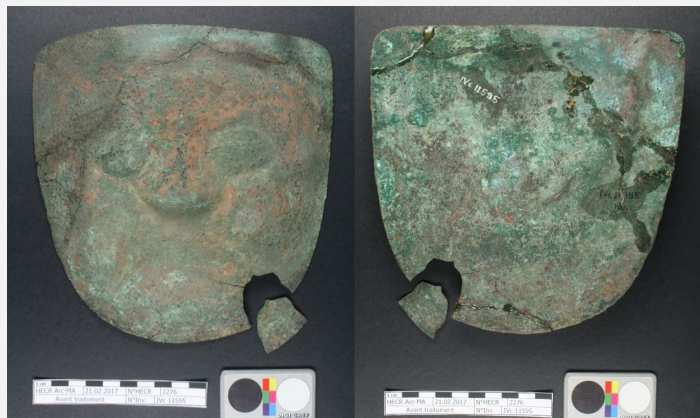
Fig. 1: Funeral mask, front and back face to the left and right respectively,

Description of the artefact	Peruvian funeral mask (Fig. 1). There are remains of red pigment and of a mineralised textile on both sides of the object. It is heavily corroded in green and red corrosion layers. It is deformed and broken. Dimensions: Length = 180mm; Width = 170mm; Height = 20 mm; WT = 158,6g.
Type of artefact	Funeral mask
Origin	Funeral mask, Peru
Recovering date	Date of excavation unknown, acquisition in 1967
Chronology category	Unknown
chronology tpq	<input type="text"/> ---- ▼
chronology taq	<input type="text" value="1500"/> A.D. ▼
Chronology comment	Tpq: unknown.
Burial conditions / environment	Unknown
Artefact location	Museum der Kulturen, Basel
Owner	Museum der Kulturen, Basel
Inv. number	IVC 11595
Recorded conservation data	N/A

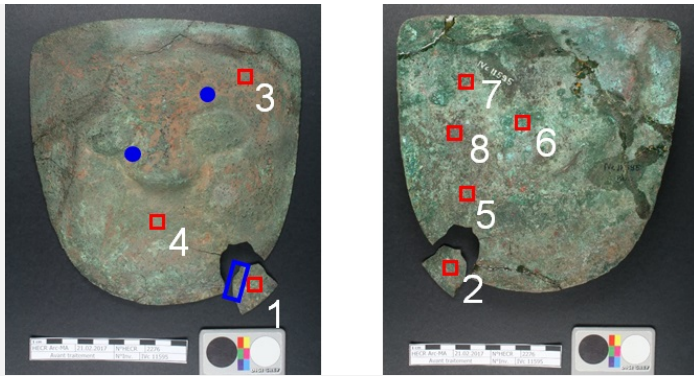
Fig. 2: Front (left) and back (right) faces showing the location of XRF analyses (red squares), sampling areas for SEM-EDS (blue points) and sampling area for examination on cross-section (blue rectangle),

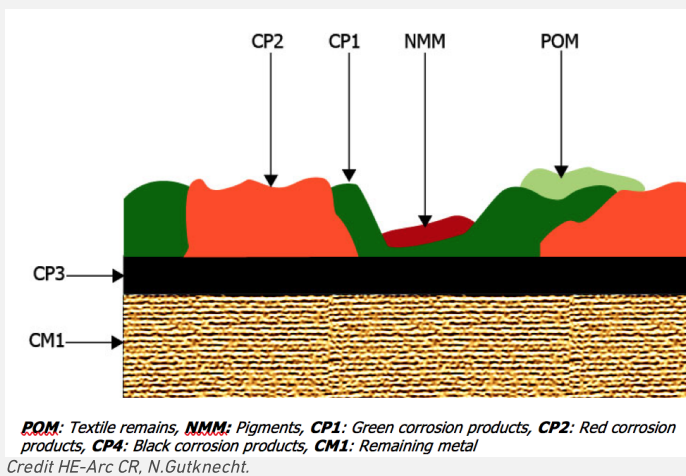
Fig. 3a: Stratigraphic representation of the front face of the funeral mask by visual macroscopic observation,

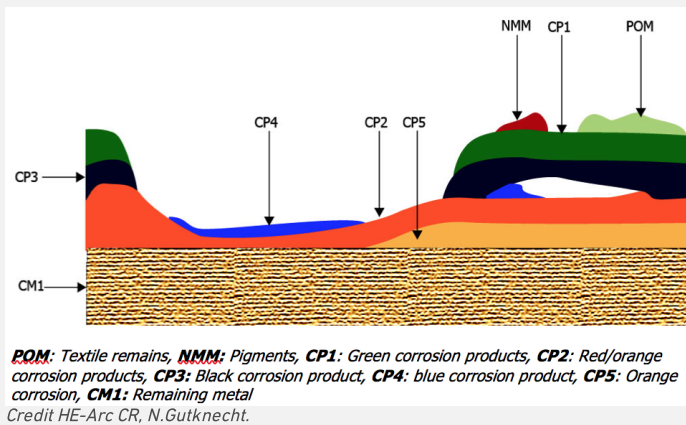
Fig. 3b: Stratigraphic representation of the back face of the funeral mask by visual macroscopic observation,

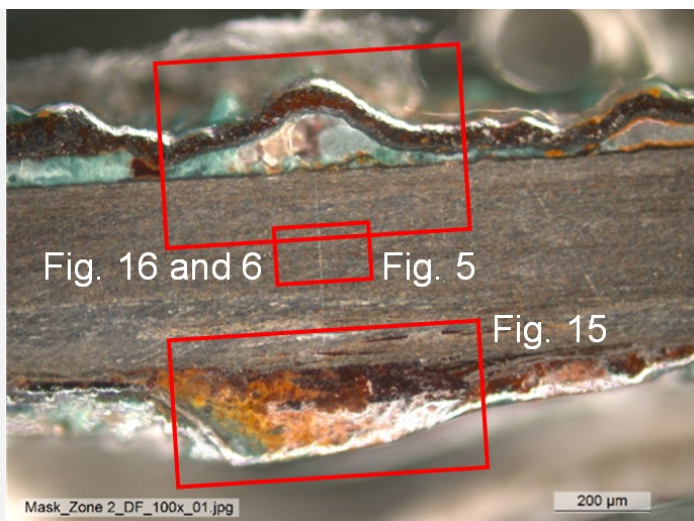
Fig. 4: Micrograph of the cross-section of the sample temporarily taken from the detached fragment of Fig. 2 showing the locations of Figs. 15 (corresponding to the front of the funeral mask), 16 (back of the funeral mask), 5 and 6,

A polished section was made from an already detached fragment that was temporarily embedded in resin (Fig. 2). On Fig. 4 the upper part of the sample corresponds to the back face of the funeral mask while the lower part corresponds to its front face. Both sides have developed subsequent layers of corrosion. In areas, these have buckled and become detached.

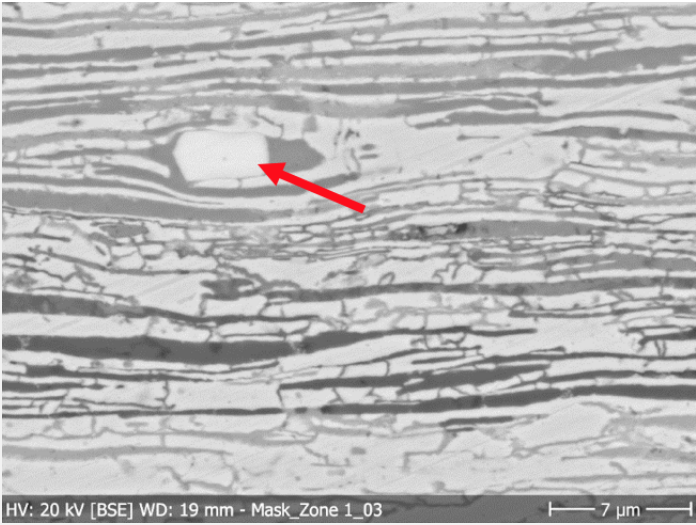
The SEM/EDS analysis of the core metal shows that there are Cu-rich phases alternating with Ag-rich phases. There are inclusions of Pb and As (Fig. 5). The surface of the metal has been decuprified (Fig. 6) according to the tumbaga making process (Scott 2000 and McEwan 2000). This pre-Columbian repeatedly hammered and annealed the metal, which would create a copper oxide scale on the surface. The latter was then dissolved in acidic plant juices (Scott 2000). This process was repeated until the surface was enriched with silver, giving it the appearance of a silver artefact.

Fig. 5: SEM image (BSE-mode) of the metal sample from Fig. 4 (detail), the elongated grains are the result of repeated hammering. Absence of strain lines indicates that the metal is annealed. The darker areas are Cu-rich phases and the lighter areas are Ag-rich phases. The arrow shows an As- and Pb inclusion,

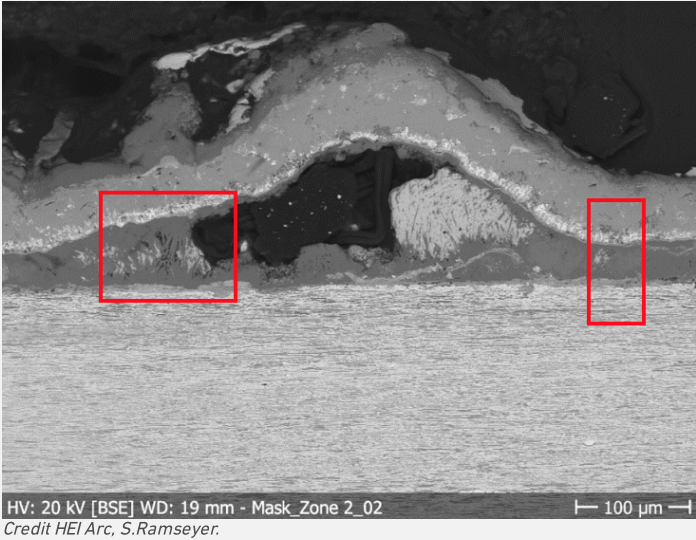
A layer of mercury can be seen with EDS (Figs. 6 and 7). Mercury was not used by the pre-Columbians in metallic form (Scott 2000 and McEwan 2000) but was common as a pigment in form of mercury sulfide (cinnabar).

Fig. 6: SEM image (BSE-mode) of the metal sample from Fig. 4 with detail (Fig. 7) indicated by the left red rectangle. The selected area for elemental chemical distribution (Fig. 8) is marked by the right red rectangle,

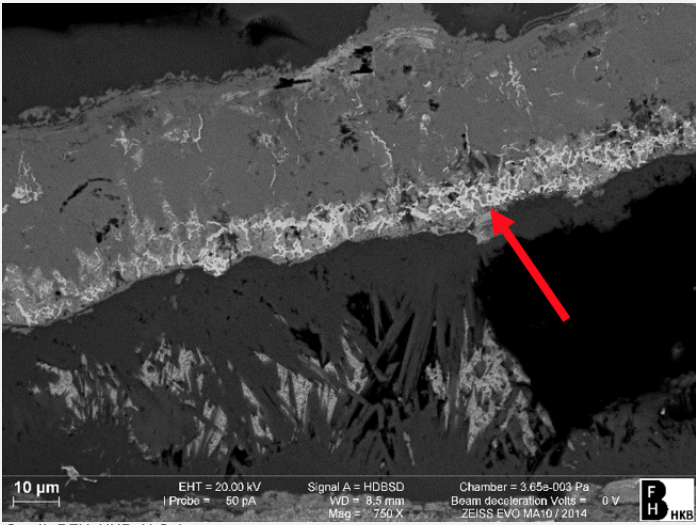
Fig. 7: SEM image of a partially refilled structural void with a silver-, copper- and mercury-rich layer (red arrow),

The silver sulphide (HgS, cinnabar, Fig. 13), present as a red pigment on the silver surface, could have been reduced through an electrochemical process in the presence of chlorides (Keune 2005). The released sulfur recombined with the silver to form black silver sulphide. Above that layer a porous mercury- and silver rich stratum has formed (see Hg & Ag on cartography Fig. 8). It remains unclear if the limit is located in the silver enriched surface or within this silver-mercury compound (Fig. 7).

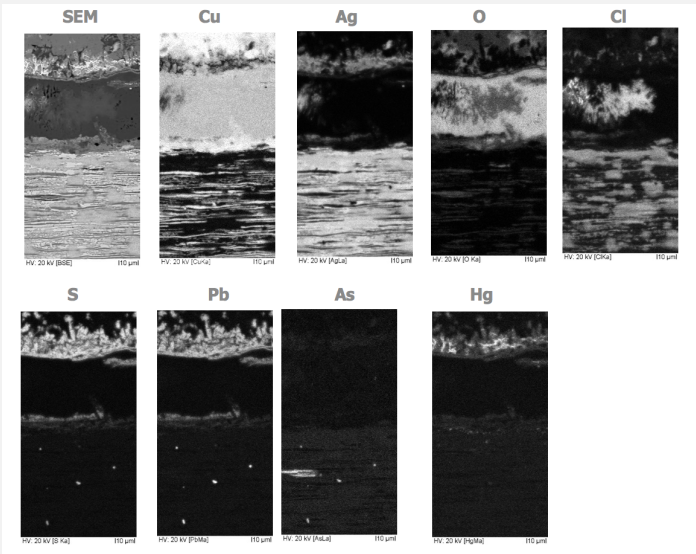
The remaining metal shows a preferential corrosion of copper and the presence of chlorides throughout the entire corroded metal, most likely in the form of Cu and Ag corrosion products (Fig. 8, Table 1). There is a preferential corrosion of copper that has fragilized the structure of the sheet metal.

Fig. 8: SEM image (BSE-mode) and elemental chemical distribution of the selected area on Fig. 6. Method of examination: SEM/EDS,

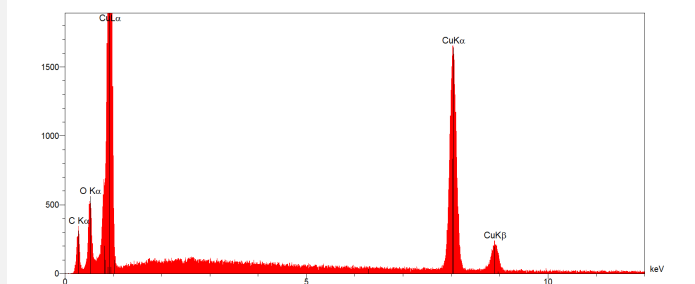
The silver enriched surface is entirely covered with copper corrosion products. The outer green layer (CP1) is a copper carbonate (Fig. 11, Table 1), while the red layers (CP2 in Fig. 15 ; CP4 and CP5 in Fig. 16) are consisting of a copper oxide, most likely cuprite (Fig. 9). Below the cuprite and above the silver enriched surface on the front face a thin black layer is present (appears grey under polarized light). SEM-EDS analysis shows that in that stratum the mercury of the pigment (Fig. 14) has been transformed into a mercury-silver compound (Figs. 7 and 10) which according to Raman spectrometry (Fig. 14) is not cinnabar anymore. In areas this silver- and mercury-rich surface has been pulled off by raising the corrosion layers, leaving structural voids that were subsequently filled by secondary corrosion products, most likely copper carbonates (Figs. 6 and 7).

Fig. 9: EDS analysis of the red corrosion layer (Fig. 4). Method of analysis: SEM-EDS, Lab of Electronic Microscopy and Microanalysis, IMA (Néode), HEI Arc,

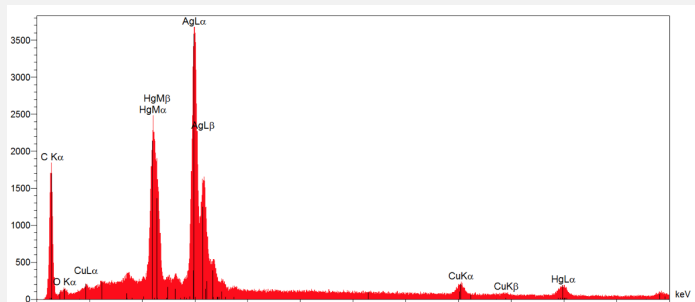
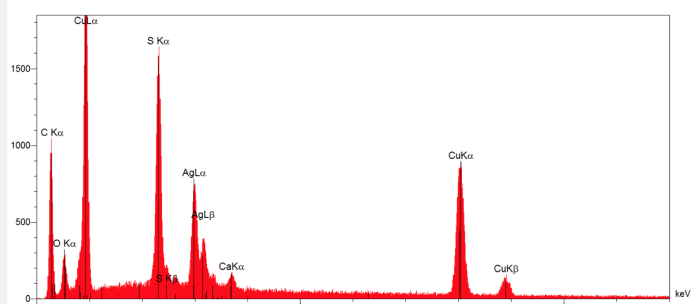
Figs. 10: EDS analysis of the layer that appears light grey under polarized light, situated below the red layer (Fig. 4). Method of analysis: SEM-EDS, Lab of Electronic Microscopy and Microanalysis, IMA (Néode), HEI Arc,

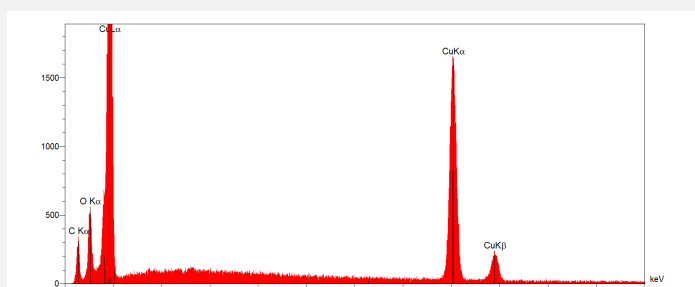
Fig. 11: EDS analysis of the green corrosion layer that has filled the structural void (Fig. 4). Method of analysis: SEM-EDS, Lab of Electronic Microscopy and Microanalysis, IMA (Néode), HEI Arc,

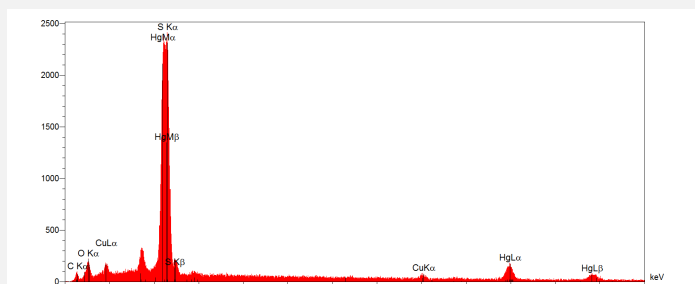
Fig. 12: EDS analysis of the red surface pigment from a surface sample. Method of analysis: SEM-EDS, Lab of Electronic Microscopy and Microanalysis, IMA (Néode), HEI Arc,

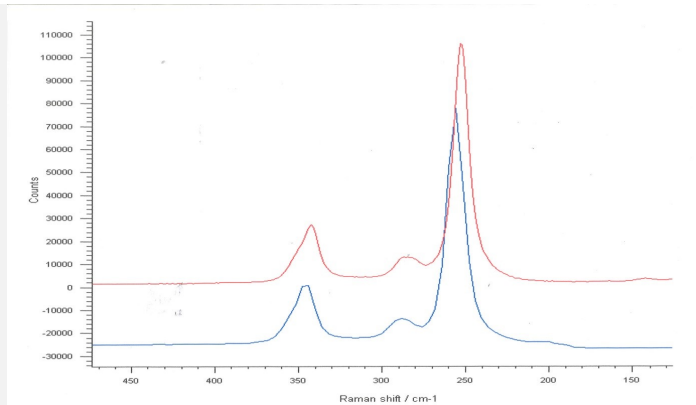
Fig. 13: Raman analysis of the red pigment on the surface (red line) and the references for cinnabar (blue line). Method of analysis: Raman spectroscopy, HKB,

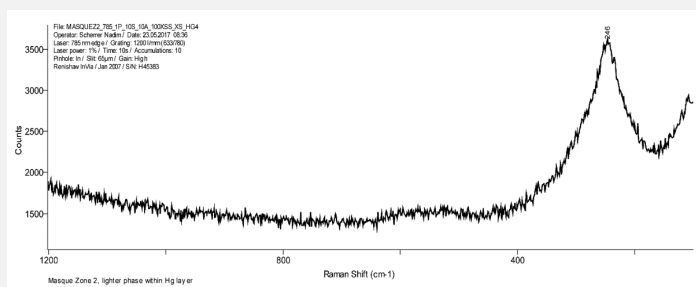
Fig. 14: Raman analysis of the mercury compounds from the cross section. Method of analysis: Raman spectroscopy, HKB,

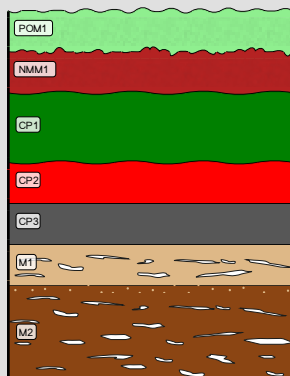
Fig. 15: Stratigraphic representation of the cross-section (dark field) from Figs. 3a or 4 (front of the object) using the MiCorr application. The characteristics of the strata are only accessible by clicking on the drawing that redirects you to the search tool by stratigraphy representation, Credit HE-Arc CR, N. Gutknecht.

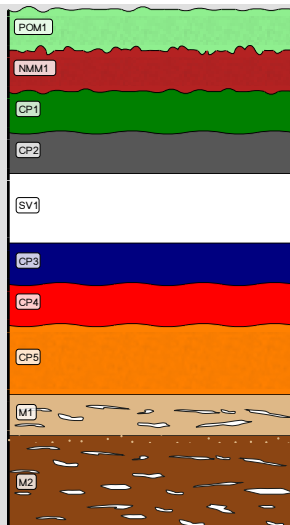
Fig. 16: Stratigraphic representation of the cross-section (dark field) from Figs. 3b and 4 (back of the object) using the MiCorr application. CP2 is CP3 while CP3 is CP4 and CP4 is CP2 in Fig. 3b. The characteristics of the strata are only accessible by clicking on the drawing that redirects you to the search tool by stratigraphy representation, Credit HE-Arc CR, N. Gutknecht.

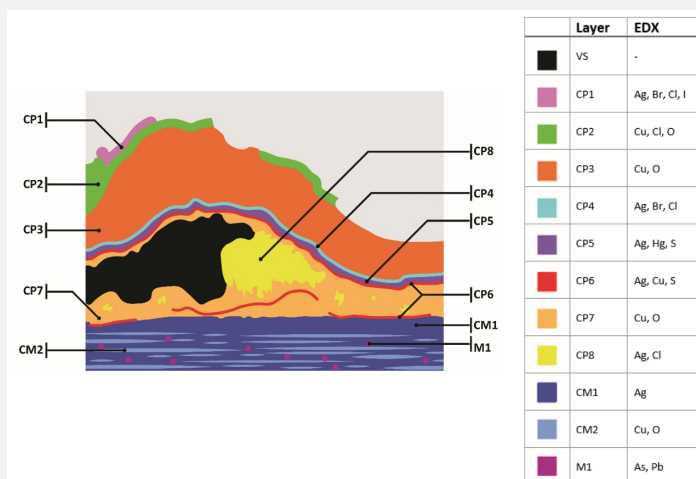
The schematic representation of corrosion layers of Fig. 3 integrating additional information based on the analyses carried out is given in Fig. 17.

Fig. 17: Improved stratigraphic representation of the funeral mask (Fig. 3) based on the results from the SEM-EDS analyses,
