# VOTIVE FIGURE OF A BAT IVB4168 – GILDED BRASS – MODERN TIMES

**Artefact name** Votive figure of a bat IVb4168

**Authors** Christian. Degriigny (HE-Arc CR, Neuchâtel, Neuchâtel, Switzerland) & Naima. Gutknecht (HE-Arc CR, Neuchâtel, Neuchâtel, Switzerland) & Valentin. Boissonnas (HE-Arc CR, Neuchâtel, Neuchâtel, Switzerland)

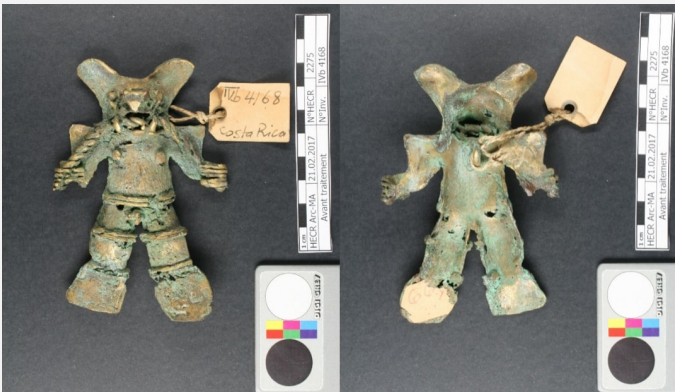
Fig. 1: Votive figure of a bat, front (left) and back (right) view,

<b>Description of the artefact</b>	The object represents a bat-like figure holding and chewing a rope (Fig. 1). There are remains of a surface gilding. The object has a red-brown adherent layer where the gold has flaked off with a heterogenous green and white loosely bound layer on top. Dimensions: Length = 110 mm; Width = 73mm; Height = 25mm; WT = 60g.
<b>Type of artefact</b>	Votive figure
<b>Origin</b>	Unknown
<b>Recovering date</b>	Unknown, acquisition in 1970
<b>Chronology category</b>	Modern Times
<b>chronology tpq</b>	<input type="text"/> ---- ▾
<b>chronology taq</b>	<input type="text"/> ---- ▾
<b>Chronology comment</b>	20th century (fake)

The metal seems to have been heavily attacked (acid dissolution). There are several perforations on the lower part of the object, and where the gold layer is absent the surface is unevenly pitted by corrosion (Figs. 1, 2 and 7). The submetallic core is not visible from the surface.

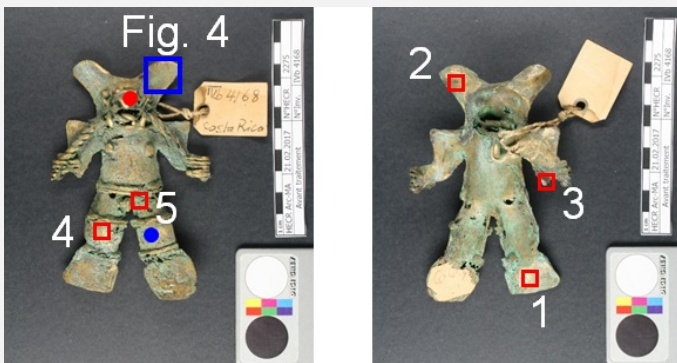
Fig. 2: Bat figure, front (left) and back (right) views with location of Fig. 4 (blue square), XRF analyses (red squares), FTIR analysis with sampling (blue point) and SEM-EDS analysis (red point),

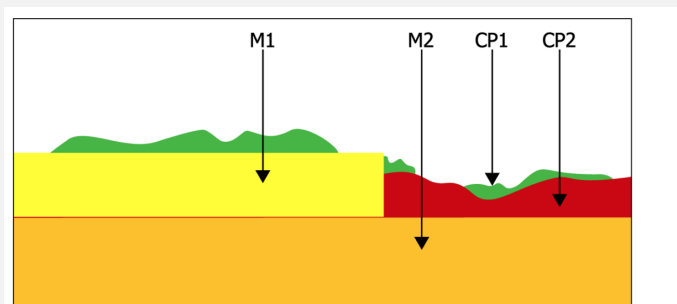
**M1:** yellow metal plating **M2:** Metal **CP1:** green/white corrosion layer **CP2:** red corrosion layer  
Credit HE-Arc CR, N.Gutknecht.

Fig. 3: Stratigraphic representation of the bat by visual macroscopic observation,

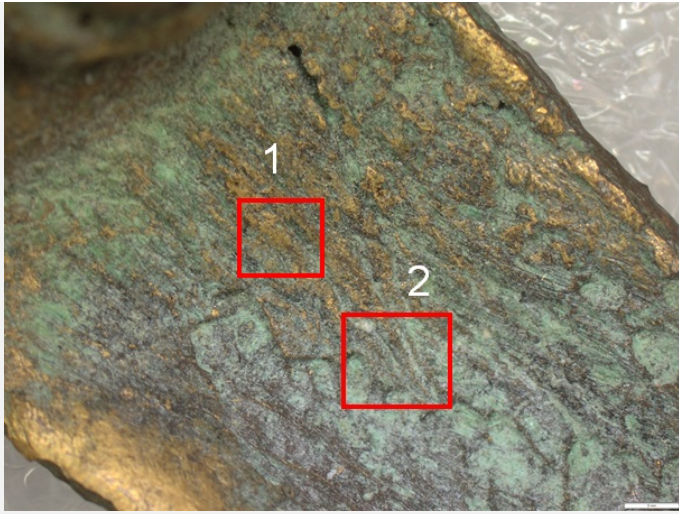
Fig. 4: Location of the areas 1 and 2 used to build the MiCorr stratigraphies of Figs. 5 and 6,

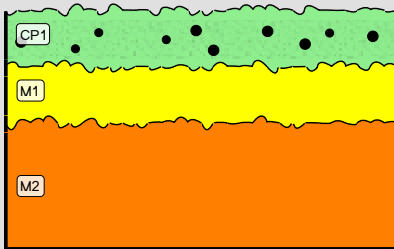
Fig 5: Stratigraphic representation of the corrosion structure of area 1 (Fig. 4) observed macroscopically under binocular microscope using the MiCorr application. The characteristics of the strata are only accessible by clicking on the drawing that redirects you to the search tool by stratigraphy representation, Credit HE-Arc CR, N.Gutknecht.

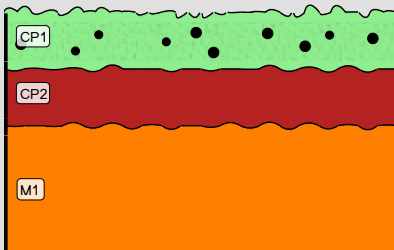
Fig. 6: Stratigraphic representation of the corrosion structure of area 2 (Fig. 4) observed macroscopically under binocular microscope using the MiCorr application. M1 is M2 in Fig. 5. The characteristics of the strata are only accessible by clicking on the drawing that redirects you to the search tool by stratigraphy representation, Credit HE-Arc CR, N.Gutknecht.

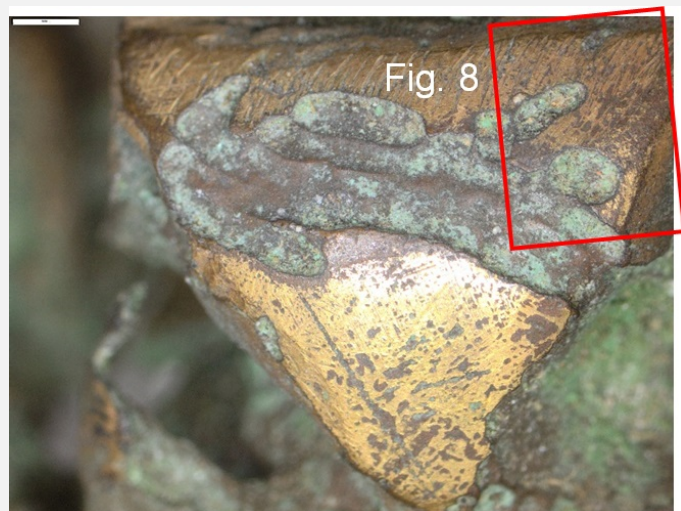
There are two corrosion products (Figs. 7 and 8). The red one (CP2) has a submetallic brightness and is opaque, non-magnetic, compact, hard and adherent. It is very thin (less than a few microns thick) and only appears where the gold layer has been lost. The EDX spectrum (Fig. 9) shows that it is a Cu- and O rich product, probably cuprite ( $\text{Cu}_2\text{O}$ ).

Fig. 7: Binocular image of the nose of the bat showing detail of Fig. 8,

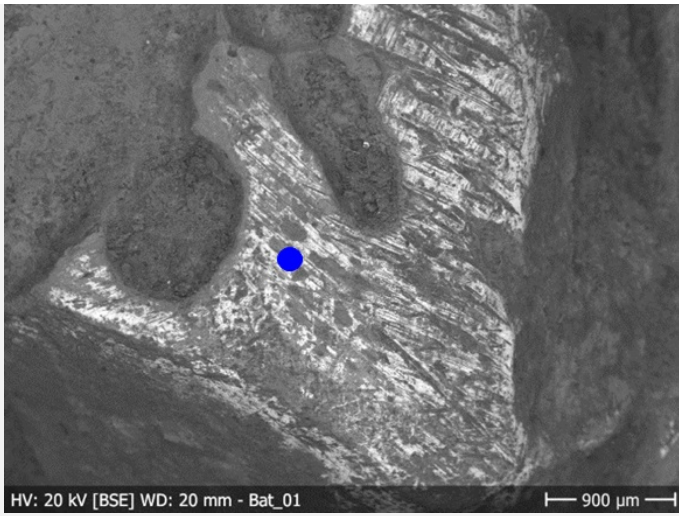
Figs. 8: SEM images of the metal on the nose of the bat. The blue point represents the area for the EDS point analysis (Fig. 9),

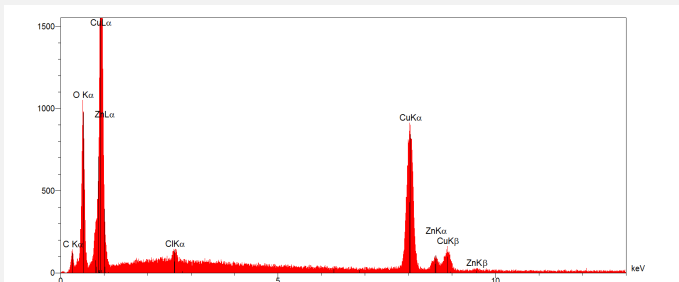
Fig. 9: EDS analysis of the red corrosion product. Method of analysis: SEM-EDS, Lab of Electronic Microscopy and Microanalysis, Néode, HEI Arc,

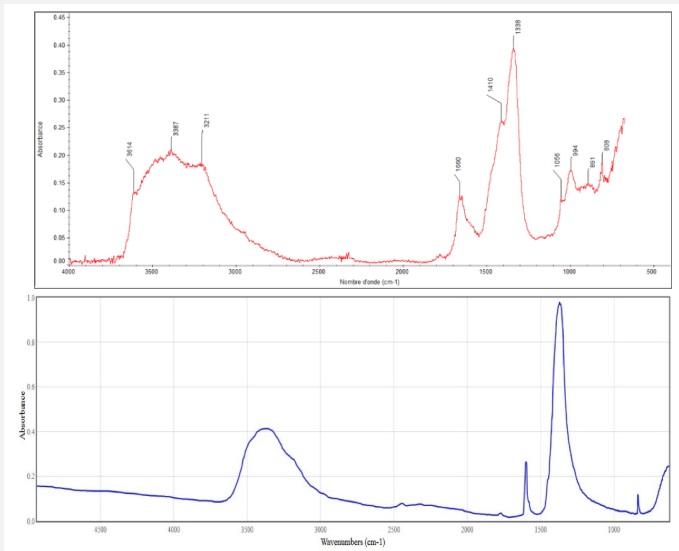
The light green to white corrosion product (CP1) has a waxy consistency and is thin, translucent, non-magnetic, powdery and very soft. It is very loosely bound. It is distributed on the whole object (front and back) as disparate clumps. It is mainly located on the cavities and irregularities of the surface. FTIR analyses (ATR mode) of both green and white areas of CP1 have similar spectra and were identified as copper nitrate (Fig. 10).

Fig. 10: FTIR spectrum (ATR mode) of the white corrosion product product (top), and of synthesized copper nitrate (Cu(NO3)2 \* 3H2O) (bottom),

FTIR analysis of the green/white corrosion product suggests that it is a copper nitrate, a highly water soluble corrosion product that cannot be found in an archaeological context. However, it has been recorded on artificially patinated copper alloys (Scott 2000; Craddock 2009).
