LEAD CAMES OF A STAINED GLASS WINDOW 52583 – PB SB ALLOY – UNKNOWN – SWITZERLAND

Artefact name	Lead comes of a stained glass window 52583
Authors	Alice Gerber. (Haute École Arc Neuchâtel, Neuchâtel, Neuchâtel, Switzerland)
Url	/artefacts/1560/

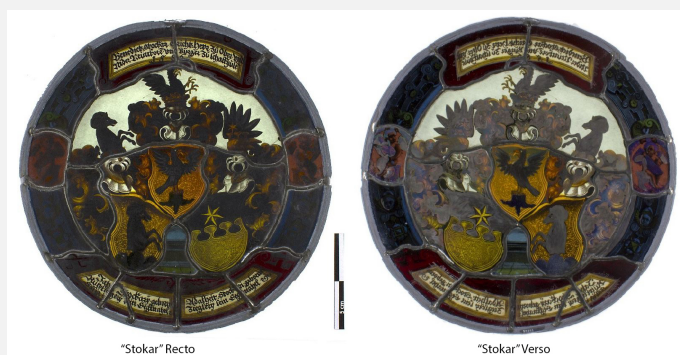
Fig. 1: Stained glass panel "Stokar" both sides,

In 2009 two stained glass panels were placed in a showcase for a permanent exhibition, the lead came were then in a good conservation condition. In 2018, the lead showed voluminous efflorescence of white, powdery corrosion products.

The environment of this showcase contained a high level of acetic acid. Lead being sensitive to organic acids, it corroded strongly. This is not new, but what is interesting here is that the two objects corroded in a very heterogeneous way. One lead came may be deformed and completely covered with bulky white efflorescences, and the one next to it shows no corrosion.

The "stokar" window, which is of interest here, was restored in 2008, just before it was put on display. The restoration consisted of replacing some of the lead came. Thus, while the object is dated to the 16th century, the replaced came were new when they entered the display case. In 2018, they were completely corroded. In comparison, the other stained glass panel, with older lead came, was placed in the same display case at the same time. For this second panel, the came are slightly corroded in 2018, but not as badly as those of the 'Stokar' panel. The metal chosen by the restorer reacted more strongly with the corrosive environment (the display case) than the historical metal.

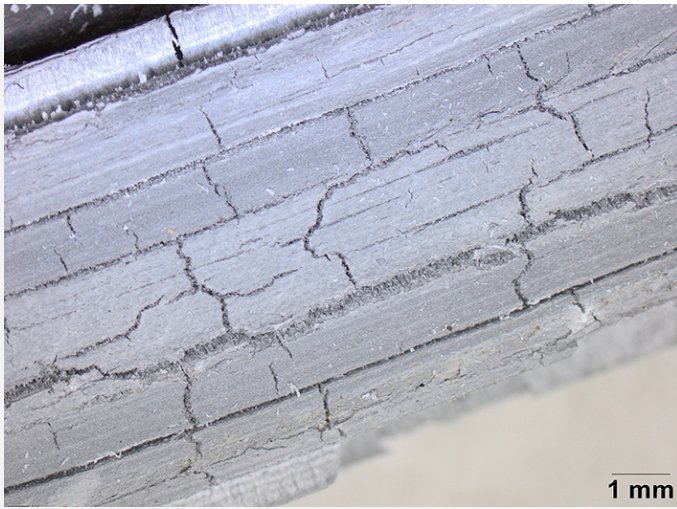
Fig. 3: Detail of the corroded lead came,

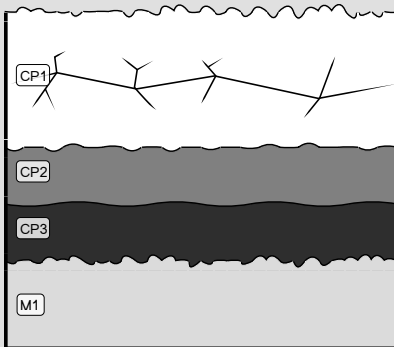
Fig. 4: Stratigraphic representation of the corrosion structure of the lead came observed macroscopically under binocular microscope using the MiCorr application. The characteristics of the strata are only accessible by clicking on the drawing that redirects you to the search tool by stratigraphy representation, Credit HE-Arc CR, A.Gerber.

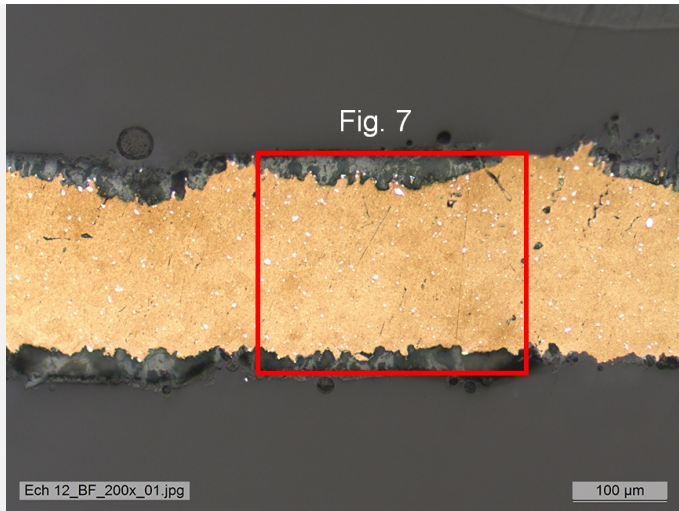
Fig. 5: Micrograph of the cross-section of the corroded lead came with location of Fig. 7, unetched, dark field. The grains of the metal are slightly visible, and the light-coloured dots in the alloy are inclusions,

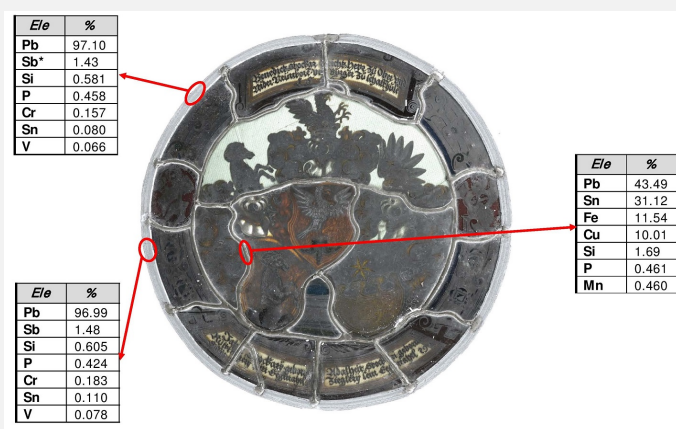
XRF analyses of the different lead comes of the "Stokar" stained glass panel showed that the tin (Sn) content is very variable from one came to another (Fig. 6). Those with a very low Sn but a high Sb (1.4%) contents are much more corroded.

Fig. 6: XRF analyses of a selection of the comes,

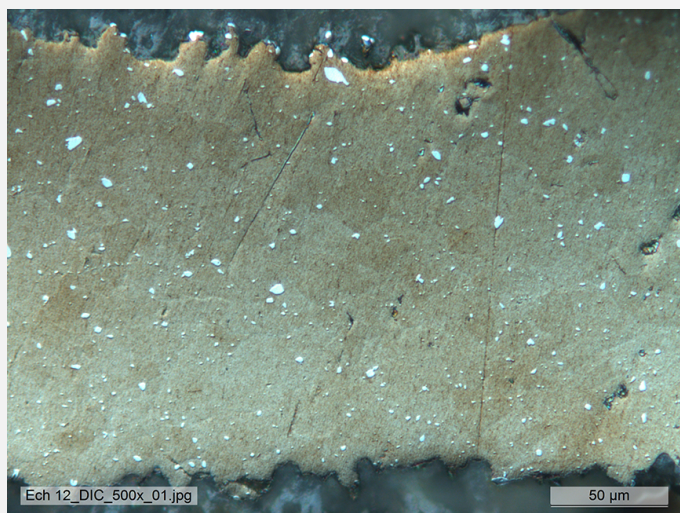
The lead alloy contains approximately 1.5% antimony. The grains of the metal are slightly visible, even without etching. The light-coloured dots in the alloy are Sb-rich inclusions (Fig. 7).

Fig. 7: Micrograph (detail of Fig. 5), unetched, dark field,

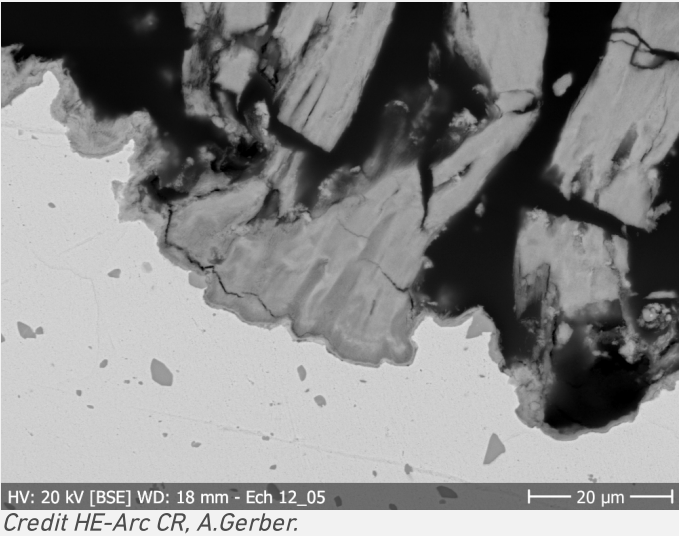
CP1 seems to be an heterogeneous compound as indicated on Figs. 8 and 9. It is heavily cracked (Fig. 9). EDX analyses do not indicate a significant difference in composition. The attack of lead by organic acids causes the formation of salts, such as lead acetate which are then transformed into basic lead carbonates by the action of CO2 from the environment as indicated by FTIR analysis of CP1.

Fig. 9: SEM image (BSE mode) of the cross-section of the corroded lead came,

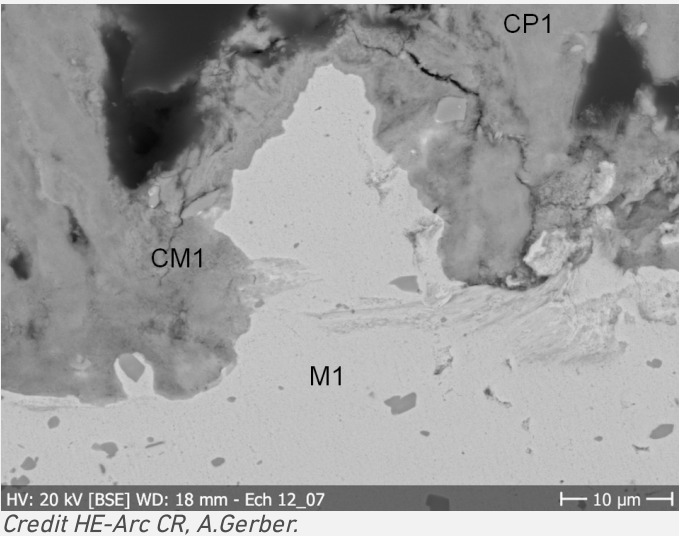
Corrosion develops specifically on comes made of a lead-antimony alloy, where antimony inclusions constitute the cathode (0.150 V/SHE) versus lead (-0.125 V/SHE) which corrodes as an anode in presence of lead acetate (the electrolyte). Fig. 8 shows that corrosion does not attack the antimony nodules in the alloy, it progresses by mineralizing the lead around these nodules.

Fig. 8: SEM image (BSE mode) of a detail of the cross-section of the corroded lead came. The area in light grey is the metal, the corrosion is in darker grey with a blurred appearance. Sb-dots are dark grey. Corrosion progresses around them, without mineralising them,

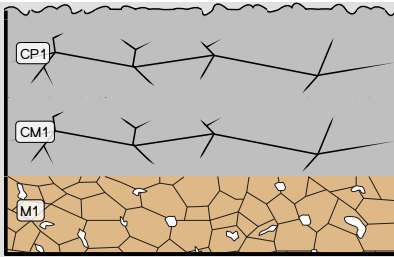
Fig. 10: Stratigraphic representation of the lead came in cross-section (dark field) using the MiCorr application with reference to Fig. 8. The characteristics of the strata are only accessible by clicking on the drawing that redirects you to the search tool by stratigraphy representation, Credit HE-Arc CR, A.Gerber.

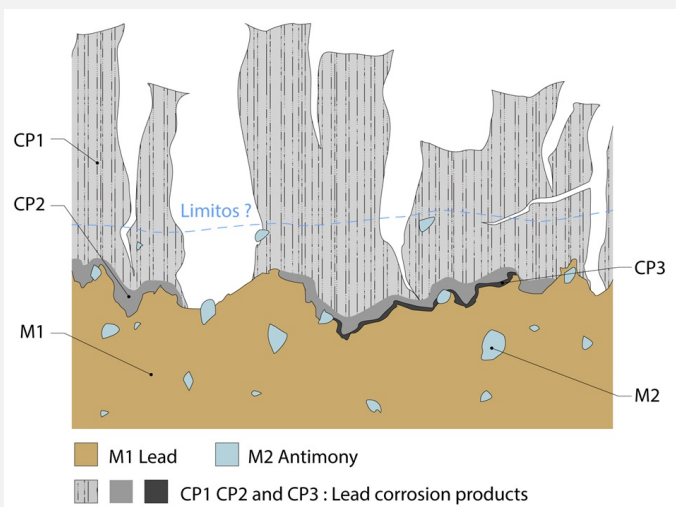
Fig. 11 shows an optimised stratigraphic representation of the corrosion structure. It is to be noted that CP1, CP2 and CP3 although visible on some cross-sections (Fig. 9) could not be differentiated by analysis.

The limit of the original surface lies somewhere in the corrosion layers. Antimony nodules are inferior markers of the limit of the original surface.

Fig. 11: Optimised stratigraphic representation of a corroded lead came integrating additional information based on the analyses carried out,
