LEAD CAMES OF A STAINED GLASS WINDOW 52583 - PB SB ALLOY - UNKNOWN - SWITZERLAND

Artefact name Lead cames of a stained glass window 52583

Authors Alice Gerber. (Haute École Arc Neuchâtel, Neuchâtel, Neuchâtel, Switzerland)

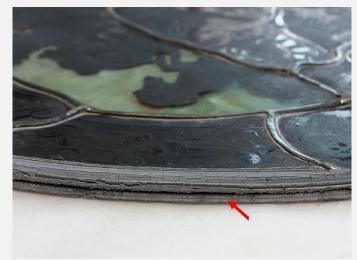
The "stokar" window, which is of interest here, was restored in 2008, just before it was put on display. The restoration consisted of replacing some of the lead cames. Thus, while the object is dated to the 16th century, the replaced cames were new when they entered the display case. In 2018, they were completely corroded. In comparison, the other stained glass panel, with older lead cames, was placed in the same display case at the same time. For this second panel, the cames are slightly corroded in 2018, but not as badly as those of the 'Stokar' panel. The metal chosen by the restorer reacted more strongly with the corrosive environment (the display case) than the historical metal.

Fig. 2: Corroded "modern" lead came on the "Stokar" stained glass panel with location of the sampling area,

This came was replaced during the 2009 restoration. The purpose was to understand why this new metal has been completely corroded in a few years (Fig. 2, 3 and 5), while the historical

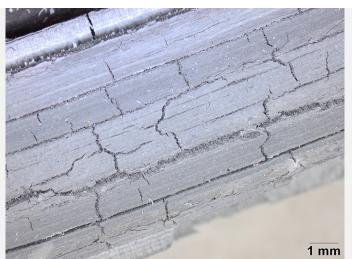
Fig. 3: Detail of the corroded lead came,

The lead came is heavily corroded and its original surface contained in the thick and very fragile corrosion layer might get lost easily in case of any physical shock.

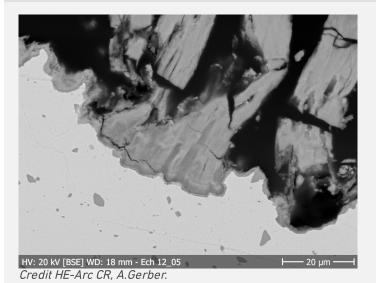
CP1 seems to be an heterogeneous compound as indicated on Figs. 8 and 9. It is heavily cracked (Fig. 9). EDX analyses do not indicate a significant difference in composition. The attack of lead by organic acids causes the formation of salts, such as lead acetate which are then transformed into basic lead carbonates by the action of CO2 from the environment as indicated by FTIR analysis of CP1.

Fig. 9: SEM image (BSE mode) of the cross-section of the corroded lead came,

Fig. 11 shows an optimised stratigraphic representation of the corrosion structure. It is to be noted that CP1, CP2 and CP3 although visible on some cross-sections (Fig. 9) could not be differentiated by analysis.

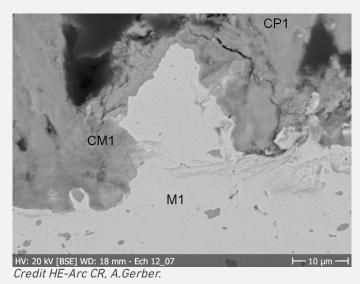
Corrosion develops specificilly on cames made of a lead-antimony alloy, where antimony inclusions constitute the cathode (0.150 V/SHE) versus lead (-0.125 V/SHE) which corrodes as an anode in presence of lead acetate (the electrolyte). Fig. 8 shows that corrosion does not attack the antimony nodules in the alloy, it progresses by mineralizing the lead around these nodules.

Fig. 8: SEM image (BSE mode) of a detail of the cross-section of the corroded lead came. The area in light grey is the metal, the corrosion is in darker grey with a blurred appearance. Sb-dots are dark grey. Corrosion progresses around them, without mineralising them,
