# LEAD CAMES OF A STAINED GLASS WINDOW 52583 – PB SB ALLOY – UNKNOWN – SWITZERLAND

**Artefact name** Lead comes of a stained glass window 52583

**Authors** Alice Gerber. (Haute École Arc Neuchâtel, Neuchâtel, Neuchâtel, Switzerland)

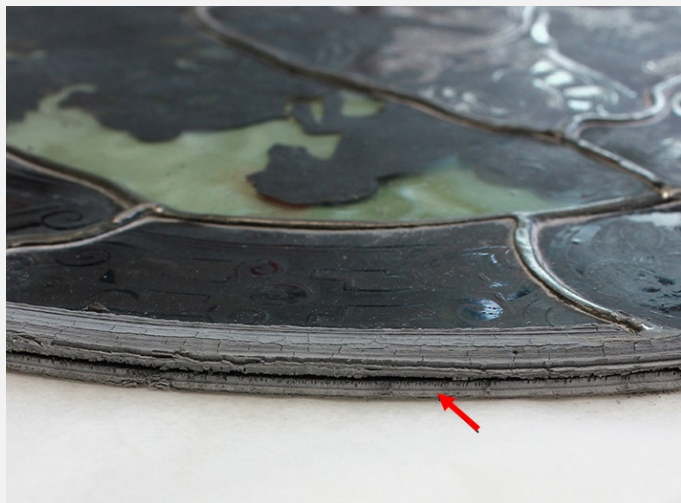
In 2009 two stained glass panels were placed in a showcase for a permanent exhibition, the lead came were then in a good conservation condition. In 2018, the lead showed voluminous efflorescence of white, powdery corrosion products.

The environment of this showcase contained a high level of acetic acid. Lead being sensitive to organic acids, it corroded strongly. This is not new, but what is interesting here is that the two objects corroded in a very heterogeneous way. One lead came may be deformed and completely covered with bulky white efflorescences, and the one next to it shows no corrosion.

The "stokar" window, which is of interest here, was restored in 2008, just before it was put on display. The restoration consisted of replacing some of the lead came. Thus, while the object is dated to the 16th century, the replaced came were new when they entered the display case. In 2018, they were completely corroded. In comparison, the other stained glass panel, with older lead came, was placed in the same display case at the same time. For this second panel, the came are slightly corroded in 2018, but not as badly as those of the 'Stokar' panel. The metal chosen by the restorer reacted more strongly with the corrosive environment (the display case) than the historical metal.

Fig. 2: Corroded "modern" lead came on the "Stokar" stained glass panel with location of the sampling area,

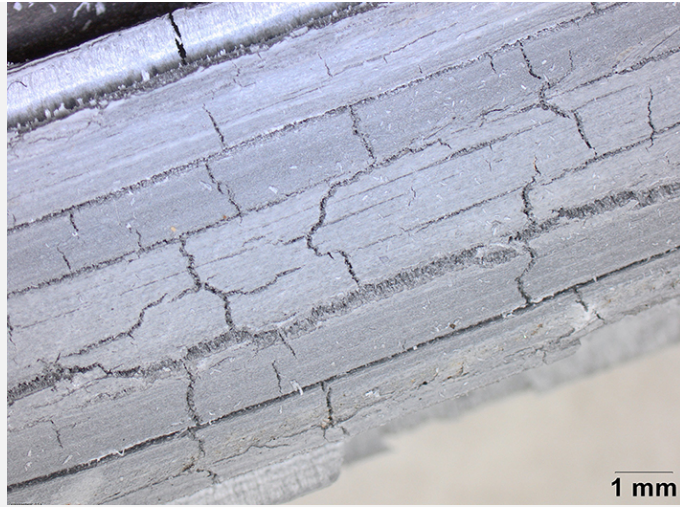
Fig. 3: Detail of the corroded lead came,

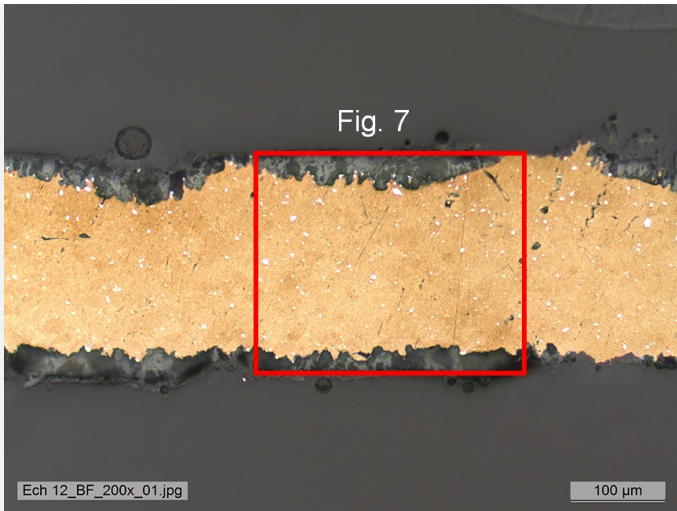
Fig. 5: Micrograph of the cross-section of the corroded lead came with location of Fig. 7, unetched, dark field. The grains of the metal are slightly visible, and the light-coloured dots in the alloy are inclusions,

<b>Description of sample</b>	The sample is a piece of metal taken from the corroded lead came of the stained glass (Fig. 2). This came was replaced during the 2009 restoration. The purpose was to understand why this new metal has been completely corroded in a few years (Fig. 2, 3 and 5), while the historical metal next to it is not affected at all.
<b>Alloy</b>	Pb Sb alloy
<b>Technology</b>	Cast and cold worked
<b>Lab number of sample</b>	None
<b>Sample location</b>	HE-Arc CR, Neuchâtel, Neuchâtel
<b>Responsible institution</b>	HE-Arc CR, Neuchâtel, Neuchâtel
<b>Date and aim of sampling</b>	None

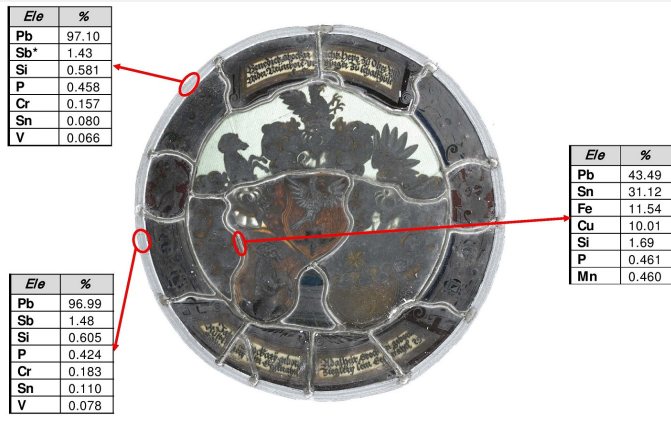
Fig. 6: XRF analyses of a selection of the comes,

XRF analyses of the different lead comes of the "Stokar" stained glass panel showed that the tin (Sn) content is very variable from one came to another (Fig. 6). Those with a very low Sn but a high Sb (1.4%) contents are much more corroded.

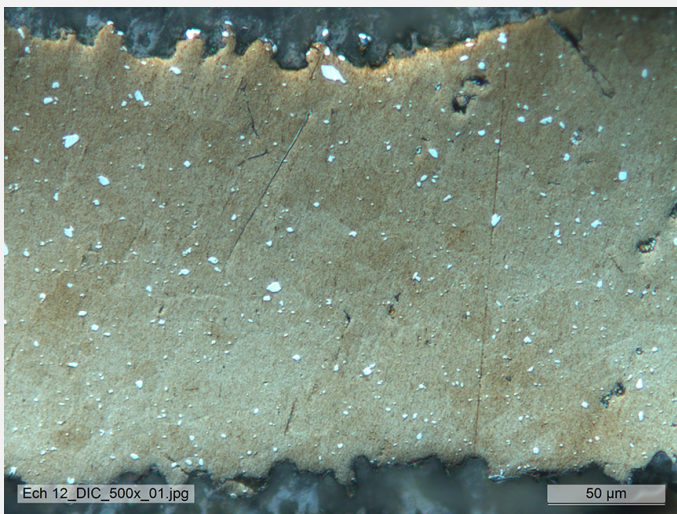
The lead alloy contains approximately 1.5% antimony. The grains of the metal are slightly visible, even without etching. The light-coloured dots in the alloy are Sb-rich inclusions (Fig. 7).

Fig. 7: Micrograph (detail of Fig. 5), unetched, dark field,

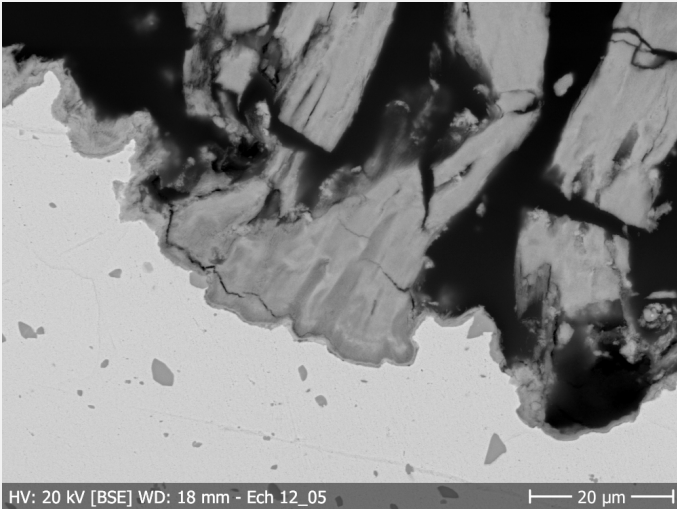
CP1 seems to be a heterogeneous compound as indicated on Figs. 8 and 9. It is heavily cracked (Fig. 9). EDX analyses do not indicate a significant difference in composition. The attack of lead by organic acids causes the formation of salts, such as lead acetate which are then transformed into basic lead carbonates by the action of CO<sub>2</sub> from the environment as indicated by FTIR analysis of CP1.

Fig. 9: SEM image (BSE mode) of the cross-section of the corroded lead came,

Fig. 11 shows an optimised stratigraphic representation of the corrosion structure. It is to be noted that CP1, CP2 and CP3 although visible on some cross-sections (Fig. 9) could not be differentiated by analysis.

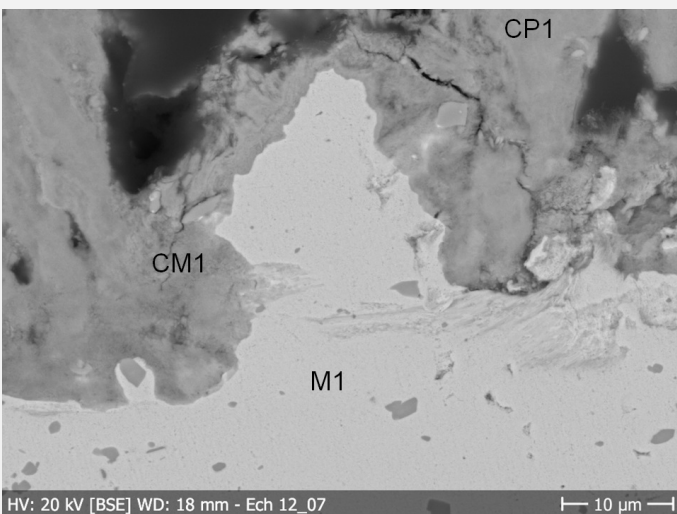
Corrosion develops specifically on comes made of a lead-antimony alloy, where antimony inclusions constitute the cathode (0.150 V/SHE) versus lead (-0.125 V/SHE) which corrodes as an anode in presence of lead acetate (the electrolyte). Fig. 8 shows that corrosion does not attack the antimony nodules in the alloy, it progresses by mineralizing the lead around these nodules.

Fig. 8: SEM image (BSE mode) of a detail of the cross-section of the corroded lead came. The area in light grey is the metal, the corrosion is in darker grey with a blurred appearance. Sb-dots are dark grey. Corrosion progresses around them, without mineralising them,

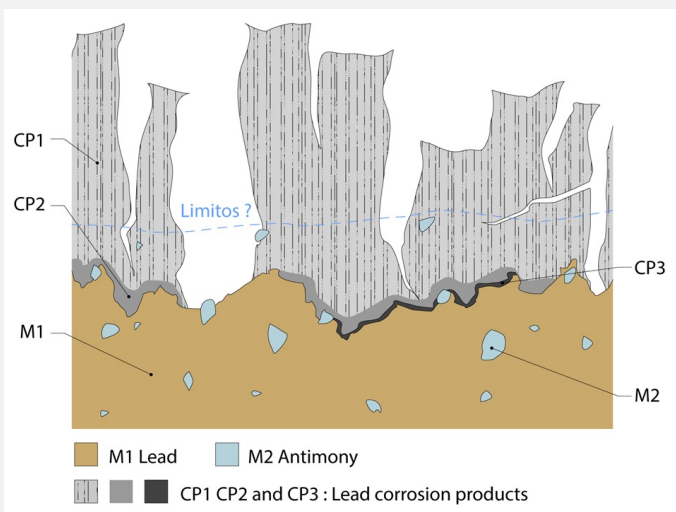
The limit of the original surface lies somewhere in the corrosion layers. Antimony nodules are inferior markers of the limit of the original surface.

Fig. 11: Optimised stratigraphic representation of a corroded lead came integrating additional information based on the analyses carried out,

The lead came is heavily corroded and its original surface contained in the thick and very fragile corrosion layer might get lost easily in case of any physical shock.
