ANTHROPOMORPHIC VASE – AG ALLOY – ROMAN TIMES

Artefact name Anthropomorphic vase

Authors (HE-Arc CR, Neuchâtel, Neuchâtel, Switzerland). (Christian Degrigny, None) & Solène. Béguelin (HE-Arc CR, Neuchâtel, Neuchâtel, Switzerland) & Valentin. Boissonnas (HE-Arc CR, Neuchâtel, Neuchâtel, Switzerland)

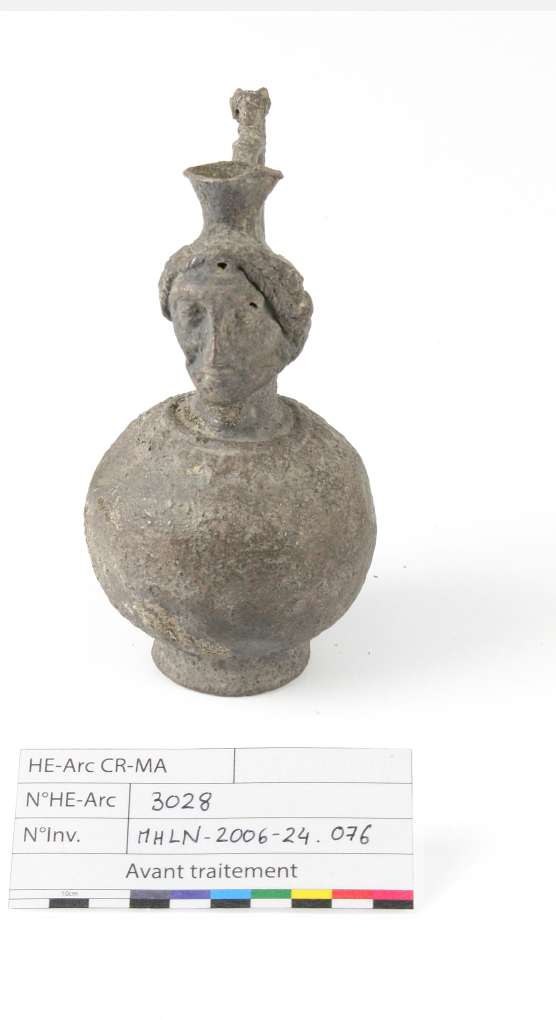
Fig. 1: Front of the vase,

Description of the artefact	This archaeological anthropomorphic vase has a round body topped by a woman's face. At the top of the handle is a ram's head. The object is covered with a brown-grey corrosion layer. The metal surface is deformed on the face and the body. H = 15.5cm ; Ø = 26cm.
Type of artefact	Vessel
Origin	Unknown
Recovering date	Date unknown
Chronology category	Roman Times
chronology tpq	<input type="text"/> ---- ▾
chronology taq	<input type="text"/> ---- ▾
Chronology comment	
Burial conditions / environment	Soil
Artefact location	Musée d'Art et d'Histoire de la Neuveville, La Neuveville, Bern
Owner	Musée d'Art et d'Histoire de la Neuveville, La Neuveville, Bern
Inv. number	MHLN-2006-24.076
Recorded conservation data	A conservation-restoration treatment was carried out in 2023. The object underwent mechanical and chemical treatment (alkaline dithionite baths).

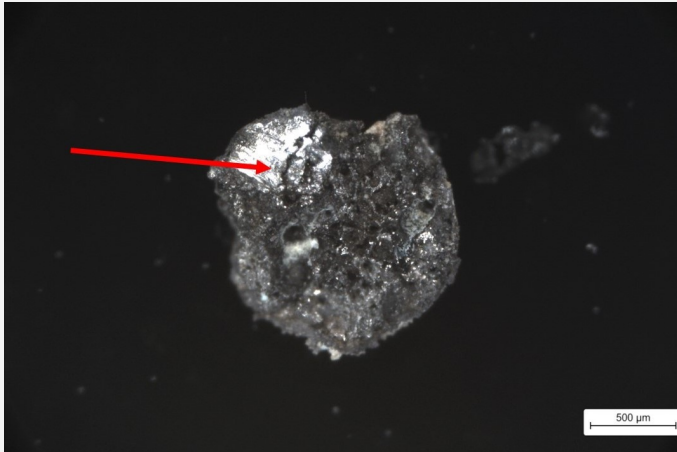
Fig. 5: Micrograph of sample 1 (Fig. 2) of the vase showing a blister (the red arrow corresponds to the area where EDX analysis was carried out),

Based on the elemental chemical distribution, we can interpret better the EDX results of samples from Figs. 5 to 8. Indeed, blisters (Fig. 5) consist mainly of silver polluted on its surface with bromine and chlorine (Fig. 17). As for the piece of mineralised metal (Fig. 8), it also consists largely of silver, bromine and chlorine (same corrosion products as the blister). This is rather typical for such an archaeological object recovered from the ground (Marchand et al., 2014). The concretion (Fig. 6) is made up of carbon, oxygen, sodium, silicon, aluminium, calcium, a little potassium and phosphorus, also from the burial context. The black element (Fig. 7) could be likened to mica or feldspath (Figs. 16 and 17 with detail in Fig. 12). There is magnesium, silicon and oxygen, again from the environment in which the object was buried.

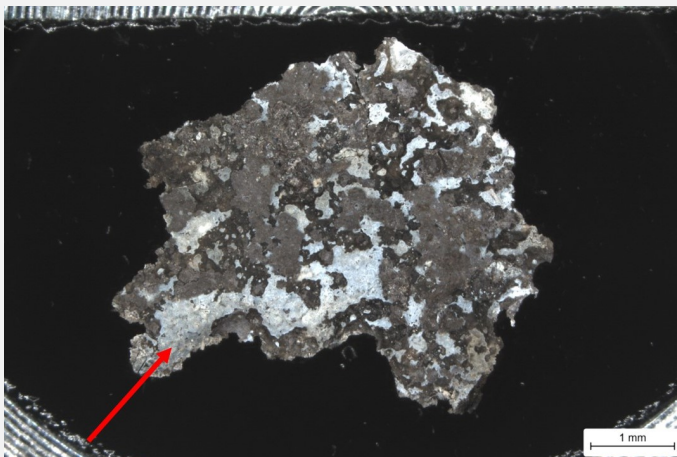
Fig. 6: Micrograph of sample 2 (Fig. 2) of the vase showing a concretion (the red arrow corresponds to the area where EDX analysis was carried out),

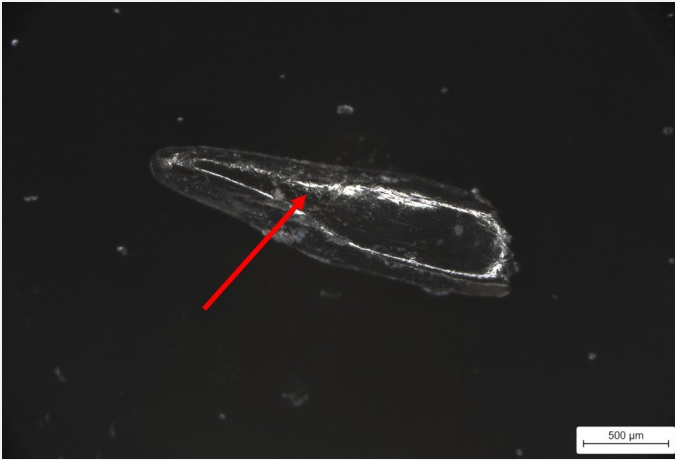
Fig. 7: Micrograph of sample 3 (Fig. 2) of the vase showing a small black element (the red arrow corresponds to the area where EDX analysis was carried out),

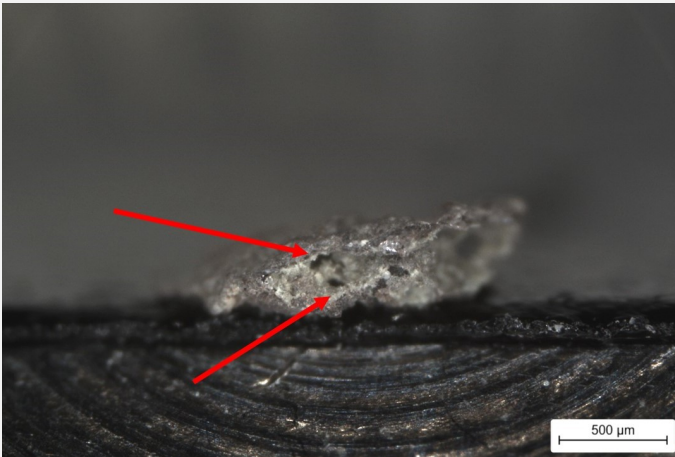
Fig. 8: Micrograph of sample 4 (Fig. 2) of the vase showing a piece of mineralized metal (the red arrows correspond to the areas where EDX analyses were carried out),

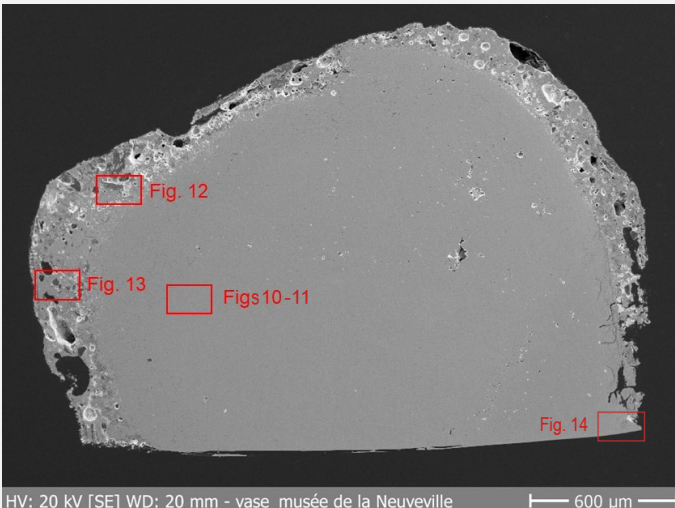
Fig. 9: SEM picture (SE mode) of the cross-section of the vase showing the location of Figs.10 to 14, unetched,

The cross-section embedded corresponds to a transversal cut made on the foot of the container (Fig. 2). A metallic core is present below the corrosion layers (Fig. 9).

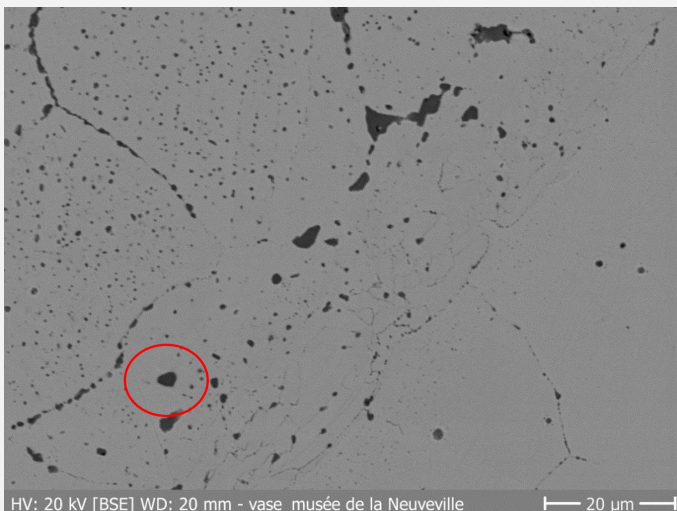
The base metal consists of 1.5% copper, 1.8% zinc and 96.7% silver by weight. Silver is therefore only lightly alloyed. The zinc and copper are in the form of inclusions (Figs. 10 and 11). The grains are clearly visible, copper and zinc have precipitated in the grain boundaries and develop intergranular corrosion (Fig. 13). Iron inclusions are also visible in places (Fig. 12). The presence of bromine and chlorine has been attested (Fig. 13).

Fig. 11: SEM picture (BSE mode) of the metal sample from Fig. 9 (detail), with copper inclusion,

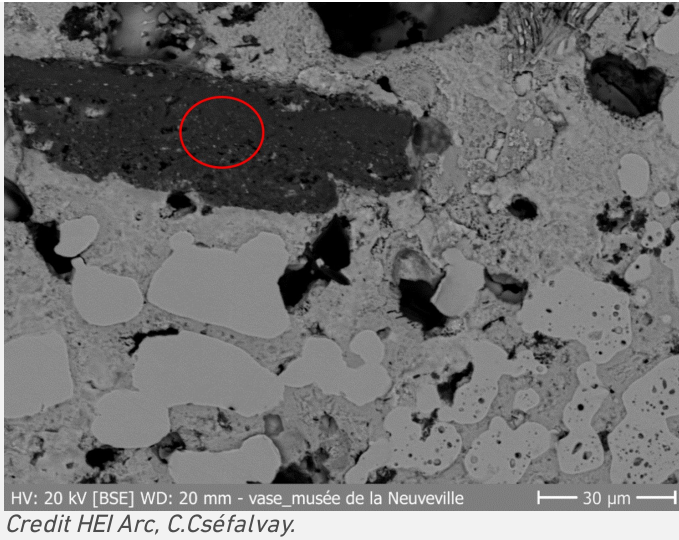
Fig. 12: SEM picture (BSE mode) of the metal sample from Fig. 9 (detail), with iron inclusion,

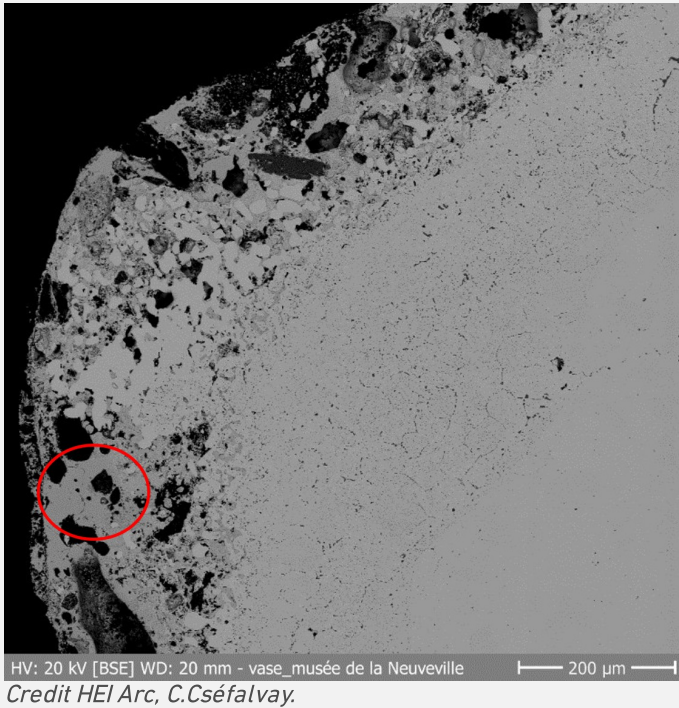
Fig. 13: SEM picture (BSE mode) of the metal sample from Fig. 9 (detail) with high amount of silver, bromine and chlorine in the red circle,

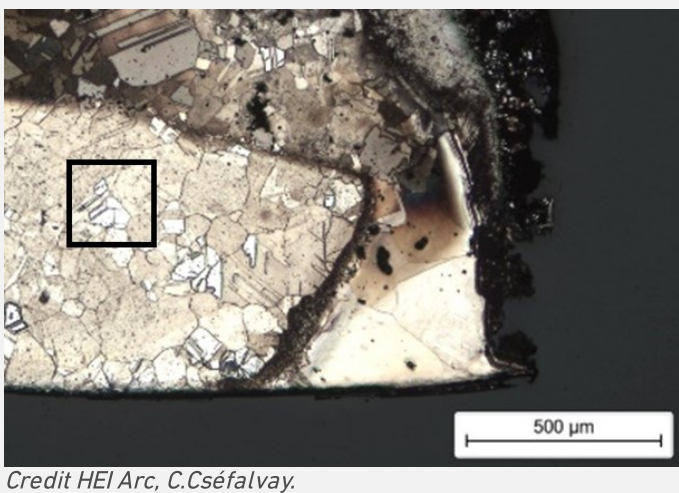
As a result of the chemical attack, various structures are visible. We can see twin lines (Fig. 14), which means that the structure has been several times annealed after hammering. We can also see in some places the presence of strain lines, which characterise the final hammering of a structure without annealing (Scott, 1991).

Fig.14 : Micrograph of the sample after etching. Twin lines are clearly visible in the black square,

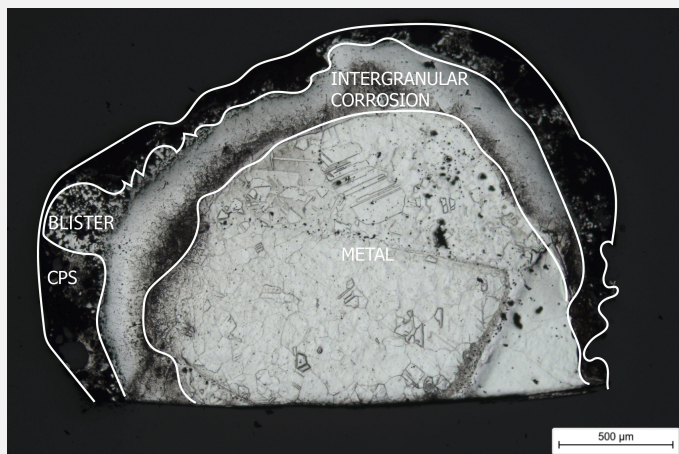
Observation of the cross-section under a microscope does not clearly distinguish the different corrosion layers on the vase. We can see a continuous, dark brown corrosion layer. The area where the sample was taken does not contain any light green or red corrosion. On the other hand, we can see that the silver forms a sort of blister which makes it difficult to distinguish the limit of the original surface (Fig. 15).

Fig. 15: Micrograph of the corrosion structure from Fig. 9 with the subdivision of the different strata,

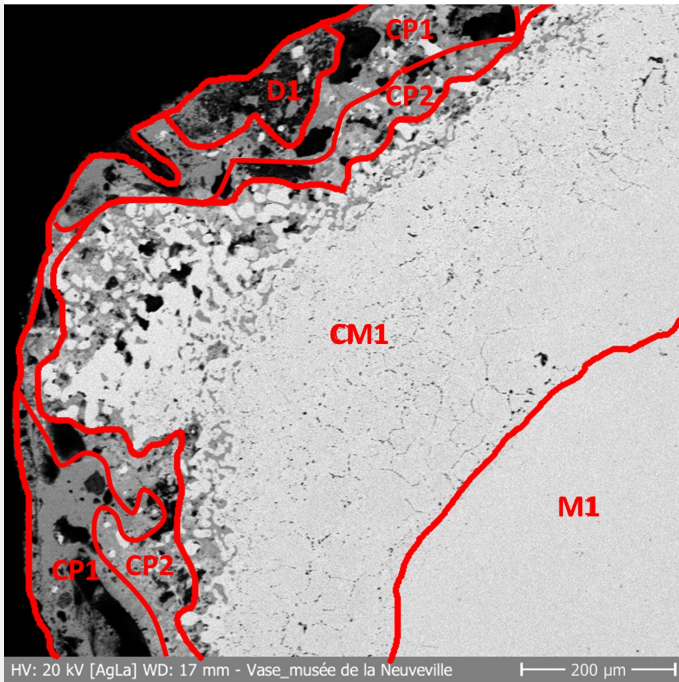
Mapping using SEM-EDS shows that the corrosion layer consists mainly of silver, bromine and chlorine, with a larger amount of chlorine next to the metal surface (CP2 in Fig. 16). There are also inclusions of calcium, iron, chromium and lead combined with oxygen. Secondly, we can see the formation of intergranular corrosion with the presence of copper and zinc at the grain boundaries (Figs. 16 to 17).

Fig. 16: Elemental distribution of Ag within the corrosion structure from Fig. 15 (detail) with the subdivision of the different strata,

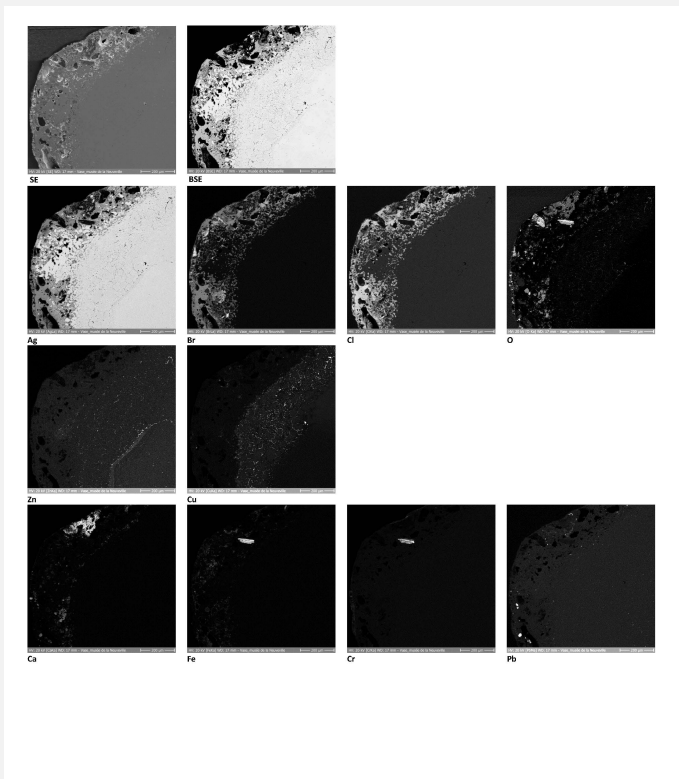
Fig. 17: SEM picture (BSE-mode) similar to Fig. 16 (detail of Fig. 15) and elemental chemical distribution,

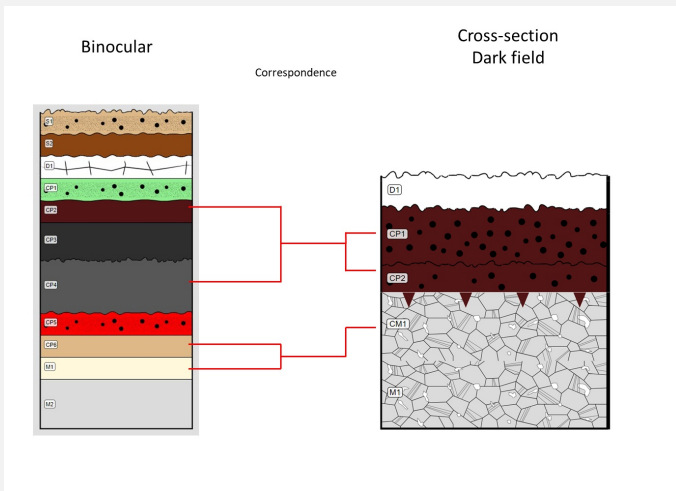
Fig. 20: Stratigraphic representation side by side of binocular view and cross-section (dark field),
