ANTHROPOMORPHIC VASE – AG ALLOY – ROMAN TIMES

Artefact name Anthropomorphic vase

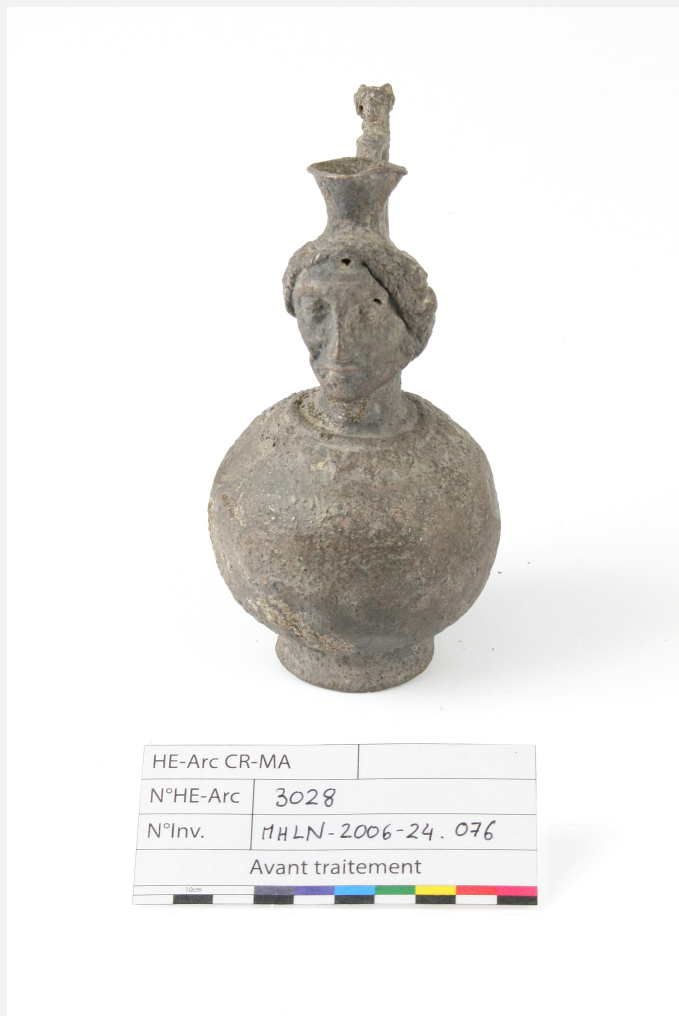
Fig. 1: Front of the vase,

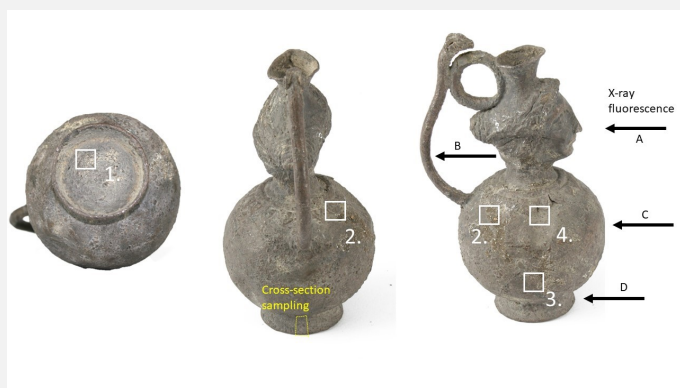
Fig. 2: Locations of the four points analysed with X-ray fluorescence (black arrows A-D), the four samples (numbers 1-4) and the cross-section (yellow) analysed with SEM-EDS,

The XRF analysis of the vase was carried out before sampling on four areas (Fig. 2). During the analysis, the layers of soil, corrosion and metal are analysed at the same time. The metal is probably a silver alloy with a small amount of Cu (and possibly Bi?). Some of the other elements detected are part of the burial environment (Al, Si, Fe, Cr) and corrosion products (Br, Cl). Titanium is probably an artefact.

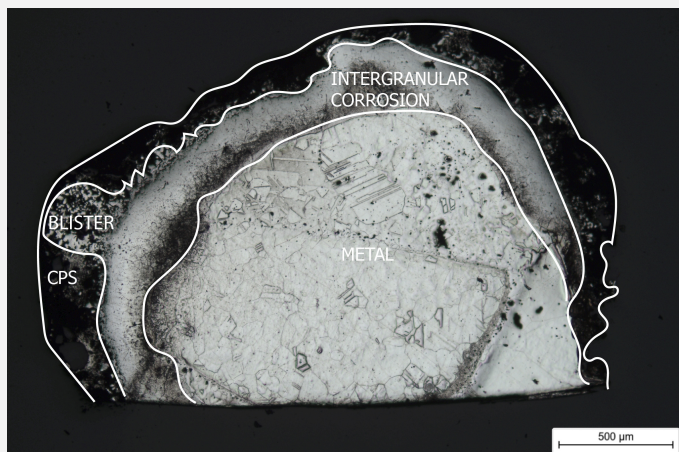
Observation of the cross-section under a microscope does not clearly distinguish the different corrosion layers on the vase. We can see a continuous, dark brown corrosion layer. The area where the sample was taken does not contain any light green or red corrosion. On the other hand, we can see that the silver forms a sort of blister which makes it difficult to distinguish the limit of the original surface (Fig. 15).

Fig. 15: Micrograph of the corrosion structure from Fig. 9 with the subdivision of the different strata,
