ANTHROPOMORPHIC VASE – AG ALLOY – ROMAN TIMES

Artefact name Anthropomorphic vase

Authors (HE-Arc CR, Neuchâtel, Neuchâtel, Switzerland). (Christian Degriigny, None) & Solène. Béguelin (HE-Arc CR, Neuchâtel, Neuchâtel, Switzerland) & Valentin. Boissonnas (HE-Arc CR, Neuchâtel, Neuchâtel, Switzerland)

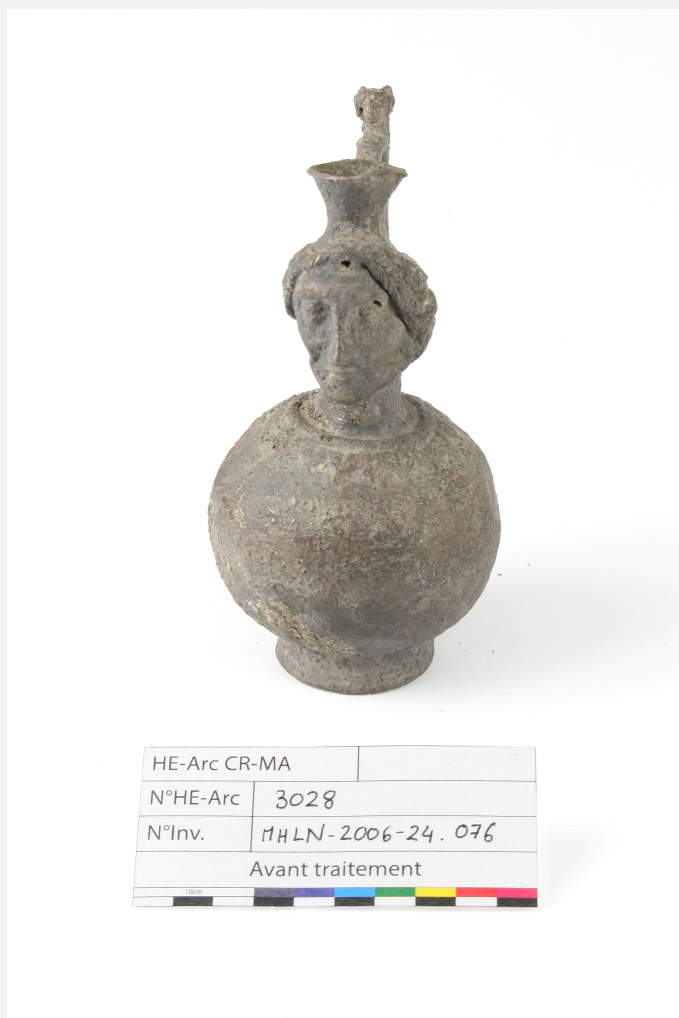
Fig. 1: Front of the vase,

Description of the artefact	This archaeological anthropomorphic vase has a round body topped by a woman's face. At the top of the handle is a ram's head. The object is covered with a brown-grey corrosion layer. The metal surface is deformed on the face and the body. H = 15.5cm ; Ø = 26cm.
Type of artefact	Vessel
Origin	Unknown
Recovering date	Date unknown
Chronology category	Roman Times
chronology tpq	<input type="text"/> ---- ▾
chronology taq	<input type="text"/> ---- ▾
Chronology comment	
Burial conditions / environment	Soil
Artefact location	Musée d'Art et d'Histoire de la Neuveville, La Neuveville, Bern
Owner	Musée d'Art et d'Histoire de la Neuveville, La Neuveville, Bern
Inv. number	MHLN-2006-24.076
Recorded conservation data	A conservation-restoration treatment was carried out in 2023. The object underwent mechanical and chemical treatment (alkaline dithionite baths).

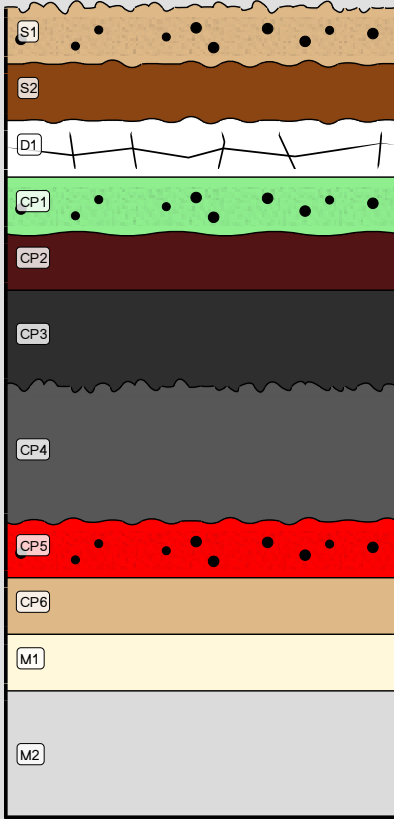
Fig. 4: Stratigraphic representation of the corrosion structure of the vase observed macroscopically under binocular microscope using the MiCorr application with reference to Fig. 3. The characteristics of the strata are only accessible by clicking on the drawing that redirects you to the search tool by stratigraphy representation, credit HE-Arc CR, S.Béguelin.
