ANTHROPOMORPHIC VASE – AG ALLOY – ROMAN TIMES

Artefact name Anthropomorphic vase

Authors (HE-Arc CR, Neuchâtel, Neuchâtel, Switzerland). (Christian Degriigny, None) & Solène. Béguelin (HE-Arc CR, Neuchâtel, Neuchâtel, Switzerland) & Valentin. Boissonnas (HE-Arc CR, Neuchâtel, Neuchâtel, Switzerland)

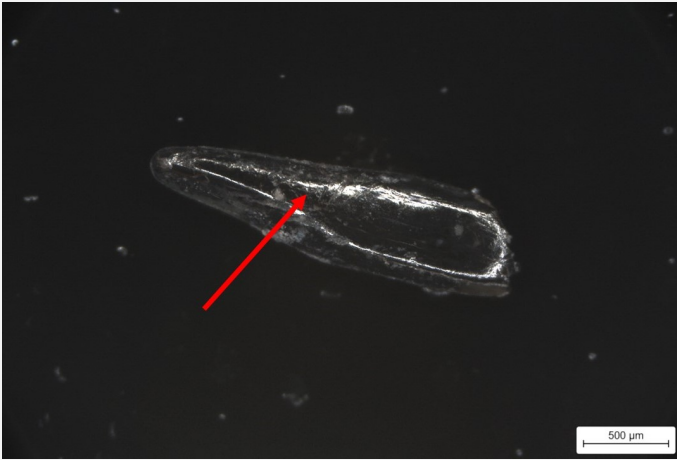
Fig. 7: Micrograph of sample 3 (Fig. 2) of the vase showing a small black element (the red arrow corresponds to the area where EDX analysis was carried out),

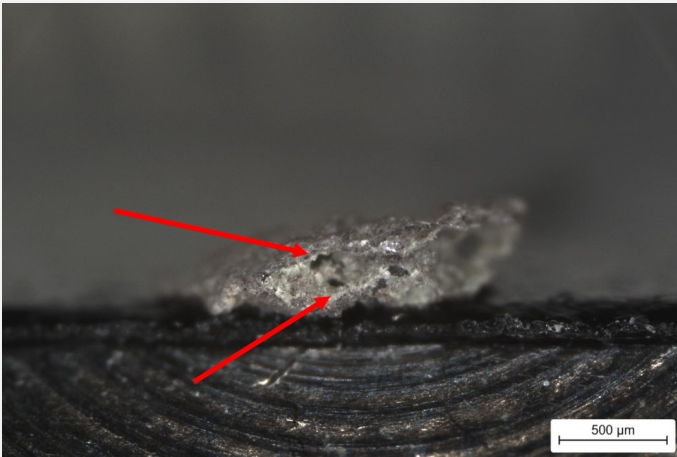
Fig. 8: Micrograph of sample 4 (Fig. 2) of the vase showing a piece of mineralized metal (the red arrows correspond to the areas where EDX analyses were carried out),

Based on the elemental chemical distribution, we can interpret better the EDX results of samples from Figs. 5 to 8. Indeed, blisters (Fig. 5) consist mainly of silver polluted on its surface with bromine and chlorine (Fig. 17). As for the piece of mineralised metal (Fig. 8), it also consists largely of silver, bromine and chlorine (same corrosion products as the blister). This is rather typical for such an archaeological object recovered from the ground (Marchand et al., 2014). The concretion (Fig. 6) is made up of carbon, oxygen, sodium, silicon, aluminium, calcium, a little potassium and phosphorus, also from the burial context. The black element (Fig. 7) could be likened to mica or feldspath (Figs. 16 and 17 with detail in Fig. 12). There is magnesium, silicon and oxygen, again from the environment in which the object was buried.

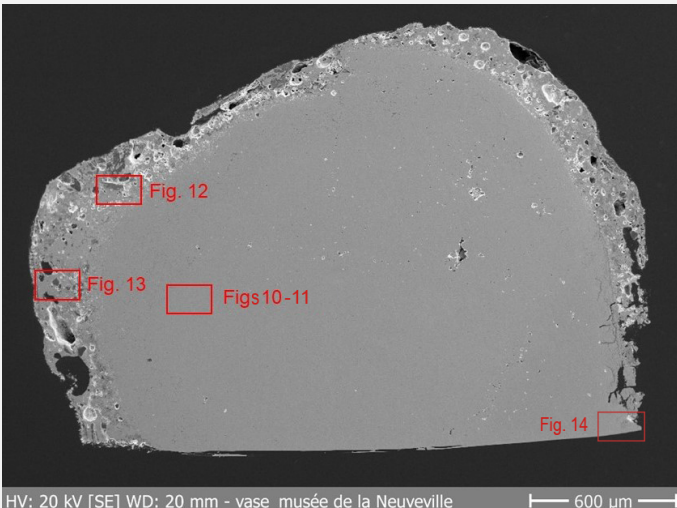
Fig. 9: SEM picture (SE mode) of the cross-section of the vase showing the location of Figs.10 to 14, unetched,

The cross-section embedded corresponds to a transversal cut made on the foot of the container (Fig. 2). A metallic core is present below the corrosion layers (Fig. 9).

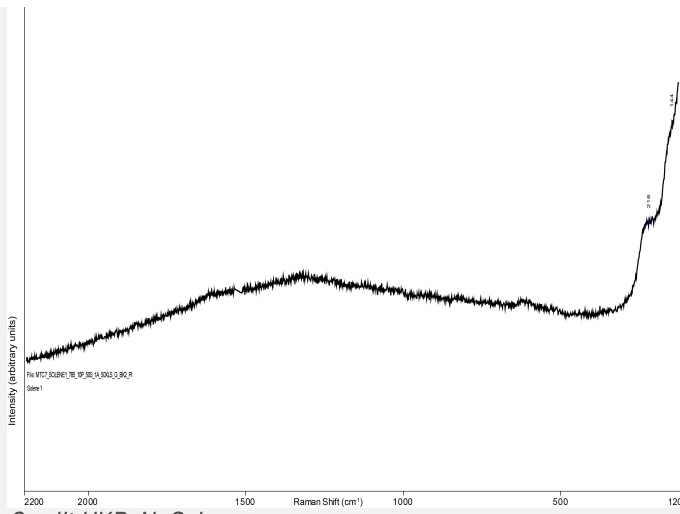
Raman analysis was carried out on a sample of mineralised metal (Fig. 18). The spectrum obtained does not correspond to those presented in the literature for silver chloride. Therefore, it remains a hypothesis.

Fig. 18: Raman spectrum of the mineralised metal sample (Fig. 8) possibly silver chloride,
