## ANTHROPOMORPHIC VASE – AG ALLOY – ROMAN TIMES

**Artefact name** Anthropomorphic vase

**Authors** (HE-Arc CR, Neuchâtel, Neuchâtel, Switzerland). (Christian Degrigny, None) & Solène. Béguelin (HE-Arc CR, Neuchâtel, Neuchâtel, Switzerland) & Valentin. Boissonnas (HE-Arc CR, Neuchâtel, Neuchâtel, Switzerland)

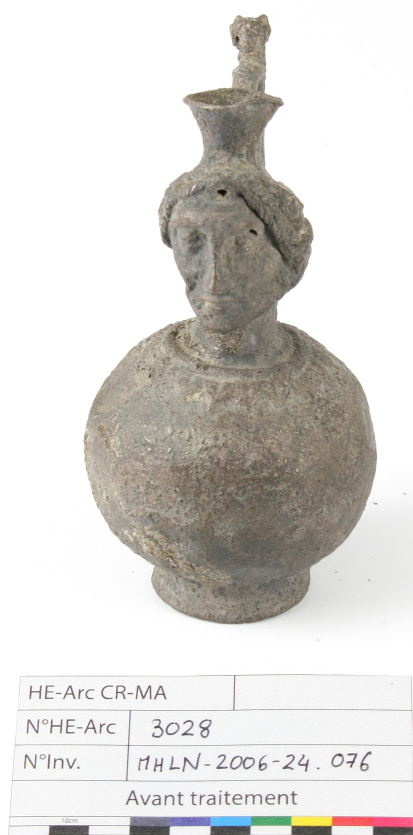
Fig. 1: Front of the vase,

<b>Description of the artefact</b>	This archaeological anthropomorphic vase has a round body topped by a woman's face. At the top of the handle is a ram's head. The object is covered with a brown-grey corrosion layer. The metal surface is deformed on the face and the body. H = 15.5cm ; Ø = 26cm.
<b>Type of artefact</b>	Vessel
<b>Origin</b>	Unknown
<b>Recovering date</b>	Date unknown
<b>Chronology category</b>	Roman Times
<b>chronology tpq</b>	<input type="text"/> ---- ▼
<b>chronology taq</b>	<input type="text"/> ---- ▼
<b>Chronology comment</b>	
<b>Burial conditions / environment</b>	Soil
<b>Artefact location</b>	Musée d'Art et d'Histoire de la Neuveville, La Neuveville, Bern
<b>Owner</b>	Musée d'Art et d'Histoire de la Neuveville, La Neuveville, Bern
<b>Inv. number</b>	MHLN-2006-24.076
<b>Recorded conservation data</b>	A conservation-restoration treatment was carried out in 2023. The object underwent mechanical and chemical treatment (alkaline dithionite baths).

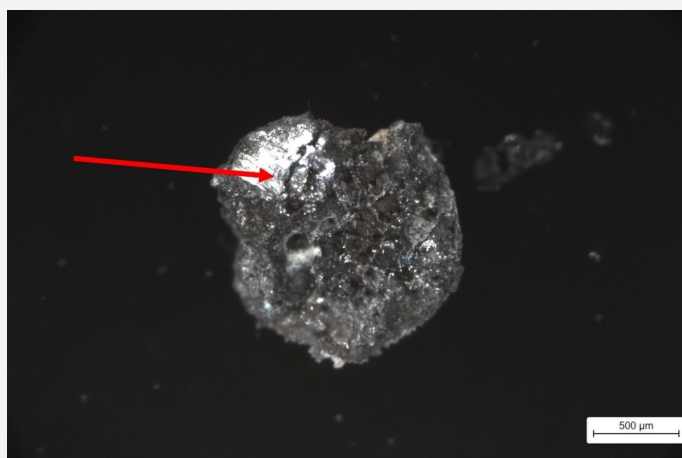
Fig. 5: Micrograph of sample 1 (Fig. 2) of the vase showing a blister (the red arrow corresponds to the area where EDX analysis was carried out),

Based on the elemental chemical distribution, we can interpret better the EDX results of samples from Figs. 5 to 8. Indeed, blisters (Fig. 5) consist mainly of silver polluted on its surface with bromine and chlorine (Fig. 17). As for the piece of mineralised metal (Fig. 8), it also consists largely of silver, bromine and chlorine (same corrosion products as the blister). This is rather typical for such an archaeological object recovered from the ground (Marchand et al., 2014). The concretion (Fig. 6) is made up of carbon, oxygen, sodium, silicon, aluminium, calcium, a little potassium and phosphorus, also from the burial context. The black element (Fig. 7) could be likened to mica or feldspath (Figs. 16 and 17 with detail in Fig. 12). There is magnesium, silicon and oxygen, again from the environment in which the object was buried.

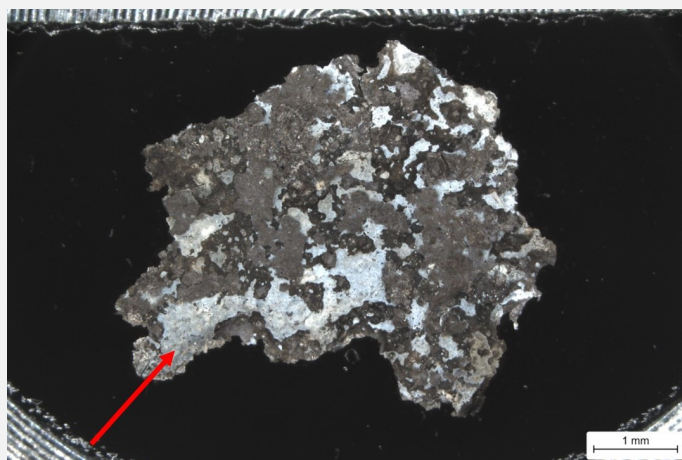
Fig. 6: Micrograph of sample 2 (Fig. 2) of the vase showing a concretion (the red arrow corresponds to the area where EDX analysis was carried out),

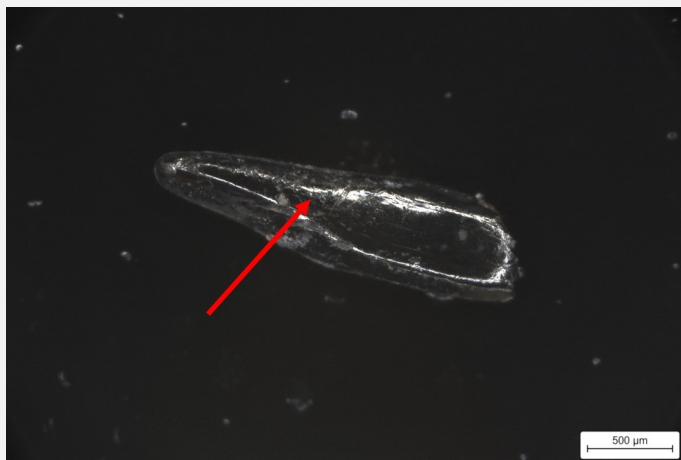
Fig. 7: Micrograph of sample 3 (Fig. 2) of the vase showing a small black element (the red arrow corresponds to the area where EDX analysis was carried out),

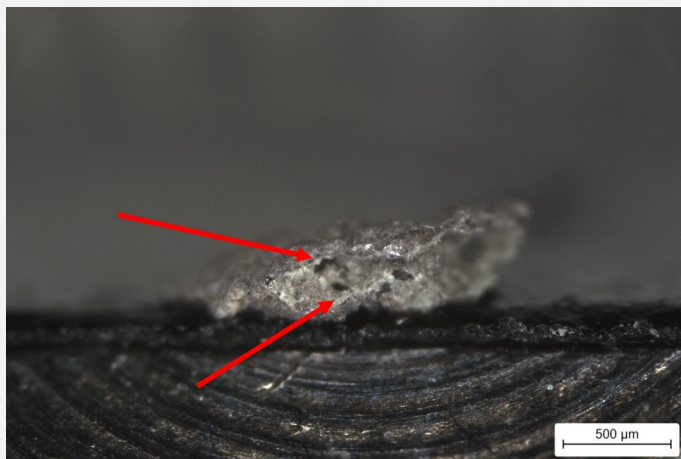
Fig. 8: Micrograph of sample 4 (Fig. 2) of the vase showing a piece of mineralized metal (the red arrows correspond to the areas where EDX analyses were carried out),

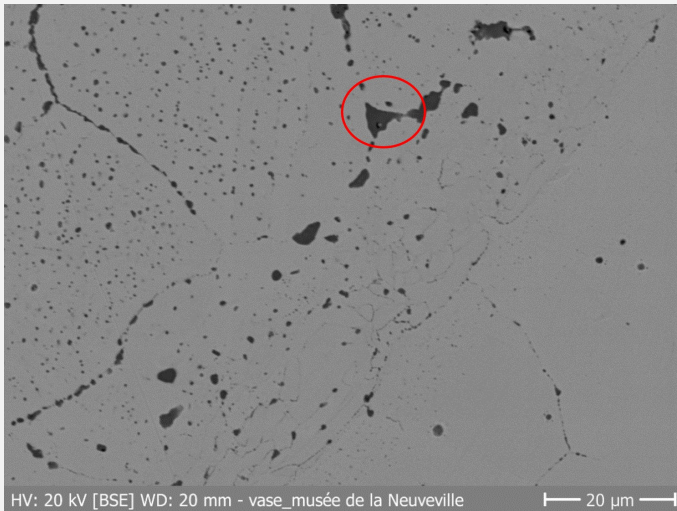
The base metal consists of 1.5% copper, 1.8% zinc and 96.7% silver by weight. Silver is therefore only lightly alloyed. The zinc and copper are in the form of inclusions (Figs. 10 and 11). The grains are clearly visible, copper and zinc have precipitated in the grain boundaries and develop intergranular corrosion (Fig. 13). Iron inclusions are also visible in places (Fig. 12). The presence of bromine and chlorine has been attested (Fig. 13).

Fig. 10: SEM picture (BSE mode) of the metal sample from Fig. 9 (detail), with zinc inclusion,

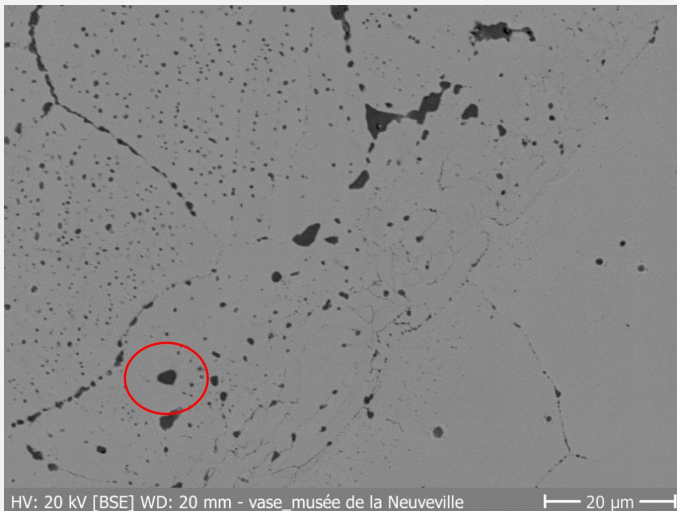
Fig. 11: SEM picture (BSE mode) of the metal sample from Fig. 9 (detail), with copper inclusion,

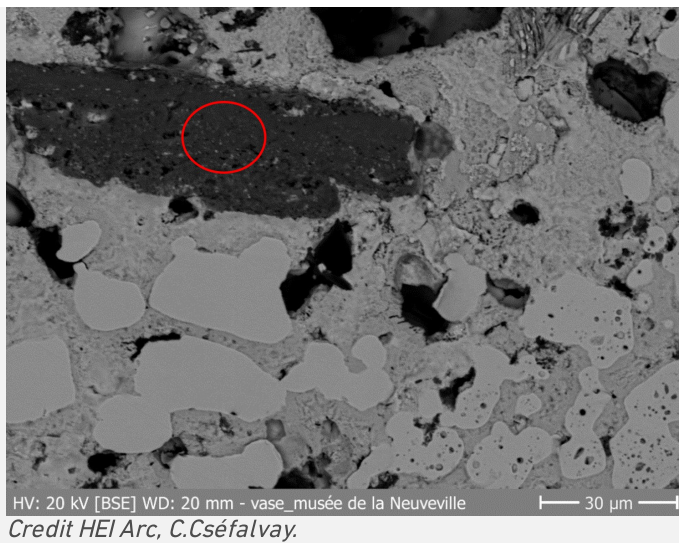
Fig. 12: SEM picture (BSE mode) of the metal sample from Fig. 9 (detail), with iron inclusion,

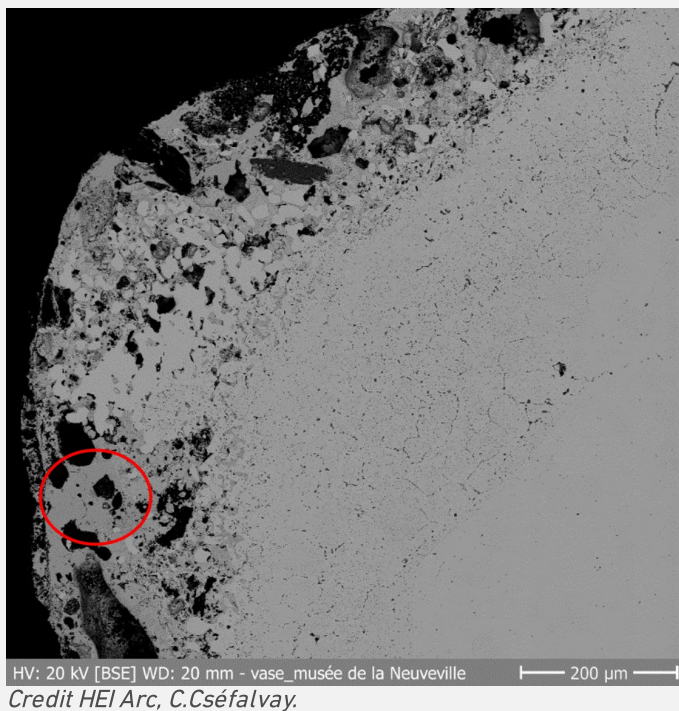
Fig. 13: SEM picture (BSE mode) of the metal sample from Fig. 9 (detail) with high amount of silver, bromine and chlorine in the red circle,

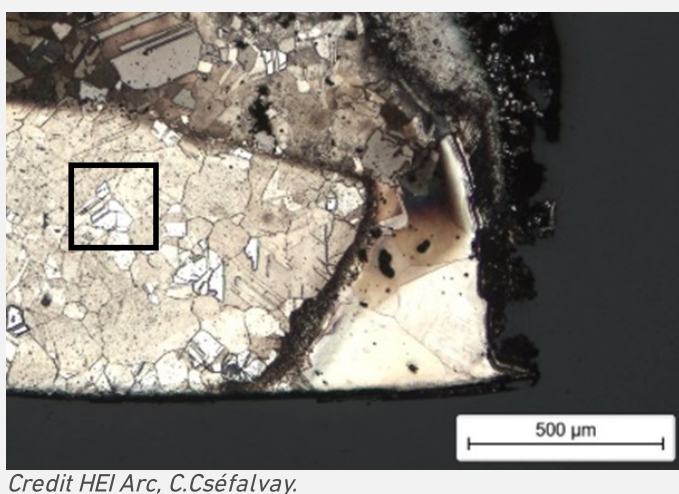
As a result of the chemical attack, various structures are visible. We can see twin lines (Fig. 14), which means that the structure has been several times annealed after hammering. We can also see in some places the presence of strain lines, which characterise the final hammering of a structure without annealing (Scott, 1991).

Fig.14 : Micrograph of the sample after etching. Twin lines are clearly visible in the black square,

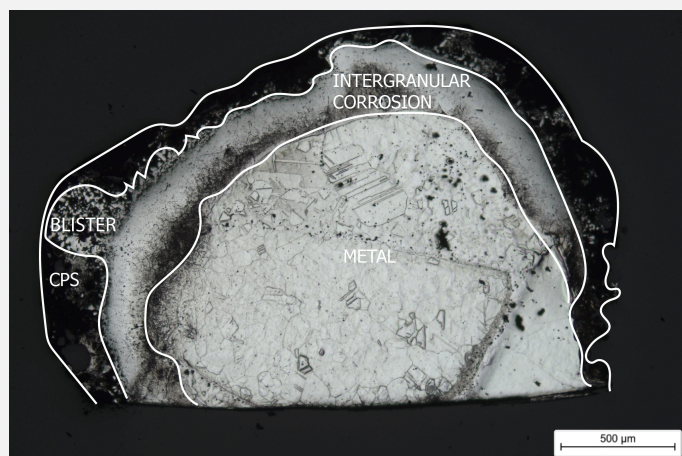
Observation of the cross-section under a microscope does not clearly distinguish the different corrosion layers on the vase. We can see a continuous, dark brown corrosion layer. The area where the sample was taken does not contain any light green or red corrosion. On the other hand, we can see that the silver forms a sort of blister which makes it difficult to distinguish the limit of the original surface (Fig. 15).

Fig. 15: Micrograph of the corrosion structure from Fig. 9 with the subdivision of the different strata,

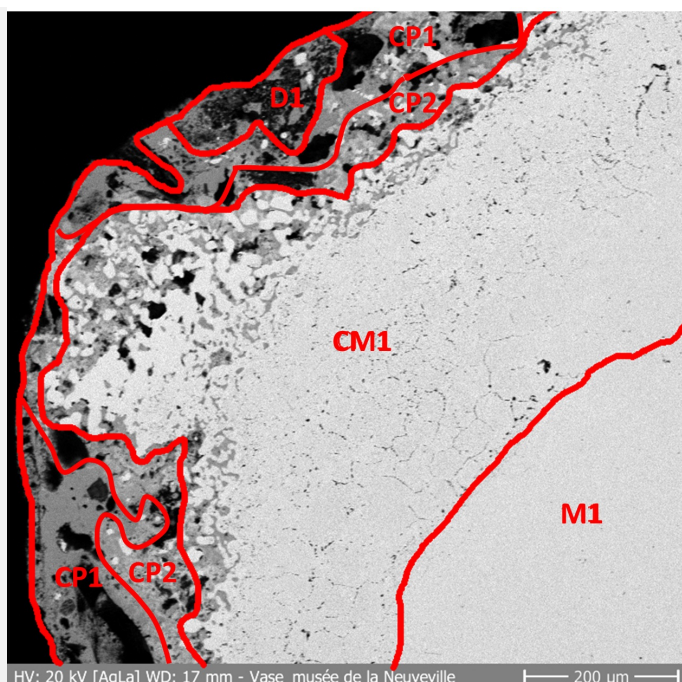
Mapping using SEM-EDS shows that the corrosion layer consists mainly of silver, bromine and chlorine, with a larger amount of chlorine next to the metal surface (CP2 in Fig. 16). There are also inclusions of calcium, iron, chromium and lead combined with oxygen. Secondly, we can see the formation of intergranular corrosion with the presence of copper and zinc at the grain boundaries (Figs. 16 to 17).

Fig. 16: Elemental distribution of Ag within the corrosion structure from Fig. 15 (detail) with the subdivision of the different strata,

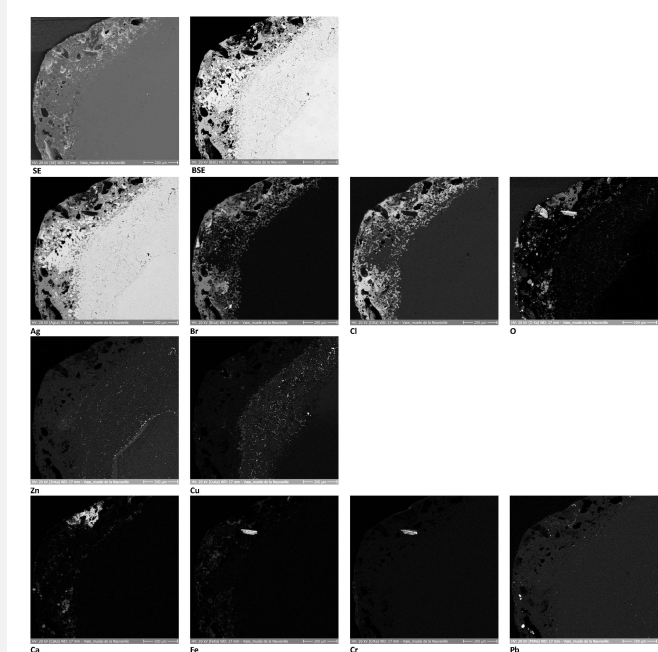
Fig. 17: SEM picture (BSE-mode) similar to Fig. 16 (detail of Fig. 15) and elemental chemical distribution,

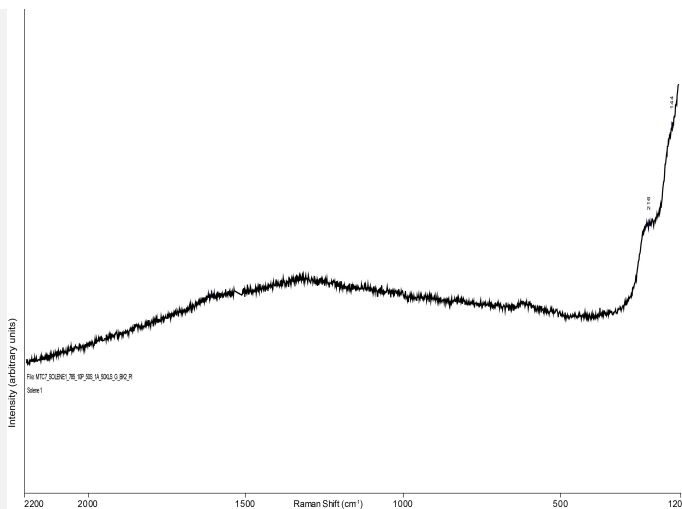
Raman analysis was carried out on a sample of mineralised metal (Fig. 18). The spectrum obtained does not correspond to those presented in the literature for silver chloride. Therefore, it remains a hypothesis.

Fig. 18: Raman spectrum of the mineralised metal sample (Fig. 8) possibly silver chloride,
