## ANTHROPOMORPHIC VASE – AG ALLOY – ROMAN TIMES

**Artefact name** Anthropomorphic vase

**Authors** (HE-Arc CR, Neuchâtel, Neuchâtel, Switzerland). (Christian Degriigny, None) & Solène. Béguelin (HE-Arc CR, Neuchâtel, Neuchâtel, Switzerland) & Valentin. Boissonnas (HE-Arc CR, Neuchâtel, Neuchâtel, Switzerland)

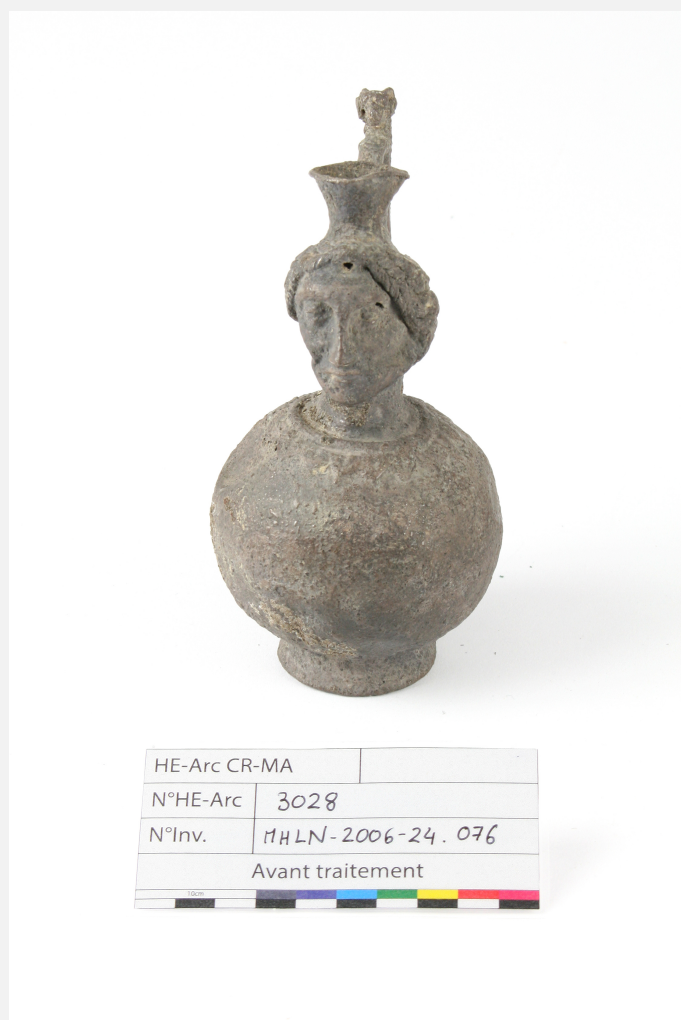
Fig. 1: Front of the vase,

<b>Description of the artefact</b>	This archaeological anthropomorphic vase has a round body topped by a woman's face. At the top of the handle is a ram's head. The object is covered with a brown-grey corrosion layer. The metal surface is deformed on the face and the body. H = 15.5cm ; Ø = 26cm.
<b>Type of artefact</b>	Vessel
<b>Origin</b>	Unknown
<b>Recovering date</b>	Date unknown
<b>Chronology category</b>	Roman Times
<b>chronology tpq</b>	<input type="text"/> ---- ▾
<b>chronology taq</b>	<input type="text"/> ---- ▾
<b>Chronology comment</b>	
<b>Burial conditions / environment</b>	Soil
<b>Artefact location</b>	Musée d'Art et d'Histoire de la Neuveville, La Neuveville, Bern
<b>Owner</b>	Musée d'Art et d'Histoire de la Neuveville, La Neuveville, Bern
<b>Inv. number</b>	MHLN-2006-24.076
<b>Recorded conservation data</b>	A conservation-restoration treatment was carried out in 2023. The object underwent mechanical and chemical treatment (alkaline dithionite baths).

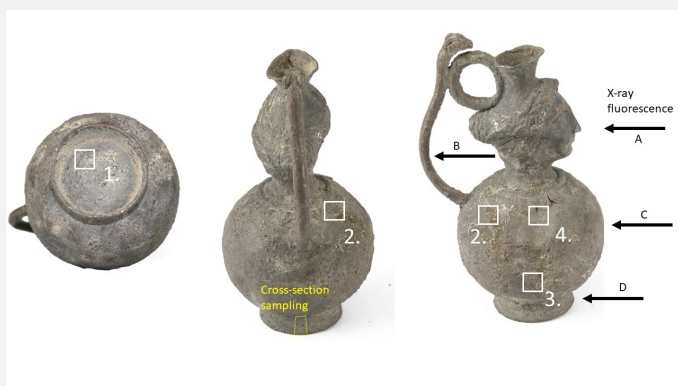
Fig. 2: Locations of the four points analysed with X-ray fluorescence (black arrows A-D), the four samples (numbers 1-4) and the cross-section (yellow) analysed with SEM-EDS,

The XRF analysis of the vase was carried out before sampling on four areas (Fig. 2). During the analysis, the layers of soil, corrosion and metal are analysed at the same time. The metal is probably a silver alloy with a small amount of Cu (and possibly Bi?). Some of the other elements detected are part of the burial environment (Al, Si, Fe, Cr) and corrosion products (Br, Cl). Titanium is probably an artefact.

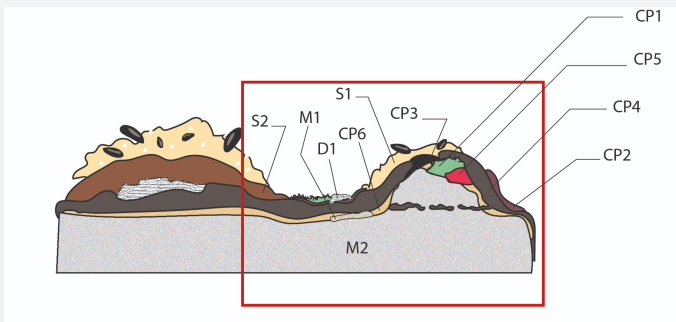
Fig. 3: Stratigraphic representation of the corrosion structure of the vase by macroscopic and binocular observation with indication of the corrosion structure used to build the MiCorr stratigraphy of Fig. 4 (red rectangle),

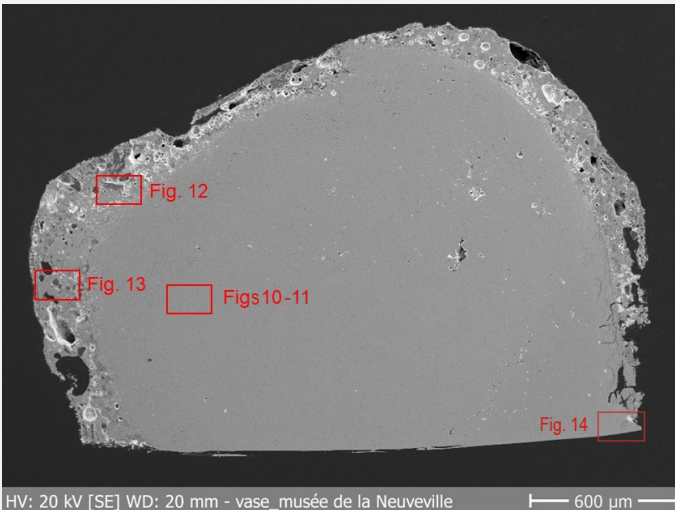
Fig. 9: SEM picture (SE mode) of the cross-section of the vase showing the location of Figs.10 to 14, unetched,

The cross-section embedded corresponds to a transversal cut made on the foot of the container (Fig. 2). A metallic core is present below the corrosion layers (Fig. 9).

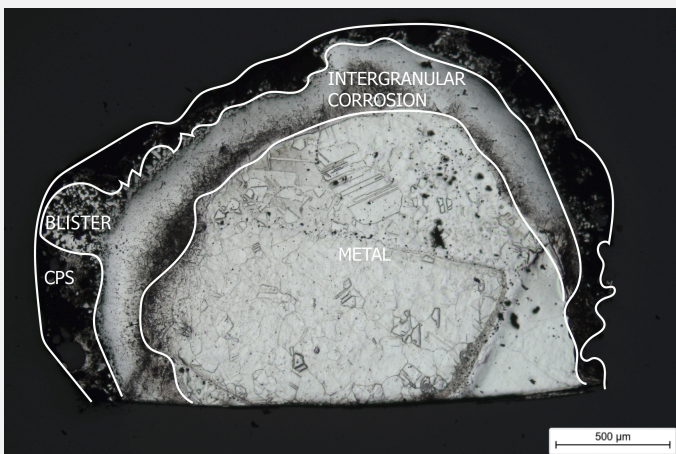
Observation of the cross-section under a microscope does not clearly distinguish the different corrosion layers on the vase. We can see a continuous, dark brown corrosion layer. The area where the sample was taken does not contain any light green or red corrosion. On the other hand, we can see that the silver forms a sort of blister which makes it difficult to distinguish the limit of the original surface (Fig. 15).

Fig. 15: Micrograph of the corrosion structure from Fig. 9 with the subdivision of the different strata,

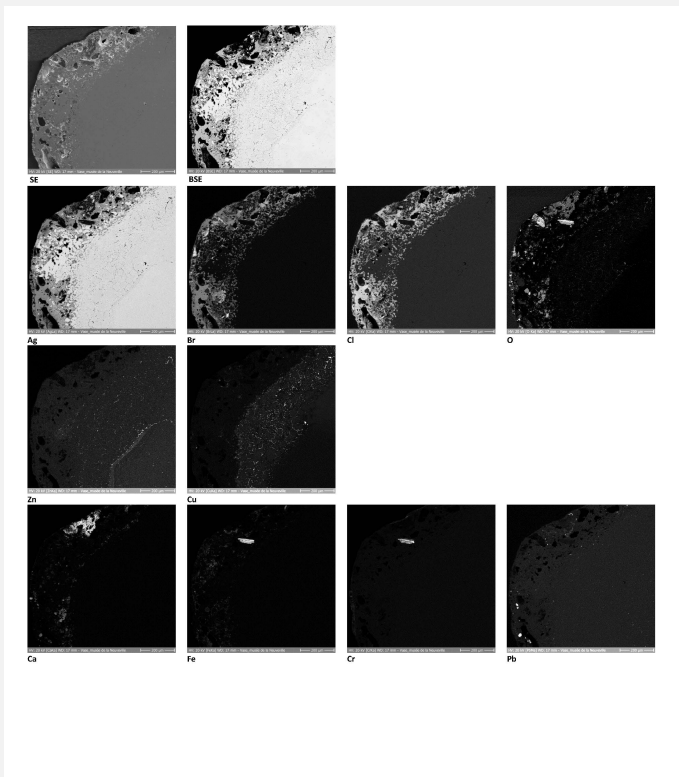
Fig. 17: SEM picture (BSE-mode) similar to Fig. 16 (detail of Fig. 15) and elemental chemical distribution,
