ANTHROPOMORPHIC VASE – AG ALLOY – ROMAN TIMES

Artefact name Anthropomorphic vase

Authors (HE-Arc CR, Neuchâtel, Neuchâtel, Switzerland). (Christian Degriigny, None) & Solène. Béguelin (HE-Arc CR, Neuchâtel, Neuchâtel, Switzerland) & Valentin. Boissonnas (HE-Arc CR, Neuchâtel, Neuchâtel, Switzerland)

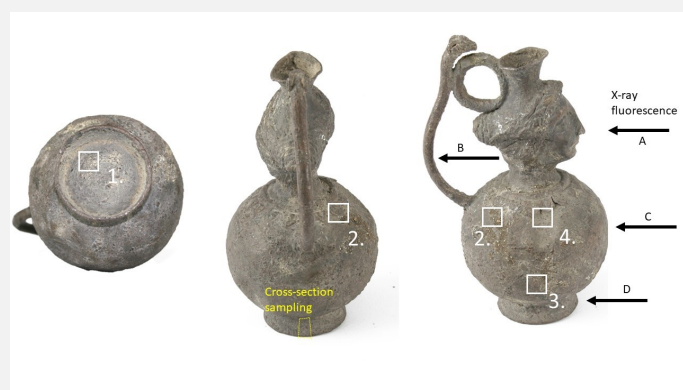
Fig. 2: Locations of the four points analysed with X-ray fluorescence (black arrows A-D), the four samples (numbers 1-4) and the cross-section (yellow) analysed with SEM-EDS,

The XRF analysis of the vase was carried out before sampling on four areas (Fig. 2). During the analysis, the layers of soil, corrosion and metal are analysed at the same time. The metal is probably a silver alloy with a small amount of Cu (and possibly Bi?). Some of the other elements detected are part of the burial environment (Al, Si, Fe, Cr) and corrosion products (Br, Cl). Titanium is probably an artefact.

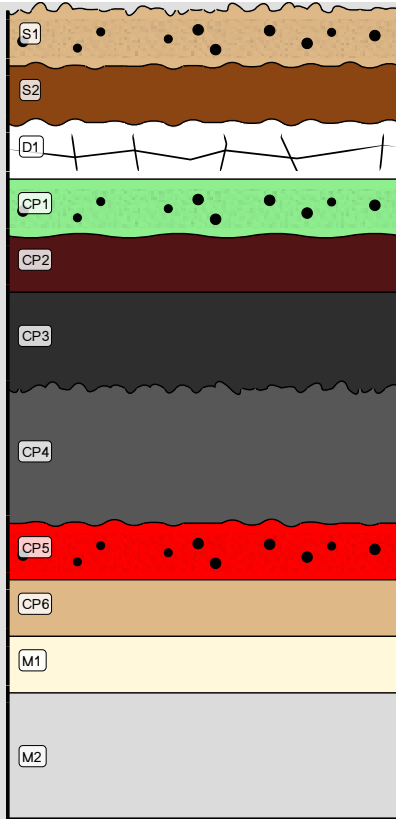
Fig. 4: Stratigraphic representation of the corrosion structure of the vase observed macroscopically under binocular microscope using the MiCorr application with reference to Fig. 3. The characteristics of the strata are only accessible by clicking on the drawing that redirects you to the search tool by stratigraphy representation, credit HE-Arc CR, S.Béguelin.

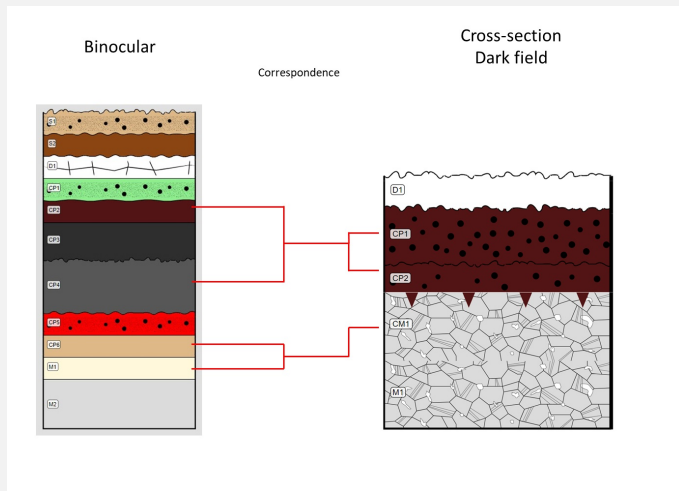
Fig. 20: Stratigraphic representation side by side of binocular view and cross-section (dark field),
