## ANTHROPOMORPHIC VASE – AG ALLOY – ROMAN TIMES

**Artefact name** Anthropomorphic vase

**Authors** (HE-Arc CR, Neuchâtel, Neuchâtel, Switzerland). (Christian Degriigny, None) & Solène. Béguelin (HE-Arc CR, Neuchâtel, Neuchâtel, Switzerland) & Valentin. Boissonnas (HE-Arc CR, Neuchâtel, Neuchâtel, Switzerland)

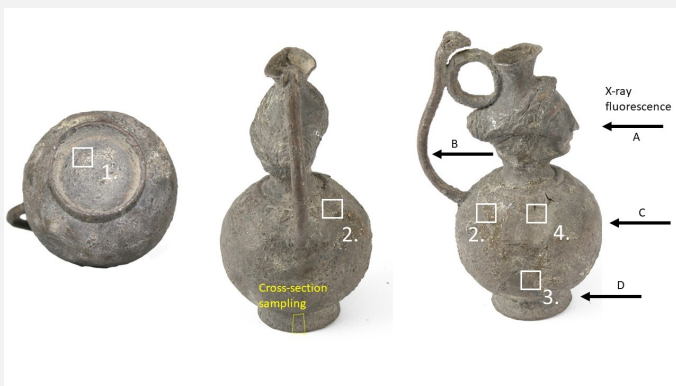
Fig. 2: Locations of the four points analysed with X-ray fluorescence (black arrows A-D), the four samples (numbers 1-4) and the cross-section (yellow) analysed with SEM-EDS,

The XRF analysis of the vase was carried out before sampling on four areas (Fig. 2). During the analysis, the layers of soil, corrosion and metal are analysed at the same time. The metal is probably a silver alloy with a small amount of Cu (and possibly Bi?). Some of the other elements detected are part of the burial environment (Al, Si, Fe, Cr) and corrosion products (Br, Cl). Titanium is probably an artefact.

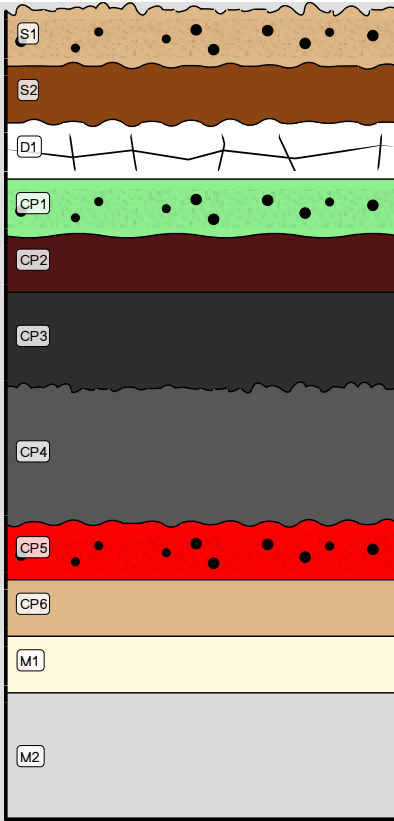
Fig. 4: Stratigraphic representation of the corrosion structure of the vase observed macroscopically under binocular microscope using the MiCorr application with reference to Fig. 3. The characteristics of the strata are only accessible by clicking on the drawing that redirects you to the search tool by stratigraphy representation, credit HE-Arc CR, S.Béguelin.

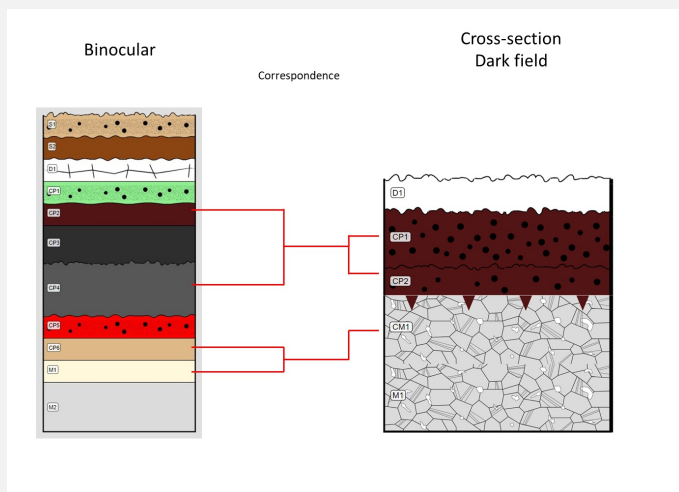
Fig. 20: Stratigraphic representation side by side of binocular view and cross-section (dark field),
