FRAGMENT OF AN AEGIS OF NEÏTH 1886.305.0096 - LEADED BRONZE - ANCIENT EGYPT

Artefact name Fragment of an Aegis of Neïth 1886.305.0096

Authors Line. Pedersen (HE-Arc, Neuchâtel, Neuchâtel, Switzerland) & Christian. Degrigny (HE-Arc CR, Neuchâtel,

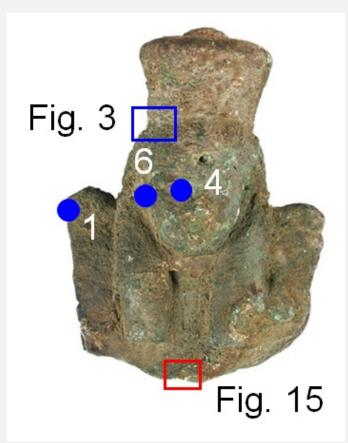
Traces of leaf gilding is still present in certain areas (Fig. 3). The lower part of the collar and the upper part of the crown are broken (Fig. 2 and 4). The surface is covered with a thick and hard, green-brown corrosion crust (Fig. 2, 3 and 4). A cross-section was studied on the lower edge that was broken after excavation. Dimensions: L = 96mm; W = 72mm; V = 72mm;

Fig. 2: Front face of the aegis with location of XRF measurements (blue spots), powder sample (red square) and gilding remains on the surface (blue square),

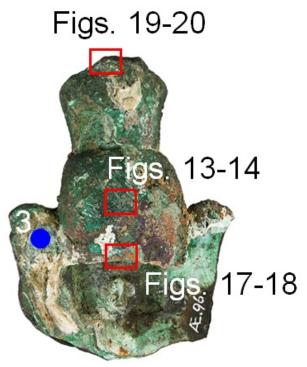
Fig. 5: Back face of the aegis with location of XRF measurement (blue spot) and powder samples (red squares),

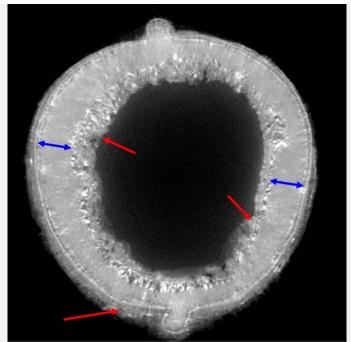
As indicated by the X-ray tomography, the metal of the aegis seems to be well preserved (Figs. 11-12).

Fig. 11: X-ray tomography by cross section of the crown showing a dense and non-porous metal core (blue arrows). The corrosion products however are porous (red arrows). The external limitos is visible as a fine line preserved under corrosion layers,

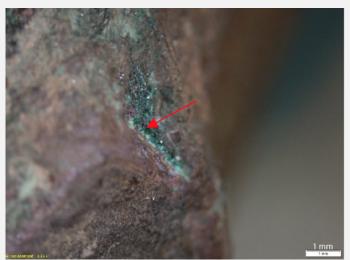
Fig. 13: Observation of the dark green corrosion product,

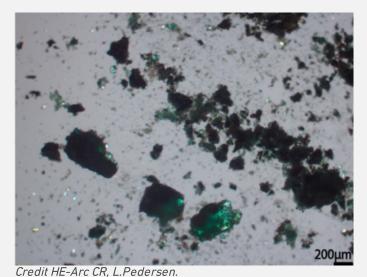
Fig. 14: Dark green corrosion product identified as

paratacamite, atacamite Cu2Cl(OH)3 by XRD. Microscopic examination under polarized light,
