FRAGMENT OF AN AEGIS OF NEÏTH 1886.305.0096 – LEADED BRONZE – ANCIENT EGYPT

Artefact name	Fragment of an Aegis of Neïth 1886.305.0096
Authors	Line. Pedersen (HE-Arc, Neuchâtel, Neuchâtel, Switzerland) & Christian. Degryny (HE-Arc CR, Neuchâtel, Neuchâtel, Switzerland) & Valentin. Boissonnas (HE-Arc CR, Neuchâtel, Neuchâtel, Switzerland)
Url	/artefacts/1567/

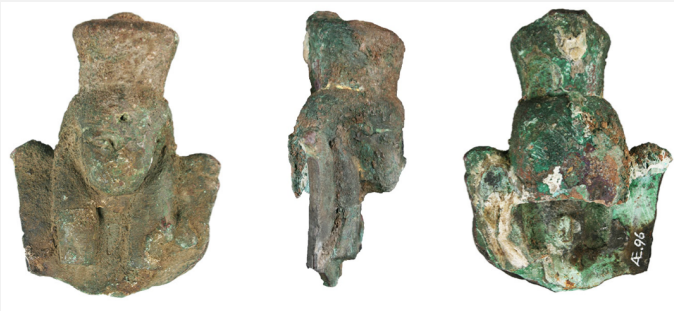
Fig. 1: Fragment of an Aegis of Neïth. From left to right: front, side view and back respectively,

Description of the artefact Fragment of an aegis surmounted by the head of Neïth, the Egyptian goddess of war (Fig. 1). Traces of leaf gilding is still present in certain areas (Fig. 3). The lower part of the collar and the upper part of the crown are broken (Fig. 2 and 4). The surface is covered with a thick and hard, green-brown corrosion crust (Fig. 2, 3 and 4). A cross-section was studied on the lower edge that was broken after excavation. Dimensions: L = 96mm; W = 72mm; T = 40mm; WT = 216g.

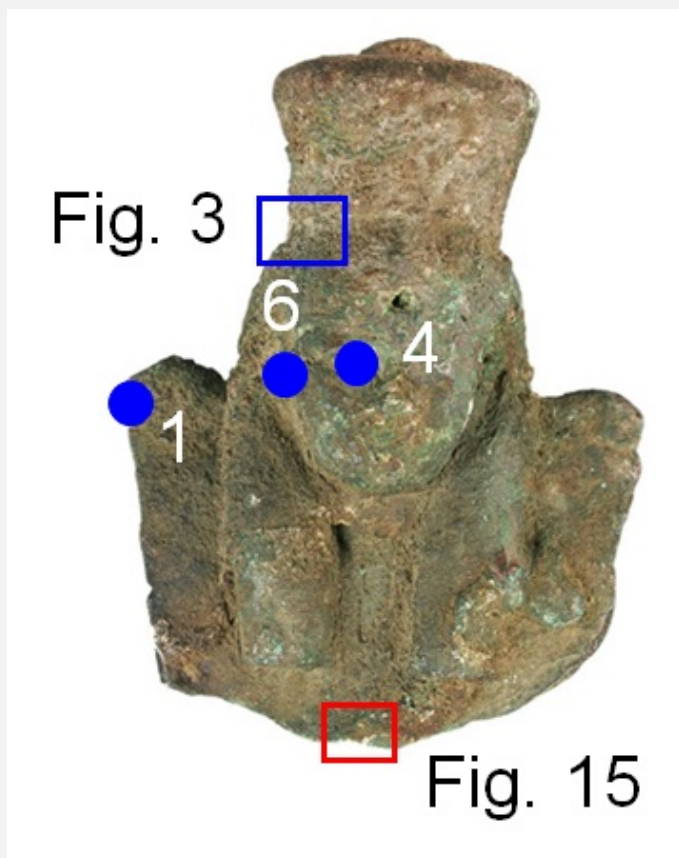
Fig. 2: Front face of the aegis with location of XRF measurements (blue spots), powder sample (red square) and gilding remains on the surface (blue square),

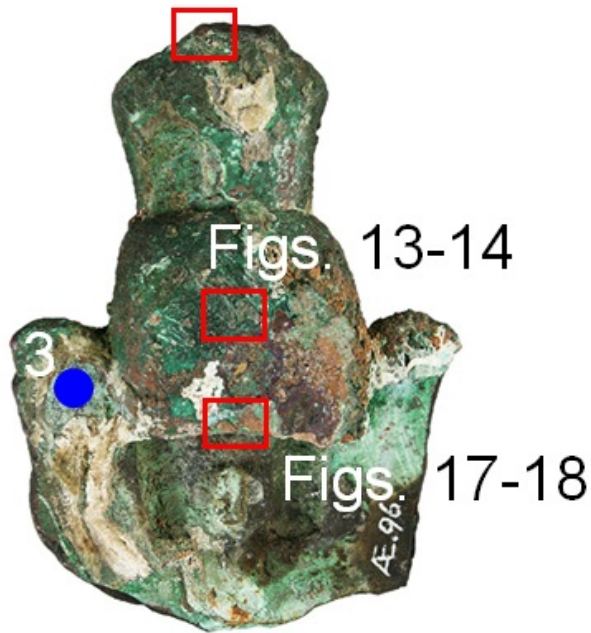
Fig. 5: Back face of the aegis with location of XRF measurement (blue spot) and powder samples (red squares),

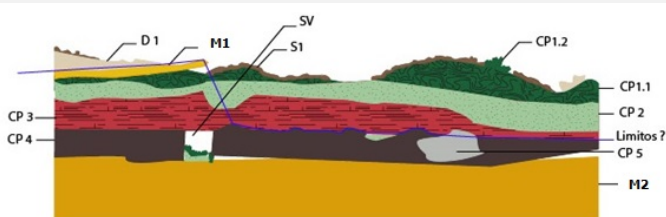
Fig. 6: Preliminary stratigraphy 1, corresponding to the front face of the aegis. S = soil, D = deposit, M = metal, CP = corrosion products, SV = structural void,

Captions	Colour, aspect, hardness and cohesion
S1	Brown, matte, can be scratched with scalpel blade but remains cohesive.
D1	White deposit: shiny, powdery when shaved with scalpel.
M1	Thin gold leaf trapped in corrosion products, brittle, yellow and not adherent.
CP1.1	Dark green corrosion layer, lumpy and matte, thick, hardly scratched by a scalpel blade, cohesive and compact.
CP1.2	Minor stratum of CP1.1. Dark green crystals appearing on the surface of the artefact. Easily scratched under the action a scalpel blade.
CP2	Light green corrosion layer, matte, thick in some places, powdery under the action of a scalpel blade. In some areas it is located directly on CP4.
CP3	Red corrosion layer, lumpy and matte, thick, sometimes hard and sometimes powdery under the action of a scalpel blade.
Limitos	Interface of the limit of the original surface. Shiny, straight and black with manufacturing traces.
CP4	Dark grey with red or green reflection. Shiny, hard, straight, dense and with traces of engraving and possible inlays.

CP5	Isolated white corrosion products: waxy and very soft.
SV	Void in CP4 resulting in loss of the limitos.
M2	Yellow stratum with metallic sheen, dense and hardly scratched by scalpel blade.

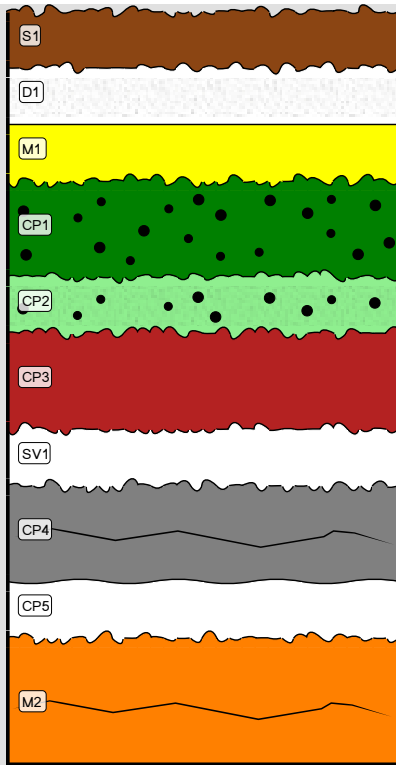
Fig.9: Schematic representation combining stratigraphies 1 and 2 under binocular microscope and using the MiCorr application. The characteristics of the strata are only accessible by clicking on the drawing that redirects you to the search tool by stratigraphy representation, Credit He-Arc CR, L.Pedersen.

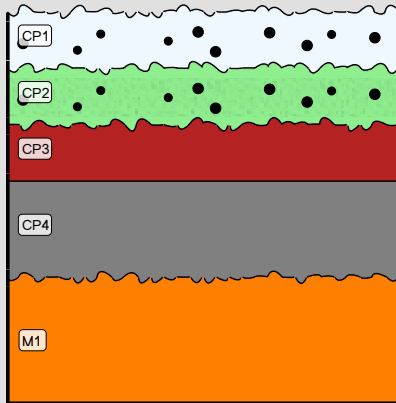
Fig.10: Schematic representation of stratigraphy 3 under binocular microscope and using the MiCorr application. CP1 is CP6 in Fig. 8. The characteristics of the strata are only accessible by clicking on the drawing that redirects you to the search tool by stratigraphy representation, Credit He-Arc CR, L. Pedersen.

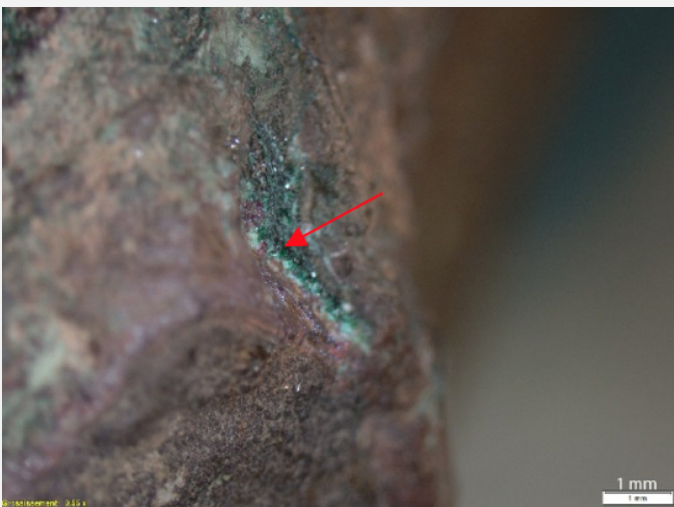
Fig. 13: Observation of the dark green corrosion product,

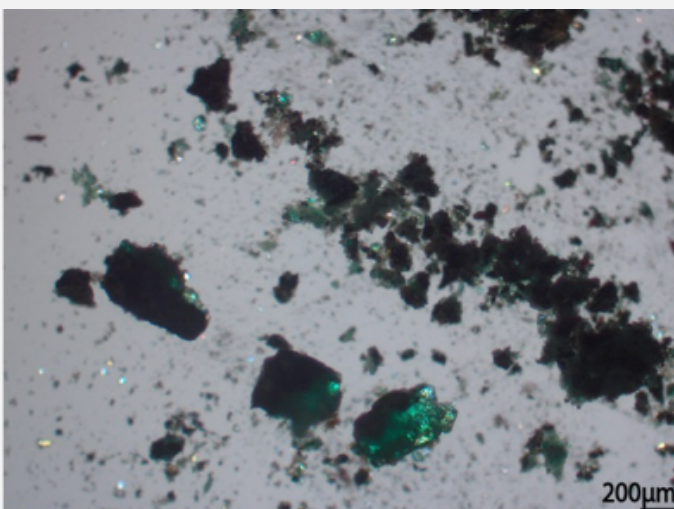
Fig. 14: Dark green corrosion product identified as paratacamite, atacamite $\text{Cu}_2\text{Cl}(\text{OH})_3$ by XRD. Microscopic examination under polarized light,

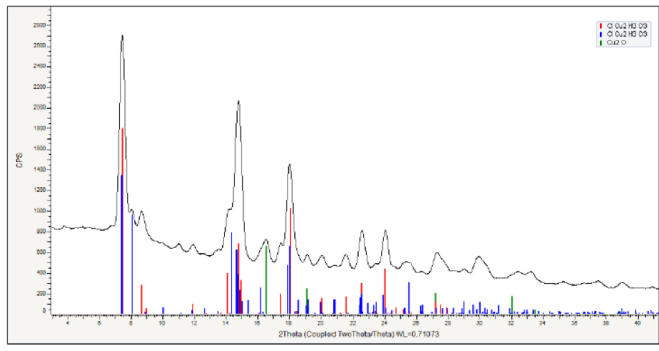
Fig. 22: XRD spectrum of the sample from the light green corrosion product showing the presence of atacamite and paratacamite ($\text{Cu}_2\text{Cl}(\text{OH})_3$) as major compound and cuprite (Cu_2O) as minor compound,

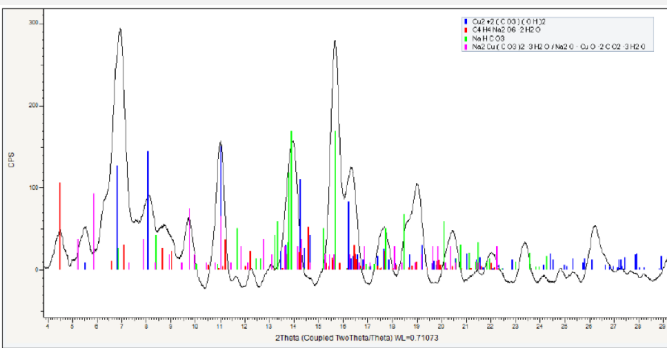
Fig. 23: XRD spectrum of the sample from the light blue corrosion product showing the presence of chalconatronite ($\text{Na}_2\text{Cu}(\text{CO}_3)_2 \cdot 3\text{H}_2\text{O}$). The other compounds are analysis supposition, but are not relevant,

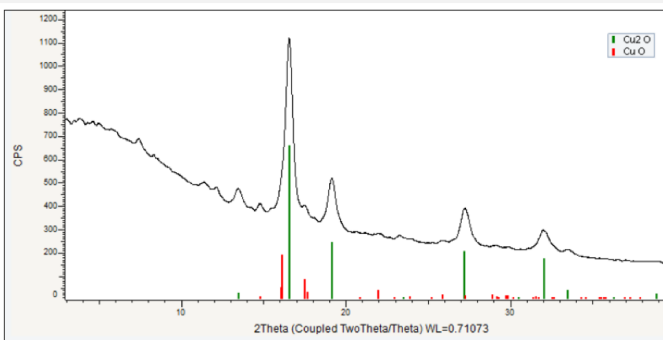
Fig. 24: XRD spectrum of the sample from the dark red corrosion product showing the presence of cuprite (Cu_2O) as major compound and tenorite (CuO) as minor compound,
