AIRCRAFT REAR FASTENING PLATE VHS-497 – AL ALLOY – MODERN TIMES – SWITZERLAND

Artefact name	Aircraft rear fastening plate VHS-497
Authors	Marianne. Senn (Empa, Dübendorf, Zurich, Switzerland) & Christian. Degriigny (HE-Arc CR, Neuchâtel, Neuchâtel, Switzerland)
Url	/artefacts/1571/

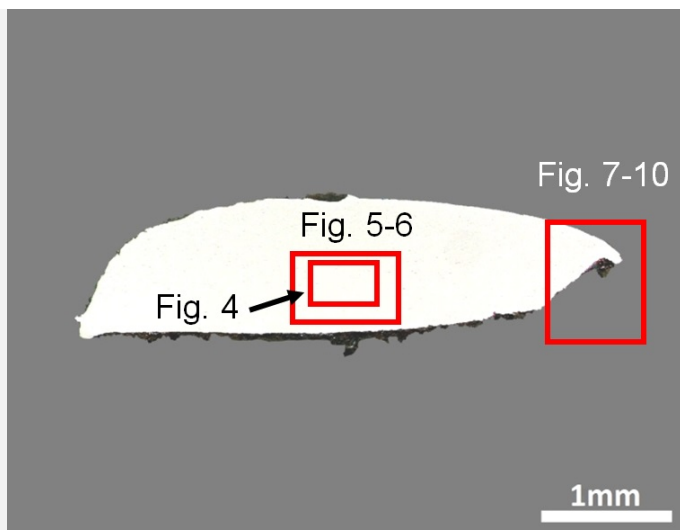
Fig. 3: Micrograph of the cross-section of the sample taken from the back fastening plate showing the location of Figs. 4 to 10,

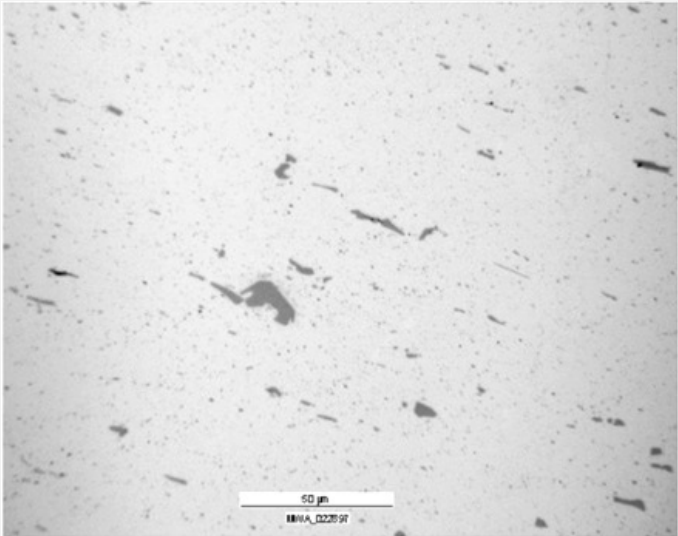
The metal is a relatively pure aluminium alloy with numerous inclusions (Table 1). From the chemical composition of the inclusions they can be interpreted as alpha-AlFeSi intermetallic compounds. In bright field we observe elongated inclusions indicating that the metal was rolled (Fig. 4). The alloy composition is similar to an unalloyed primary aluminium (Al content between 99 and 99.8 mass%). The O content reflects the immediate oxidation of the metal and is not part of the alloy. After etching the organisation of inclusions in rows is more easily seen (Fig. 5). The SEM image shows large grains formed after annealing (Fig. 6). The average hardness of the metal is HV1 40.

Fig. 4: Micrograph of the metal sample from Fig. 3 (detail), unetched, bright field. The metal matrix is in white, the elongated inclusions in grey,

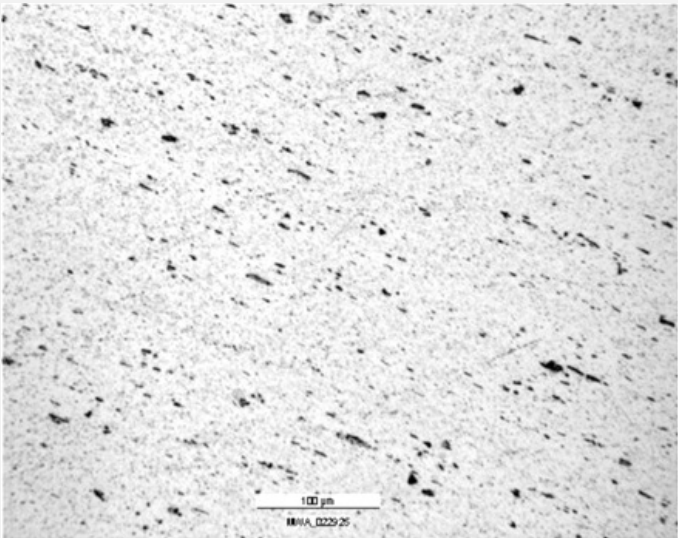
Fig. 5: Micrograph of the metal sample from Fig. 3 (detail), etched, bright field. The metal matrix is in white, the elongated inclusions in dark-grey and black,

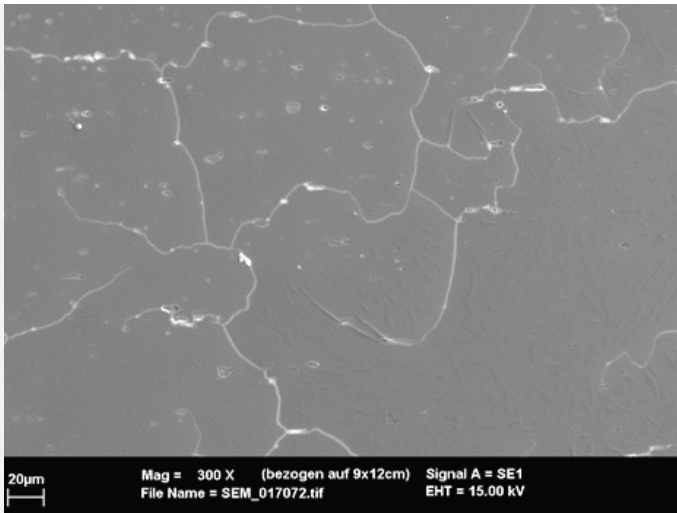
Fig. 6: SEM image of the metal sample from Fig. 3 (detail), SE-mode, etched. We observe the presence of large grains and numerous elongated inclusions,

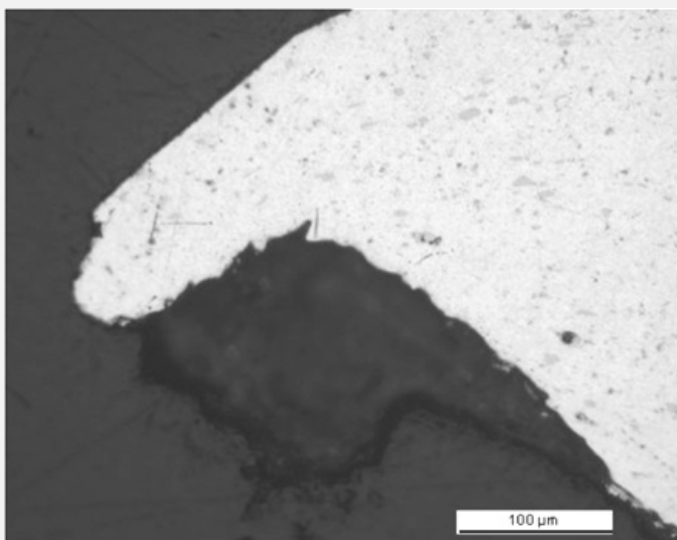
The metal is covered by a very thin corrosion layer (CP1). In addition to this, locally thicker adhering materials can be observed (NMM1, appearing as dark-grey area in Fig. 7). Under polarized light, they appear blue-brown (Fig. 8). Analysis by SEM-EDS indicates that the metal is, as expected, covered by a very thin Al and O-rich layer whereas the particles in the adherent material contain C, O, Si, Ca, Fe, Zn, S and even Ti (Figs. 9 and 10). The location of the adherent material and the presence of both Zn and Ti suggest that it is a residue of a paint coating.

Fig. 7: Micrograph showing the metal - adhering material interface from Fig. 3 (reversed picture, detail), unetched, bright field. We observe in white the metal matrix and dark-grey the adhering material,

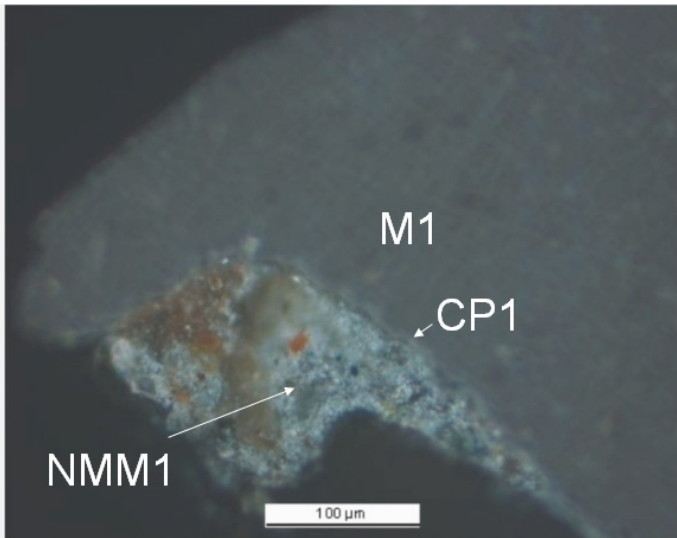
Fig. 8: Micrograph (same as Fig. 7) and corresponding to the stratigraphy of Fig. 11, unetched, polarised light. We observe in grey the metal matrix and blue-brown the adhering material,

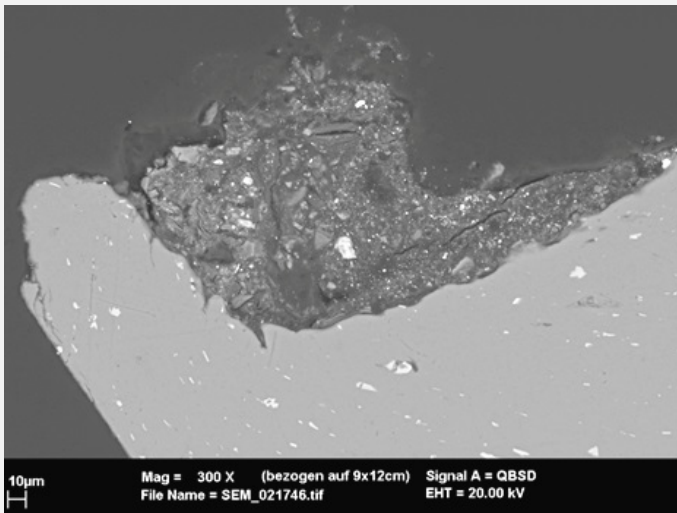
Fig. 9: SEM image (same as Fig. 7, inverted picture, detail), BSE-mode, unetched,

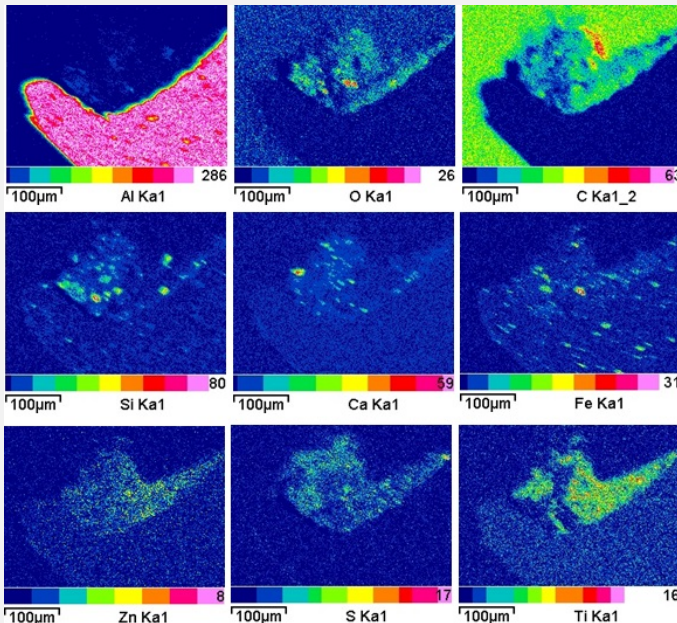
Fig. 10: Elemental chemical distribution of the selected area from Fig. 9. Method of examination: SEM/EDS, Laboratory of Analytical Chemistry, Empa,

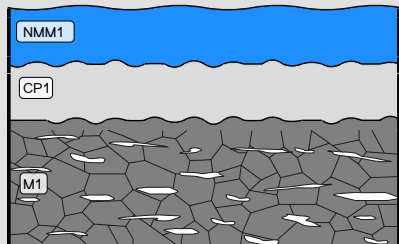
Fig. 11: Stratigraphic representation of the sample taken from the back fastening plate in cross-section (dark field) using the MiCorr application. The characteristics of the strata are only accessible by clicking on the drawing that redirects you to the search tool by stratigraphy representation. This representation can be compared to Fig. 8, Credit HE-Arc CR.
