# AIRCRAFT FRONT FASTENING PLATE VHS-497 (2) – AL CU SN ZN SI ALLOY – MODERN TIMES – SWITZERLAND

**Artefact name** Aircraft front fastening plate VHS-497 (2)

**Authors** Marianne. Senn (Empa, Dübendorf, Zurich, Switzerland) & Christian. Degryny (HE-Arc CR, Neuchâtel, Neuchâtel, Switzerland)

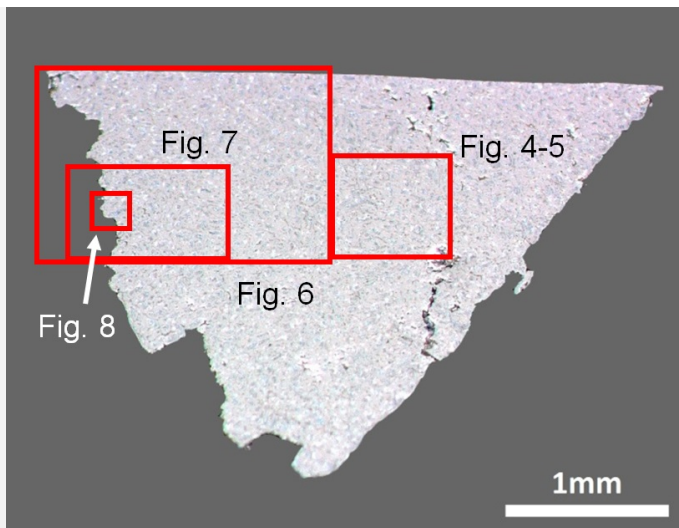
Fig. 3: Micrograph of the cross-section of the sample taken from the front fastening plate showing the location of Figs. 4 to 8,

| <b>Description of sample</b> | The top part has been cut during sampling (Fig. 2). The more regular right side is the plate surface and the irregular side is the broken edge (Fig. 3). Dimensions: L = 4mm ; W = 4mm. |

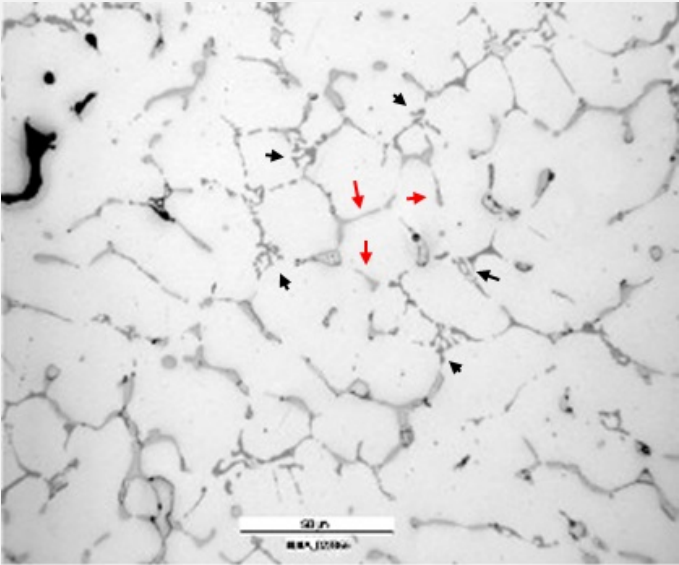
The metal is an aluminium alloy containing Cu, Sn, Zn and Si (Table 1). The unetched metal shows an as-cast structure consisting of the aluminium matrix with Sn (not soluble in Al) inclusions (Figs. 4 and 5), intermetallic compounds such as Al<sub>2</sub>Cu (Fig. 4, red arrows) and clusters of Al,Fe,Cu & Si phases (Fig. 4, black arrows). There are porosities in the metal (Figs. 3 and 5). The average hardness of the metal is HV1 80.

Fig. 4: Micrograph of the metal sample from Fig. 3 (detail), unetched, bright field. The cast structure is revealed by light grey intermetallic compounds (Al<sub>2</sub>Cu, red arrows), dark-grey Al,Fe, Si & Cu phase clusters (black arrows) and Sn inclusions (nodules). On the top left some pores can be seen,

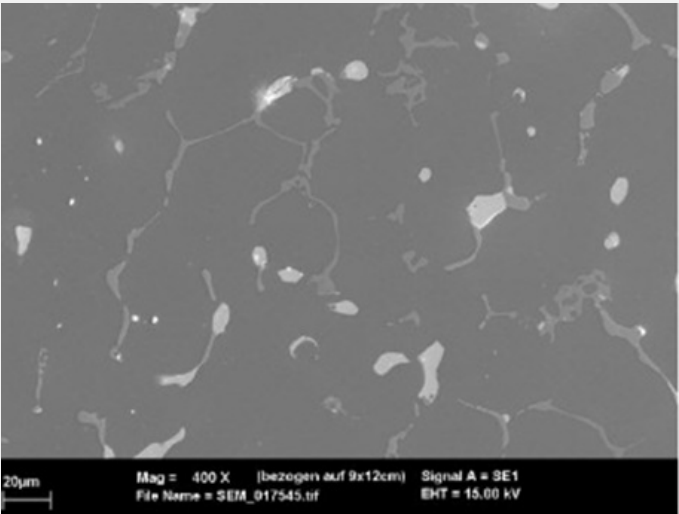
Table 1: Chemical composition (mass %) of the metal and inclusions (from Fig. 5, <: below the detection limit). Method of analysis: SEM/EDS, Laboratory of Analytical Chemistry, Empa.

Fig. 5: SEM image of the metal sample from Fig. 3 (detail), SE-mode, unetched. We observe in dark-grey the metal matrix, in medium-grey the intermetallic compound Al<sub>2</sub>Cu as well as Al,Fe, Si & Cu phase clusters and in light-grey the Sn inclusions,

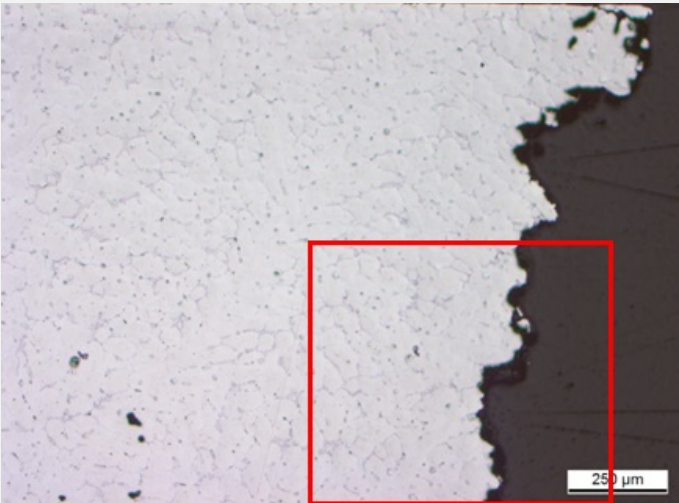
No corrosion layer can be seen on the metal surface (Figs. 3 and 6). Under polarized light small white and brown particles are visible on the broken edge (D1, Fig. 7). Their analysis reveals the presence of silica particles surrounded by dirt (Table 2 and Fig. 8). The metal surface is covered by a thin oxygen bearing skin (CP1, Fig. 8).

Fig. 6: Micrograph showing the metal - “corrosion products” interface from Fig. 3 (reversed picture, detail), unetched, bright field. We observe in white the metal matrix, in dark-grey Al,Fe, Si & Cu phase and light-grey Al2Cu intermetallic compounds. The micrograph of Fig. 7 is marked by a rectangle,

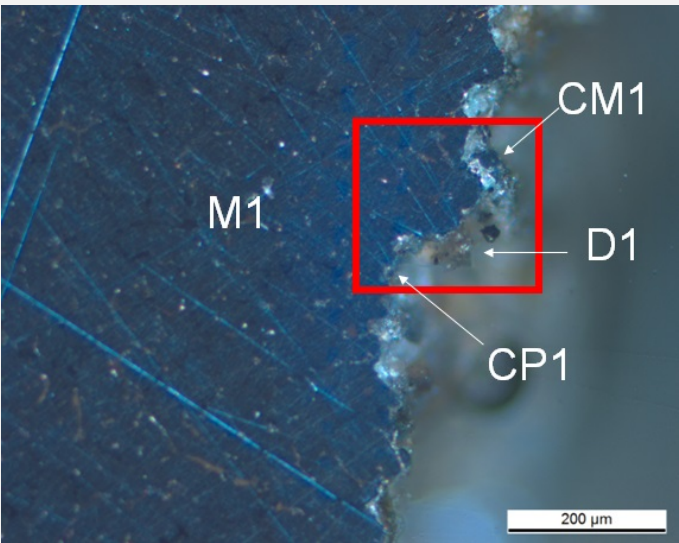
Fig. 7: Micrograph from Fig. 6 (detail) and corresponding to the stratigraphy of Fig. 9, unetched, polarised light. We observe in dark blue the metal matrix and blue-brown the adherent material. The area selected for elemental chemical distribution (Fig. 8) is marked by a rectangle,

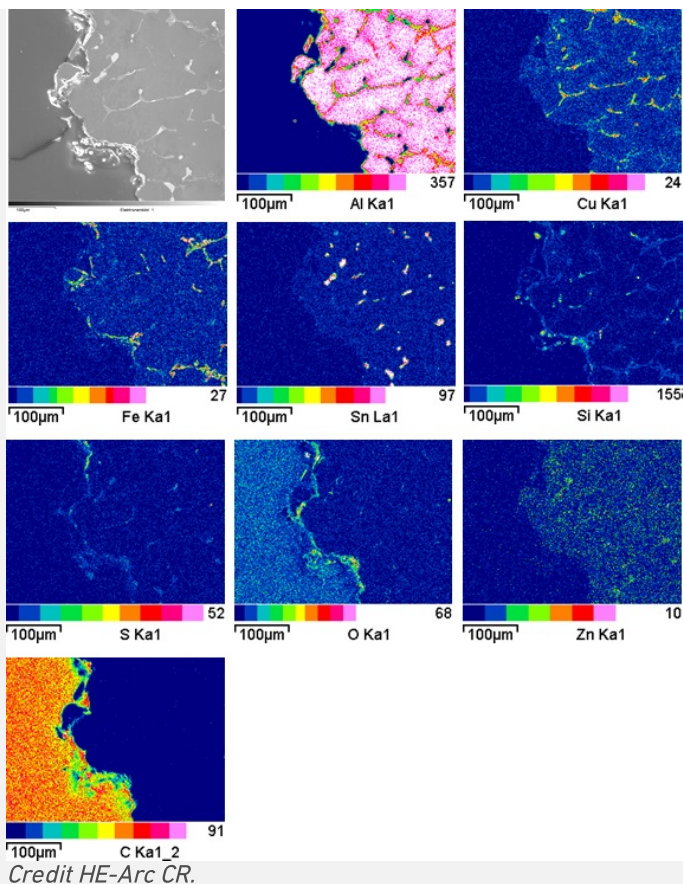
Table 2: Chemical composition (mass %, <: below the detection limit) of the adhering particles to the metal surface (from Fig. 8). Method of analysis: SEM/EDS, Laboratory of Analytical Chemistry, Empa.

Fig. 8: SEM image, BSE-mode, and elemental chemical distribution of the selected area from Fig. 7 (reversed picture, detail). Method of examination: SEM/EDS, Laboratory of Analytical Chemistry, Empa,

This front fastening plate of Dufaux IV plane is made in cast Al-Cu-Sn-Zn-Si, an alloy rather common at the beginning of the 20th century. No corrosion layer has been found on the metal surface except adherent silica-rich particles and the thin oxidised skin typical of Al alloys. The presence of these materials can be explained by the regular maintenance of the metal, probably using silicon carbide abrasive paper.
