SACRIFICIAL ANODE VHS-8339 – ZN ALLOY – MODERN TIMES – SWITZERLAND

Artefact name	Sacrificial anode VHS-8339
Authors	Marianne. Senn (Empa, Dübendorf, Zurich, Switzerland) & Christian. Degryny (HE-Arc CR, Neuchâtel, Neuchâtel, Switzerland)
Url	/artefacts/1575/

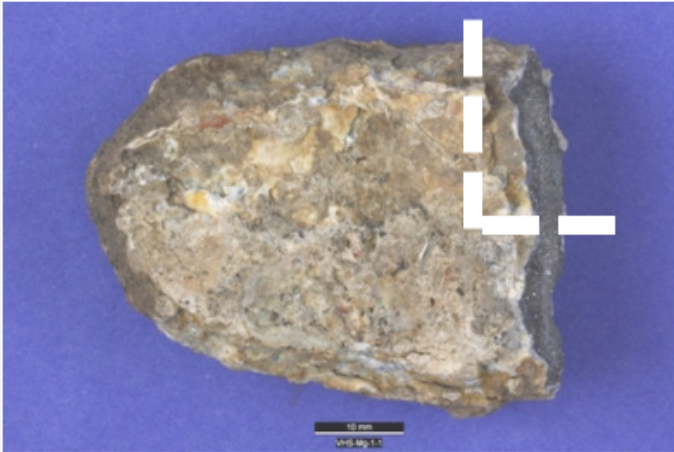
Fig. 2: Location of sampling area,

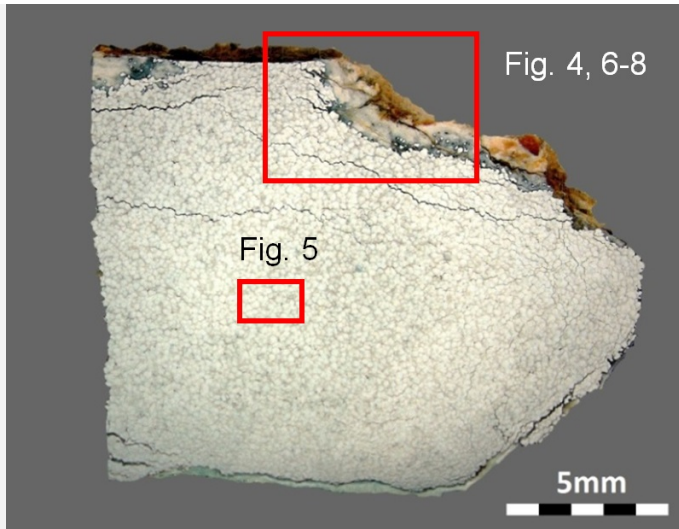
Fig. 3: Micrograph of the cross-section of the fragment sampled from the sacrificial anode showing the location of Figs. 4 to 8,

Description of sample	The sample (Fig. 3) shows a cross-section from the fragment of the sacrificial anode (Fig. 2). It has a silvery appearance. The thickness of the corrosion crust is variable. Dimensions: L = 17mm; W = 14mm.
Alloy	Zn Alloy
Technology	Cast and annealed
Lab number of sample	VHS-Mq-1
Sample location	HE-Arc CR, Neuchâtel, Neuchâtel
Responsible institution	Swiss Museum of Transport, Luzern, Lucerne
Date and aim of sampling	07/09/2009 metallography

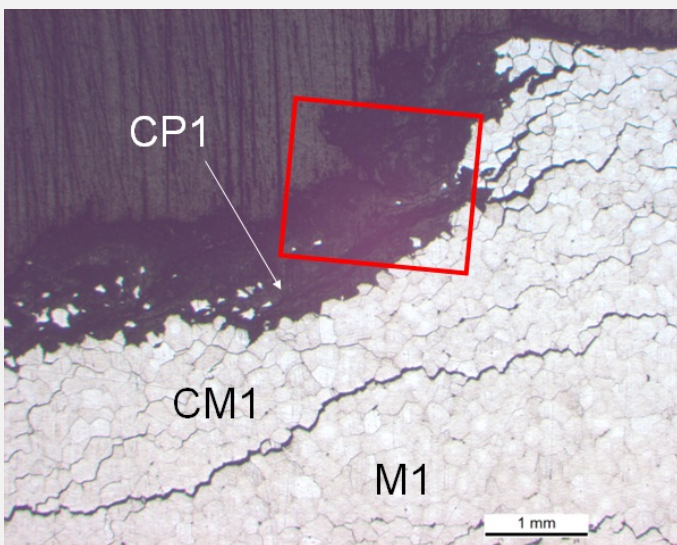
The remaining metal is an almost pure zinc alloy (Table 1). The oxygen content is not from the original alloy, but is due to secondary corrosion. The metal grains are visible without etching and present a polygonal structure (Figs. 4 and 5). The structure is recrystallized after annealing. The recrystallization of zinc alloys begins at room temperature.

Fig. 4: Micrograph of the metal sample from Fig. 3 (reversed picture, detail), unetched, bright field. Extensive intergranular corrosion is visible. The rectangle marks Fig. 6,

Extensive intergranular corrosion / cracking has developed in the metal structure (Figs. 4, 5). The metal is covered by a corrosion crust that is hardly visible in bright field and which contains remnant metal (Fig. 4). On most of the sample the corrosion crust is uniform. In areas we see cracks (Fig. 6) appearing as brown lines separating the corrosion crust (Fig. 7). In bright field the corrosion crust appears grey containing dark-grey zones (Fig. 6). Under polarized light, the corrosion crust appears white with darker parts including remnant metal (Fig. 7). It contains Zn and O as well as S along some cracks (Table 2 and Fig. 8).

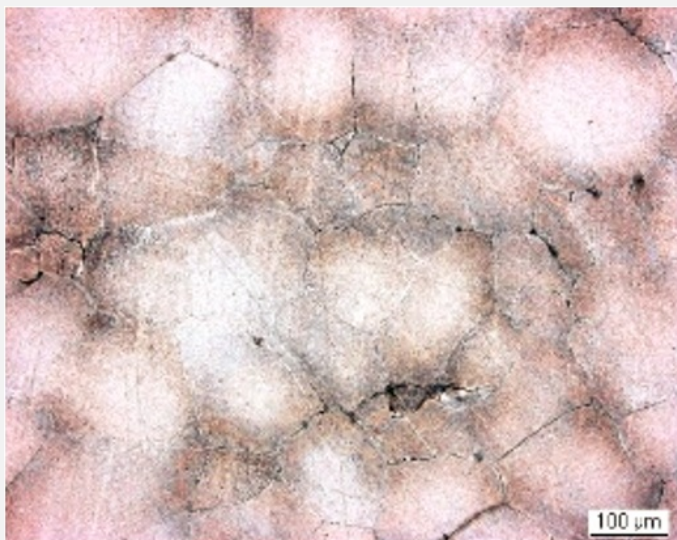
Fig. 5: Micrograph of the metal sample from Fig. 3 (detail), etched,

Microstructure Recrystallized structure (polygonal grains)

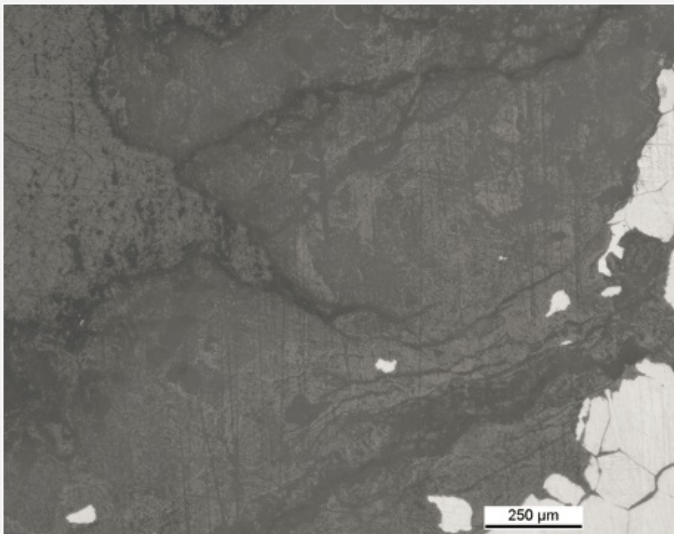
Table 2. Chemical composition (mass %, <: below the detection limit) of the corrosion layer from Figs. 6 and 8. Method of analysis: SEM/EDS, Laboratory of Analytical Chemistry, Empa.

Fig. 6: Micrograph showing the metal - corrosion products interface from Fig. 5 (detail), unetched, bright field,

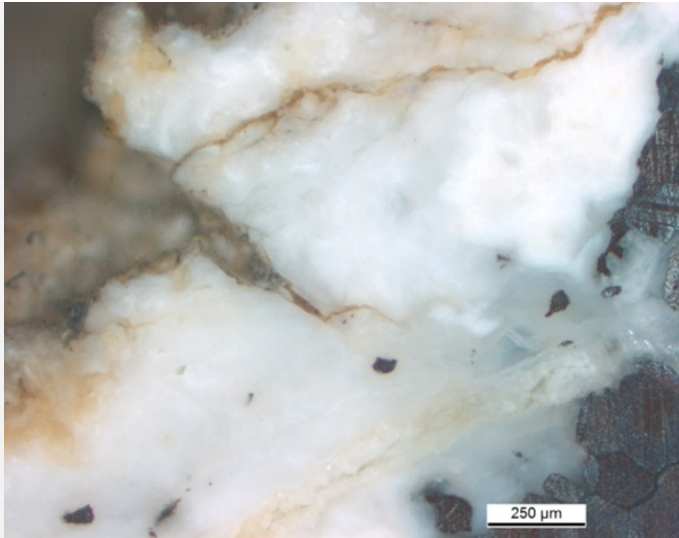
Fig. 7: Micrograph (same as Fig. 6) corresponding to the stratigraphy of Fig. 4, unetched, polarised light. We observe in dark-grey the metal, in white the corrosion crust separated by brown cracks including remnant metal,

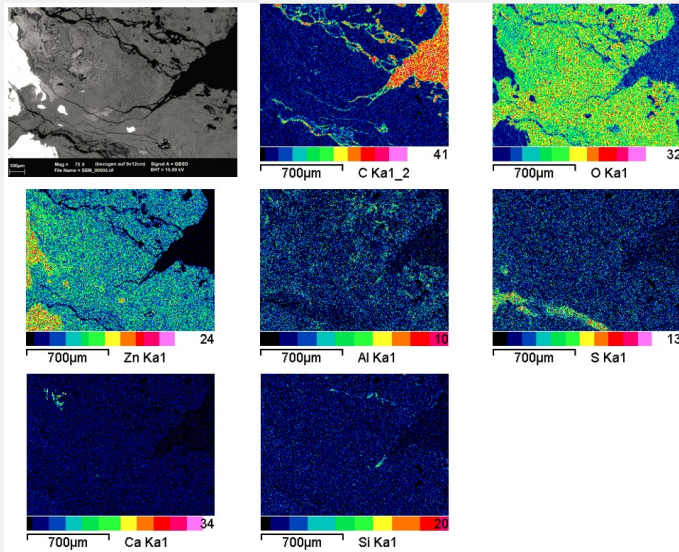
Elements	O	Al	Zn	Total
Light-grey corrosion part	23	<	77	98
Dark grey corrosion part	38	<1	68	107

Fig. 8: SEM image, BSE-mode, and elemental chemical distribution of most of the area of Fig. 6 (reversed picture). Method of examination: SEM/EDS, Laboratory of Analytical Chemistry, Empa,
