# SACRIFICIAL ANODE VHS-8339 – ZN ALLOY – MODERN TIMES – SWITZERLAND

<b>Artefact name</b>	Sacrificial anode VHS-8339
<b>Authors</b>	Marianne. Senn (Empa, Dübendorf, Zurich, Switzerland) & Christian. Degrygn (HE-Arc CR, Neuchâtel, Neuchâtel, Switzerland)
<b>Url</b>	/artefacts/1575/

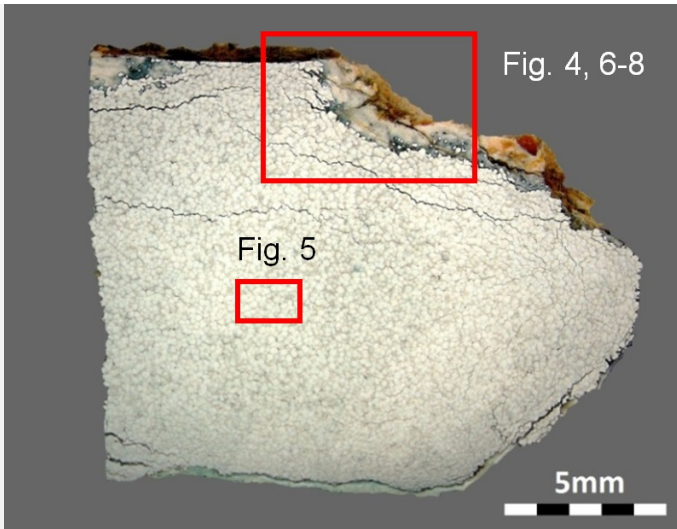
Fig. 3: Micrograph of the cross-section of the fragment sampled from the sacrificial anode showing the location of Figs. 4 to 8,

<b>Description of sample</b>	The sample (Fig. 3) shows a cross-section from the fragment of the sacrificial anode (Fig. 2). It has a silvery appearance. The thickness of the corrosion crust is variable. Dimensions: L = 17mm; W = 14mm.
<b>Alloy</b>	Zn Alloy
<b>Technology</b>	Cast and annealed
<b>Lab number of sample</b>	VHS-Mq-1
<b>Sample location</b>	HE-Arc CR, Neuchâtel, Neuchâtel
<b>Responsible institution</b>	Swiss Museum of Transport, Luzern, Lucerne
<b>Date and aim of sampling</b>	07/09/2009 metallography

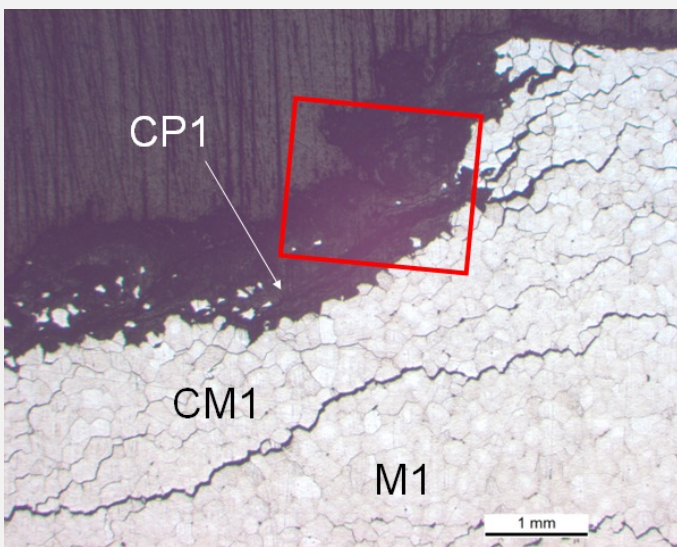
The remaining metal is an almost pure zinc alloy (Table 1). The oxygen content is not from the original alloy, but is due to secondary corrosion. The metal grains are visible without etching and present a polygonal structure (Figs. 4 and 5). The structure is recrystallized after annealing. The recrystallization of zinc alloys begins at room temperature.

Fig. 4: Micrograph of the metal sample from Fig. 3 (reversed picture, detail), unetched, bright field. Extensive intergranular corrosion is visible. The rectangle marks Fig. 6,

Extensive intergranular corrosion / cracking has developed in the metal structure (Figs. 4, 5). The metal is covered by a corrosion crust that is hardly visible in bright field and which contains remnant metal (Fig. 4). On most of the sample the corrosion crust is uniform. In areas we see cracks (Fig. 6) appearing as brown lines separating the corrosion crust (Fig. 7). In bright field the corrosion crust appears grey containing dark-grey zones (Fig. 6). Under polarized light, the corrosion crust appears white with darker parts including remnant metal (Fig. 7). It contains Zn and O as well as S along some cracks (Table 2 and Fig. 8).

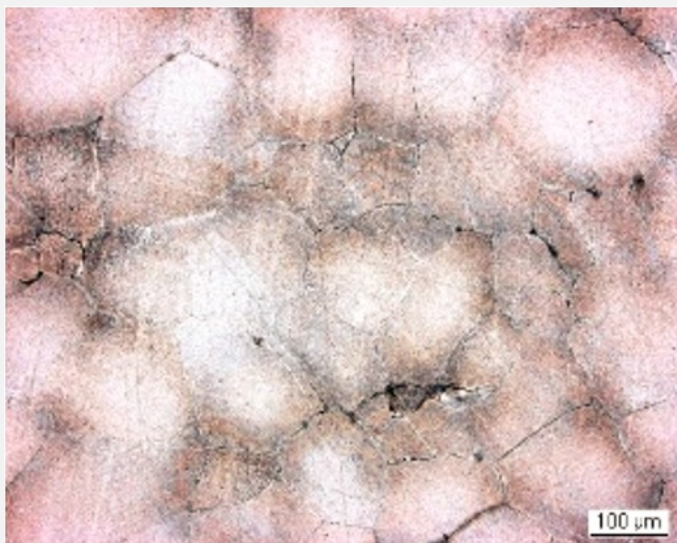
Fig. 5: Micrograph of the metal sample from Fig. 3 (detail), etched,

**Microstructure** Recrystallized structure (polygonal grains)
