# ARMATURE FROM A CLOCK MOVEMENT MIH IV-212 - ZN AL SN CU ALLOY - MODERN TIMES - SWITZERLAND

<b>Artefact name</b>	Armature from a clock movement MIH IV-212
<b>Authors</b>	Marianne. Senn (Empa, Dübendorf, Zurich, Switzerland) & Christian. Degriigny (HE-Arc CR, Neuchâtel, Neuchâtel, Switzerland)
<b>Url</b>	/artefacts/1576/

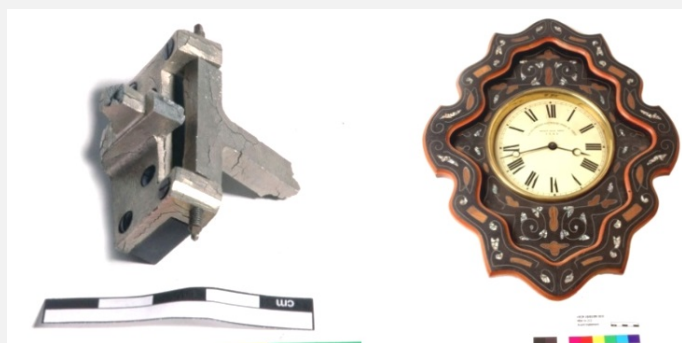
Fig. 1: Broken armature (left) from the clock movement of a wooden wall clock (right) (after Seematter 2009),

<b>Description of the artefact</b>	Armature from the clock movement of a wooden wall clock with electric movement, broken in two elements (Fig. 1 and Fig. 2) with a heavily cracked surface.
<b>Type of artefact</b>	Horological object
<b>Origin</b>	Wooden wall clock, La Chaux-de-Fonds, Neuchâtel, Switzerland
<b>Recovering date</b>	1902-1904
<b>Chronology category</b>	Modern Times
<b>chronology tpq</b>	<input type="text" value="1902"/> A.D. ▾
<b>chronology taq</b>	<input type="text" value="1904"/> A.D. ▾
<b>Chronology comment</b>

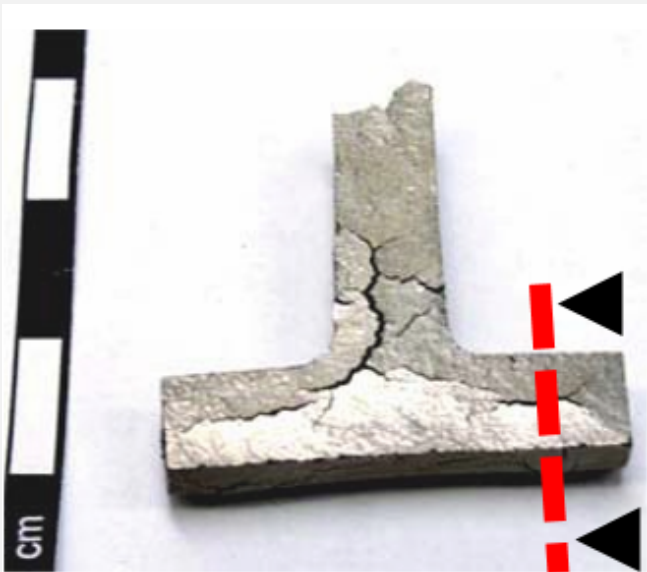
Fig. 2: Location of sampling area on one of the two broken elements of the armature,

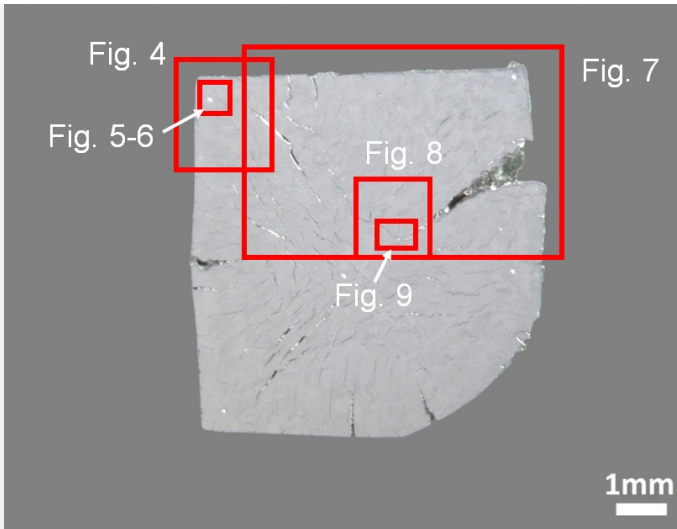
Fig. 3: Micrograph of the cross-section of the fragment sampled from the armature showing the location of Figs. 4 to 9,

<b>Description of sample</b>	This sample is the complete cross-section from one of the two broken elements of the armature (Fig. 2). The metal has large cracks radiating from the centre to the outside which have deformed the armature (Fig. 3).
<b>Alloy</b>	Zn Al Sn Cu Alloy
<b>Technology</b>	As-cast
<b>Lab number of sample</b>	MIH-VI-212
<b>Sample location</b>	HE-Arc CR, Neuchâtel, Neuchâtel
<b>Responsible institution</b>	International museum of horology (IMH), La Chaux-de-Fonds, Neuchâtel
<b>Date and aim of sampling</b>	2009, metal analysis

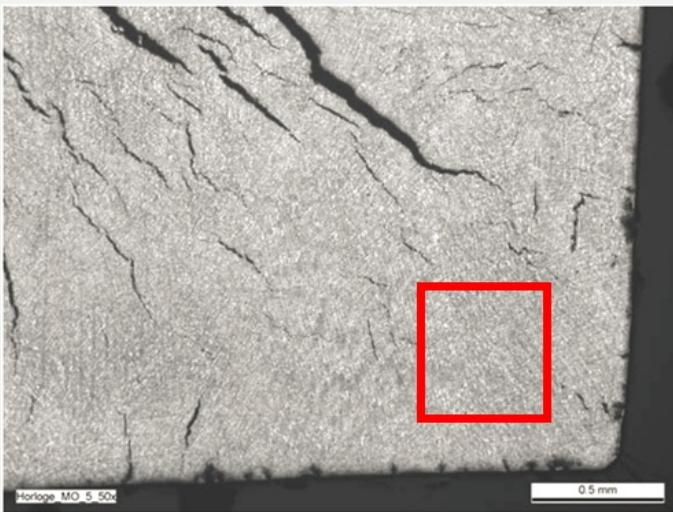
The metal is a Zn-Al-Sn-Cu alloy (Table 1) with an average hardness of HV1 105. A fine dendritic structure is observed (Fig. 4) which consists of clearly separated Zn, Al-Cu and Sn-rich phases (Figs. 5 and 6). Pb is associated with Sn but also forms tiny nodules.

Fig. 4: Micrograph of the metal sample from Fig. 3 (inverted picture, rotated by 270°, detail), unetched, bright field. A dendritic structure is visible. The micrograph of Fig. 5 is marked by a square,

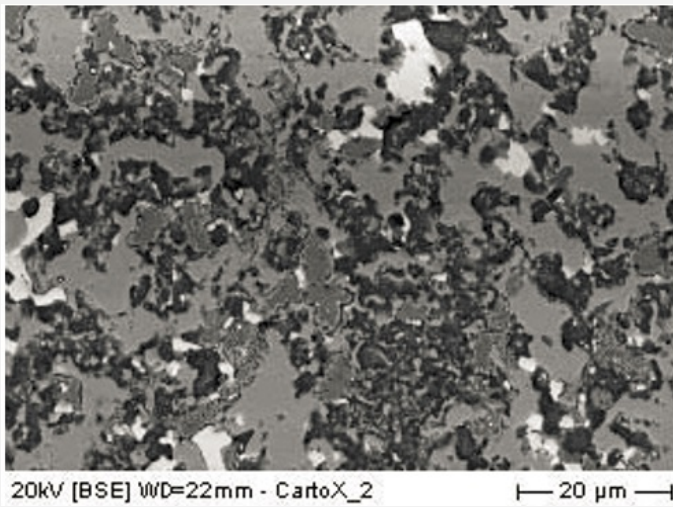
Fig. 5: SEM image, BSE-mode, detail from Fig. 4 (detail), unetched, bright field. Three phases appear: in light-grey the Zn-rich phase, in dark-grey the Al and Cu-rich phase and in white the Sn-rich phase,

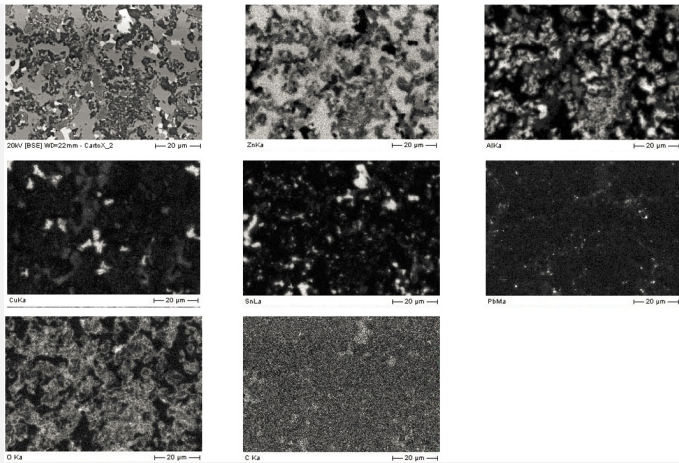
Fig. 6: SEM image, BSE-mode, and elemental chemical distribution of the selected area from Fig. 5. Method of examination: SEM/EDS, Lab of Electronic Microscopy and microanalysis, IMA (Néode), HEI Arc,

The Zn-rich phase is heavily oxidised internally (Fig. 6). The corrosion has developed throughout the entire metal body, generating cracks (Figs. 7 and 8). The cracks are Zn, O and C-rich (Fig. 9) and could be composed of zinc carbonate.

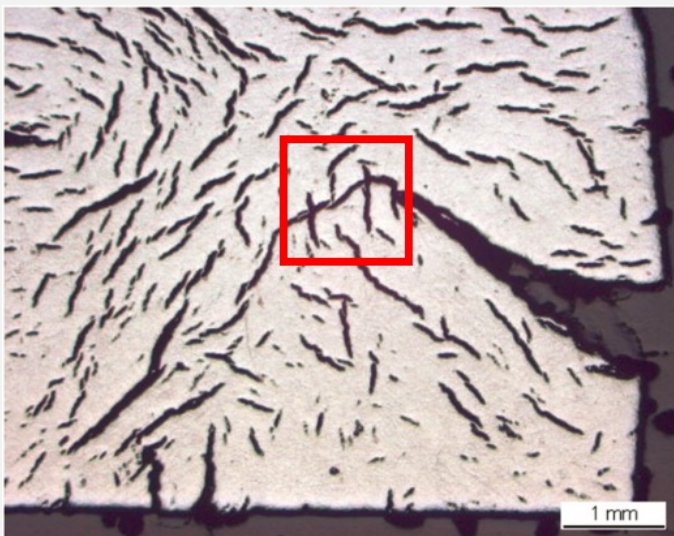
Fig. 7: Micrograph showing the metal - "corrosion products" interface from Fig. 3 (reversed picture, detail), unetched, bright field,

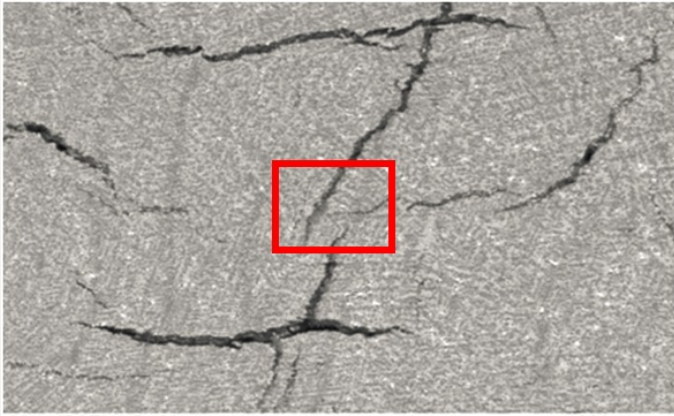
Fig. 8: Micrograph of the metal sample, detail from Fig. 7 (reversed and rotated by 90°), unetched, bright field. A dendritic structure is visible. The area selected for elementary mapping (Fig. 9) is marked by a rectangle. Can be compared to the stratigraphy representation of Fig. 10,

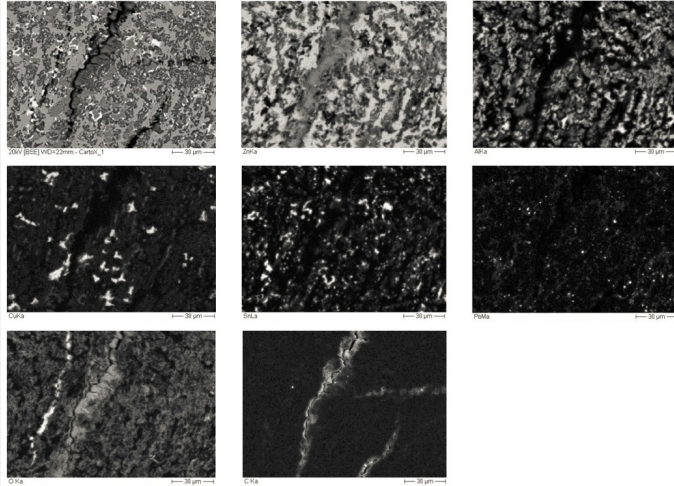
Fig. 9: SEM image, BSE-mode, and elemental chemical distribution of the selected area from Fig. 8 (detail). Method of examination: SEM/EDX, Lab of Electronic Microscopy and microanalysis, IMA (Néode), HEI Arc,

**Corrosion form** Internal cracking  
**Corrosion type** zinc pest
